# Your Inspection Report

xxx My Street  
My Town, MA 02000

**INSPECTION DATE:**  
Monday, October 30, 2017

RE: Report No. 1424, v.2  
xxx My Street  
My Town, MA  
02000

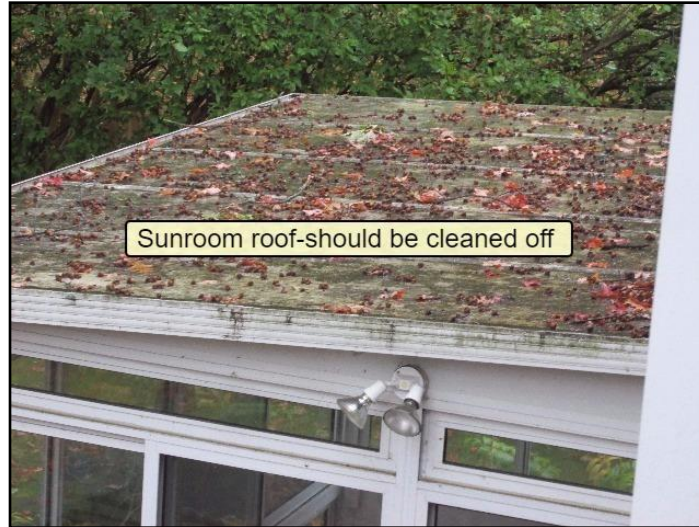
1.

**General:** • Synthetic plastic roofing on sun room at rear

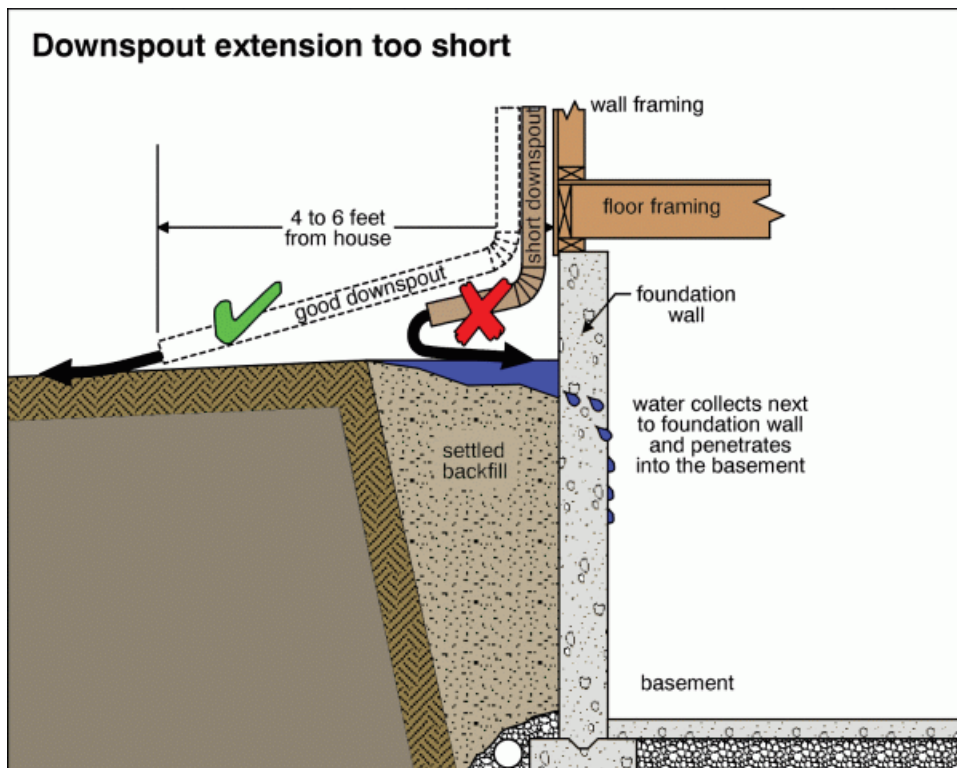
## Downspout extension too short

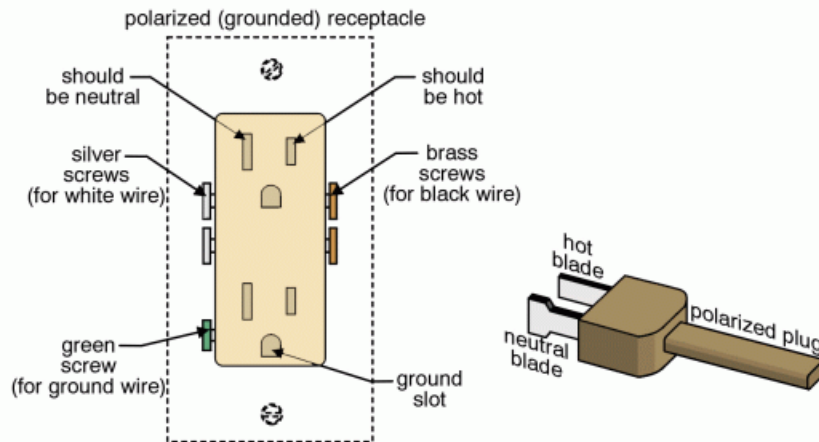
### Reversed polarity

when the polarity is reversed, the wide receptacle slot is (incorrectly) hot and the narrow slot is neutral - this is not uncommon when people forget that the black wire should be attached to the receptacle's brass screws

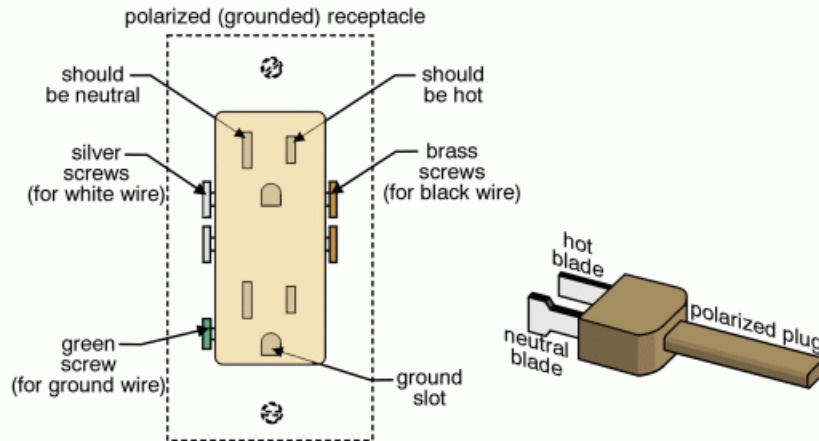
### Reversed polarity

when the polarity is reversed, the wide receptacle slot is (incorrectly) hot and the narrow slot is neutral - this is not uncommon when people forget that the black wire should be attached to the receptacle's brass screws

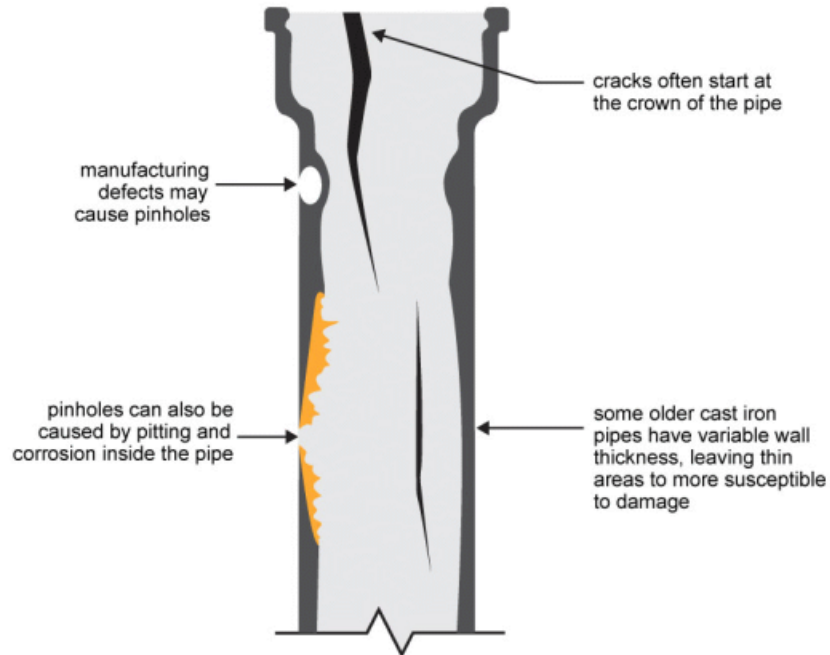
## Pinholing and cracks in cast iron stacks

38. *Rust*

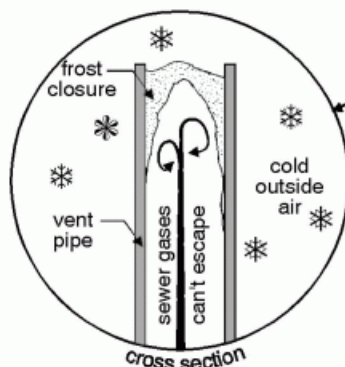
## Vent too tall

if the plumbing vent extends too far above the roof, frost closure can become a problem

on flat roofs, the vent should extend at least 6" above the high water level

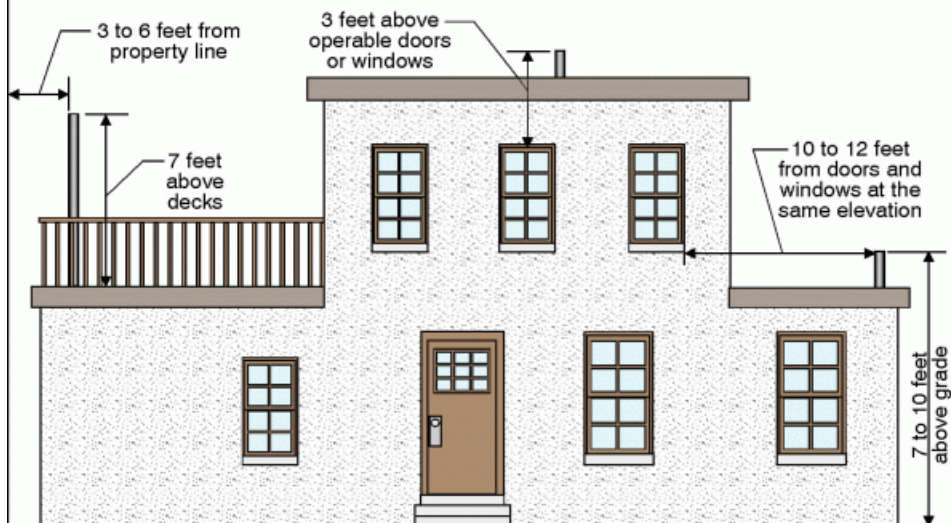
45. Vent termination problems

## Plumbing vent clearances
