# YOUR INSPECTION REPORT

596 Durie Street  
Toronto, ON M6S 3H1

Wednesday, February 12, 2020

RE: Report No. 2609, v.3  
596 Durie Street  
Toronto, ON  
M6S 3H1

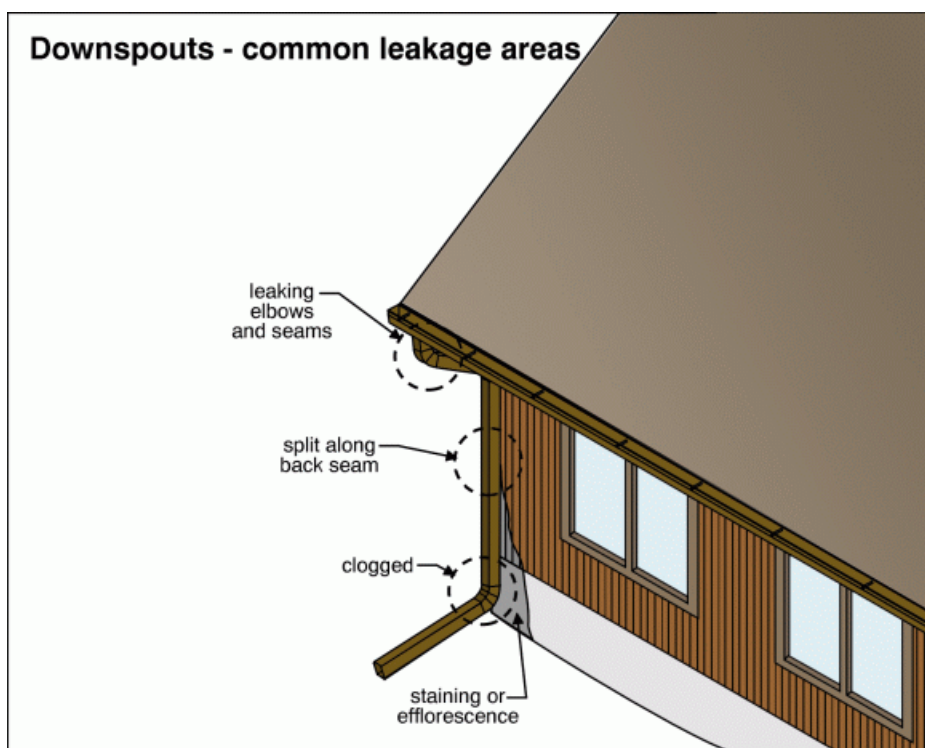
6. Damage

Condition: • [Damage](#)

Implication(s): Chance of water damage to contents, finishes and/or structure

Task: Repair / Replace

Time: Prior to first use

Cost: Minor

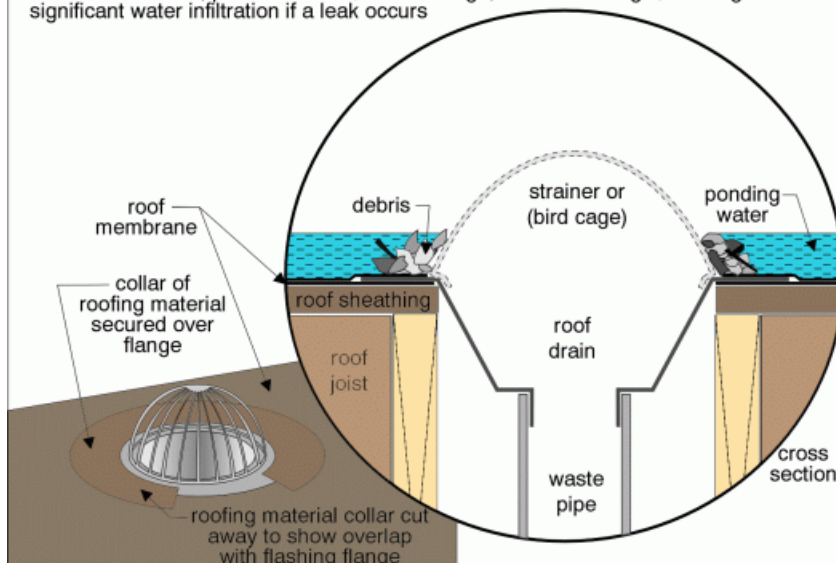
Condition: • [Clogged](#)

Implication(s): Chance of water damage to contents, finishes and/or structure

### Clogged interior flat roof drain

interior flat roof drains clogged with debris can cause water ponding, leading to: shortened roof life, possible freeze/thaw damage, additional weight/roof sag and significant water infiltration if a leak occurs

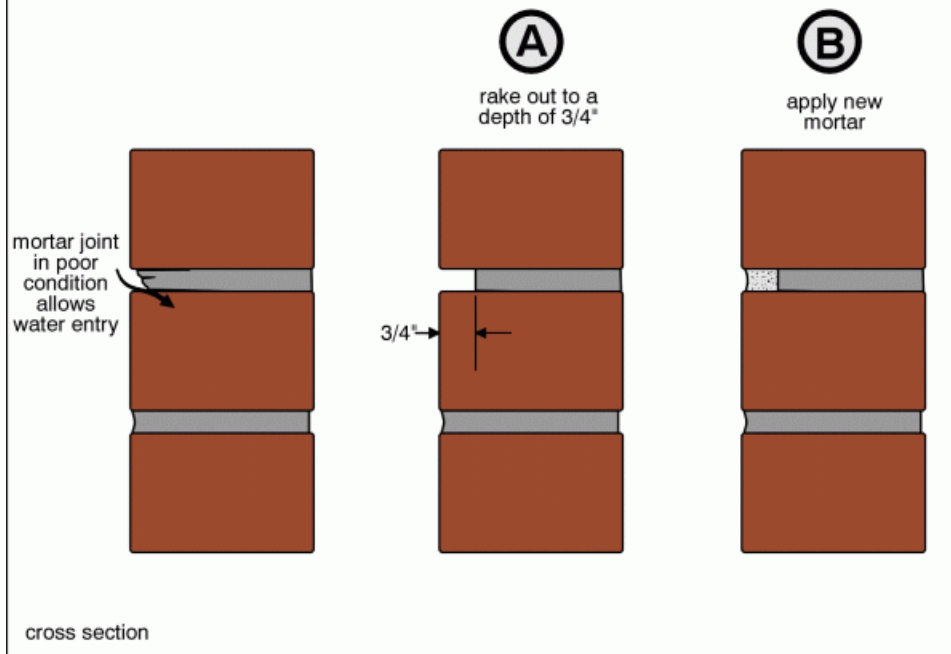
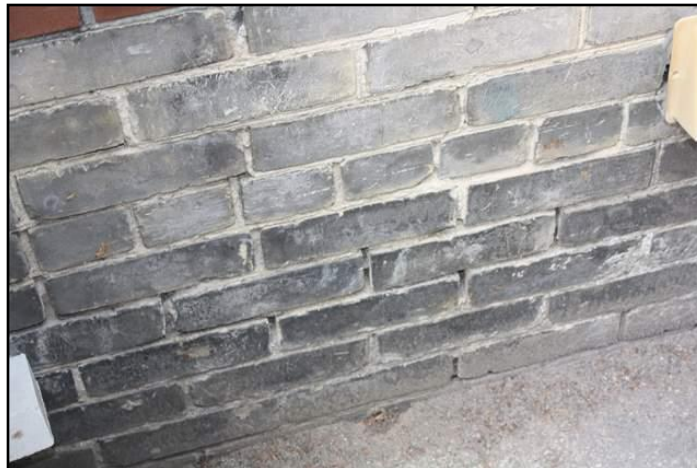
9. Example

**Condition:** • [Mortar deterioration](#)

Provide mortar (Repointing, Tuck pointing) at various areas of the exterior brick and the stone foundation. This is very common maintenance for homes of this age.

**Task:** Repair

**Cost:** Regular maintenance item

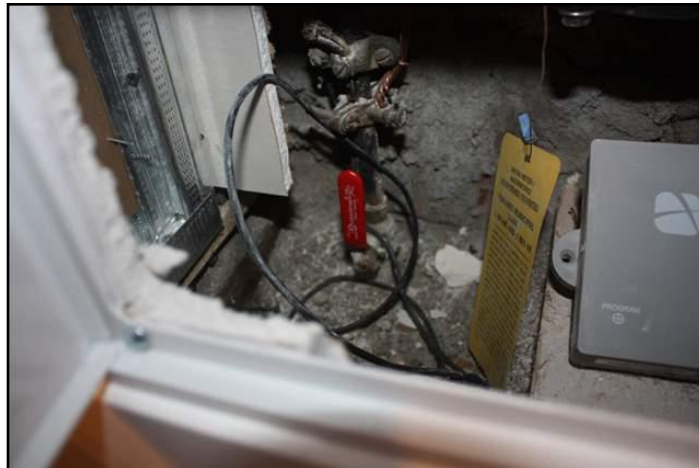
27. Front of the basement

**Main water shut off valve at the:**

- Front of the basement
