Your Inspection Report

55 Parkdale Rd
Toronto, ON

INSPECTION DATE:
Thursday, June 2, 2016

RE: Report No. 53827
55 Parkdale Rd
Toronto, ON

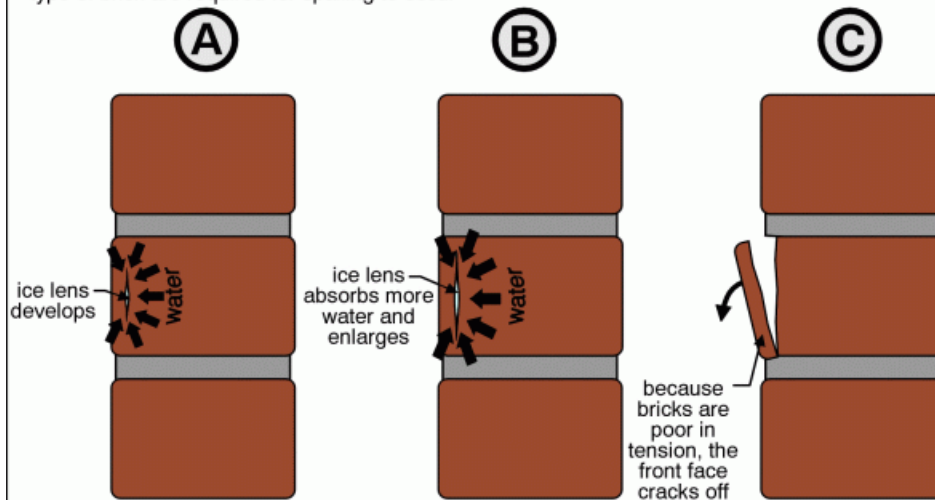
Freezing water spalls bricks

freezing temperatures, saturated brick and a susceptible type of brick are required for spalling to occur

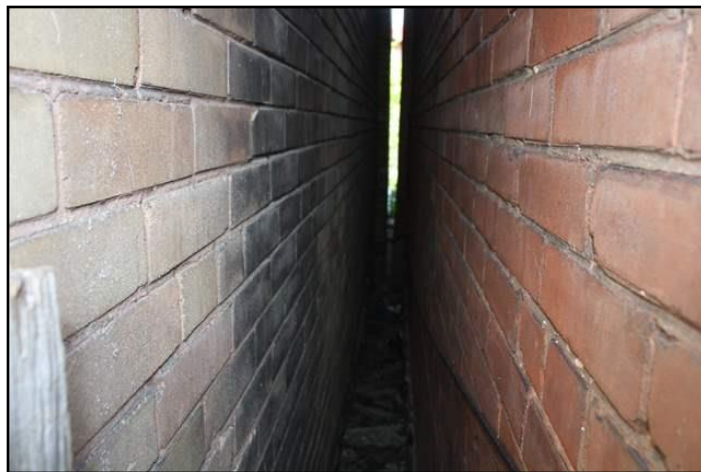
- Garage - storage restricted the inspection
- Wall - no access
