YOUR INSPECTION REPORT

546 Beresford Avenue
Toronto, ON M6S 3C3

INSPECTION DATE:
Friday, March 23, 2018

RE: Report No. 2247
546 Beresford Avenue
Toronto, ON
M6S 3C3

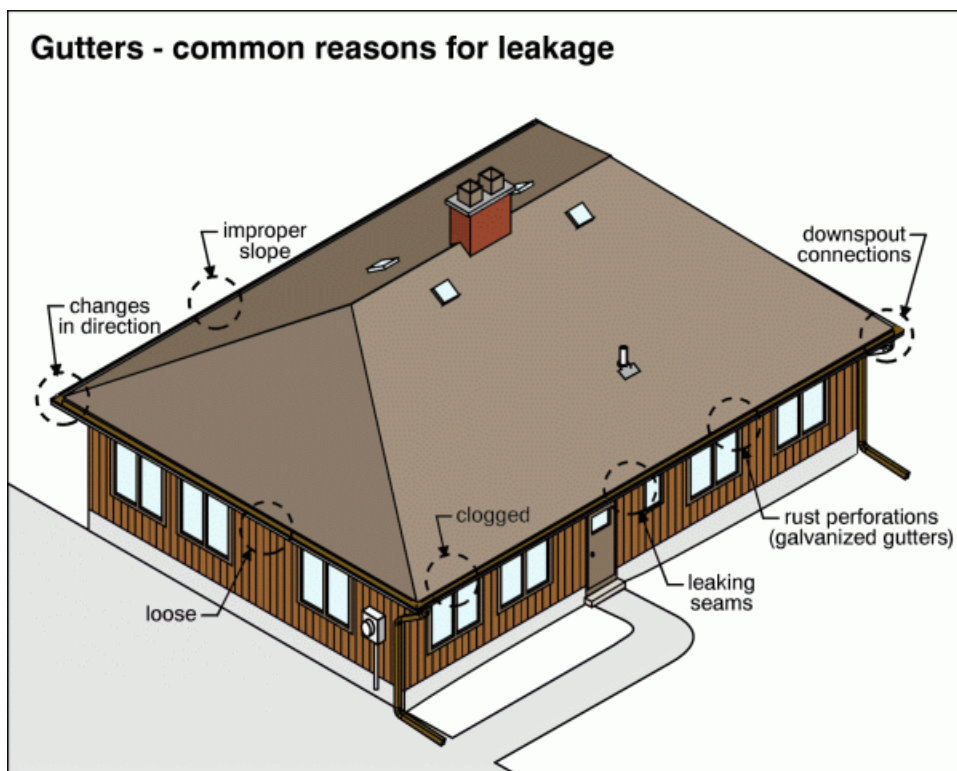
Condition: • [Clogged](#)

Implication(s): Chance of water damage to contents, finishes and/or structure

Time: Less than 1 year

Cost: Regular maintenance item

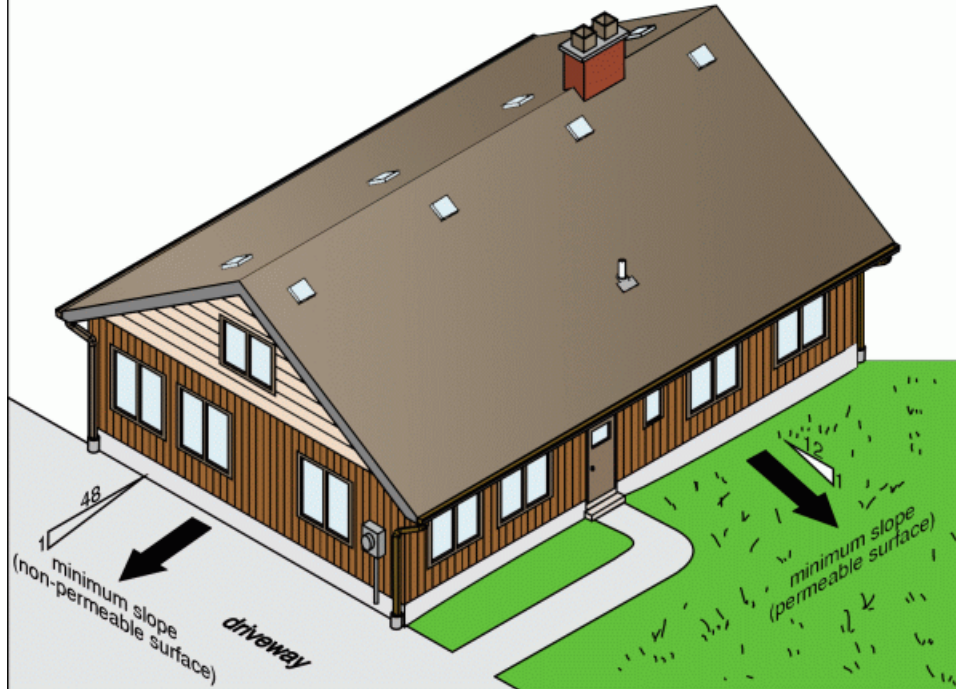
7. Example

Condition: • Low Areas.

Time: Regular maintenance / Ongoing

Recommended grading slopes

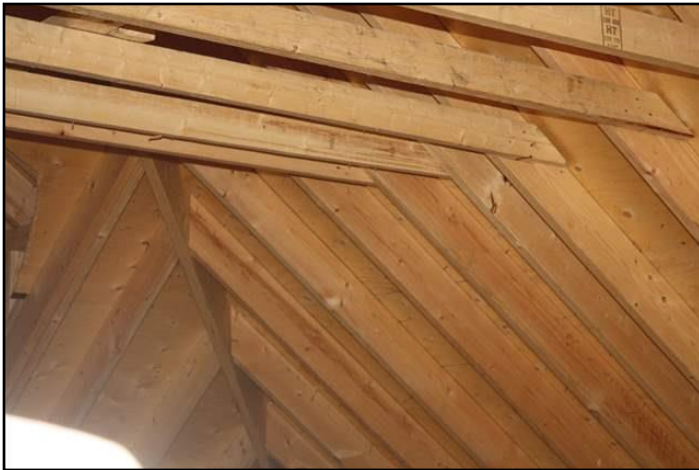
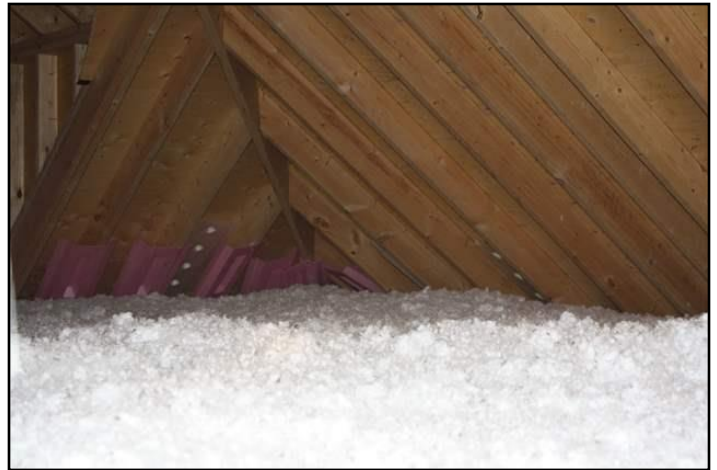
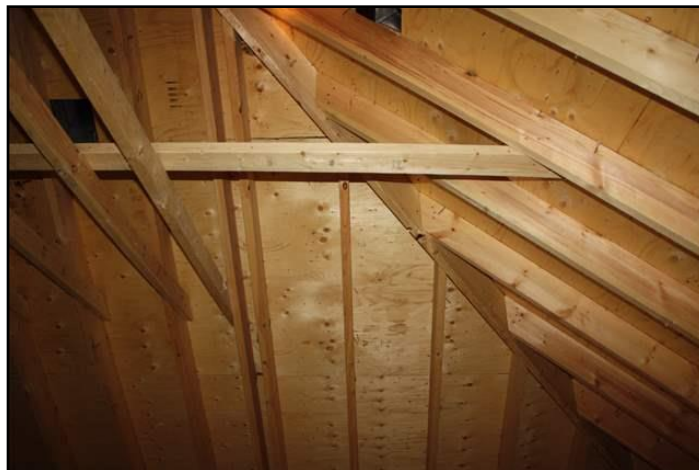
ALL NEW COMPONENTS IN ATTIC

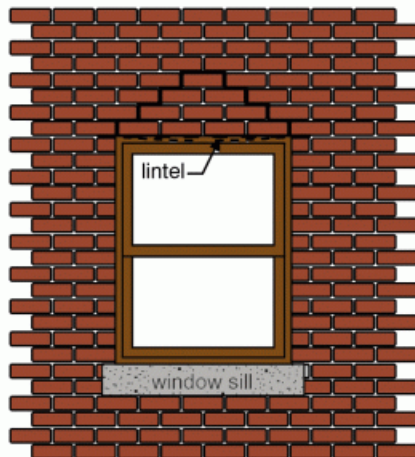
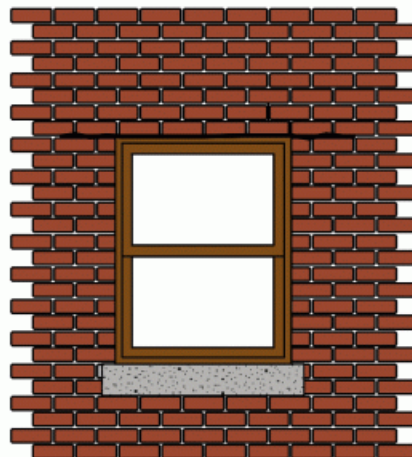
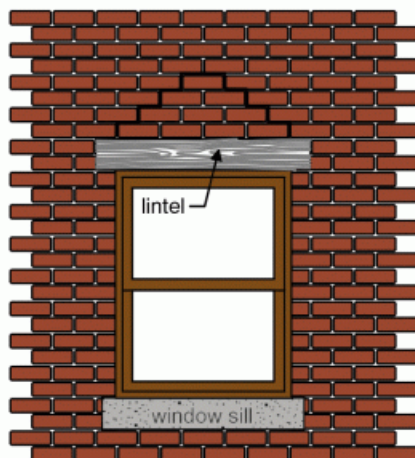
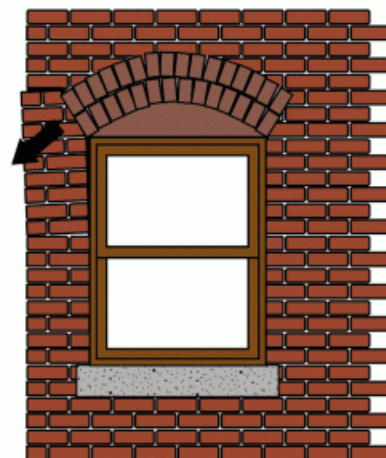
Lintel related wall cracks

Condition: • [Cracked](#)

Very common to find cracks and settlements at arches above windows. Patch to prevent further damage and/or

crack pattern commonly associated with sagging lintels due to undersizing or deterioration

horizontal crack is often caused by rusting steel lintels expanding

cracking caused by deterioration of wood lintel

cracking due to insufficient material beside arch to resist lateral thrust

Task: Repair

Time: Regular maintenance

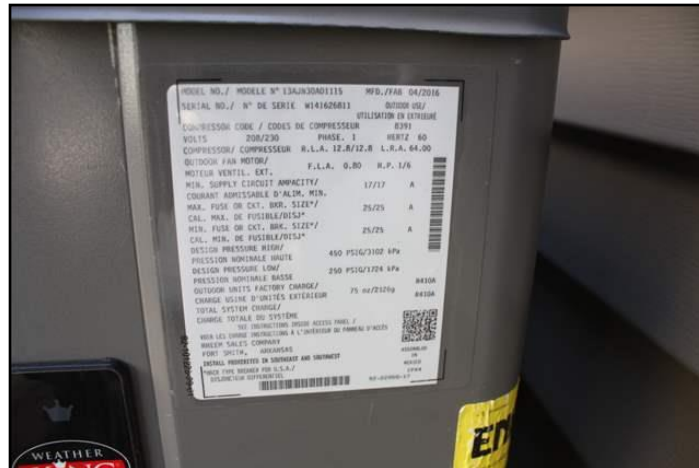
16. Data plate

Compressor approximate age:

• 2 years

Typical life expectancy: • 10 to 15 years

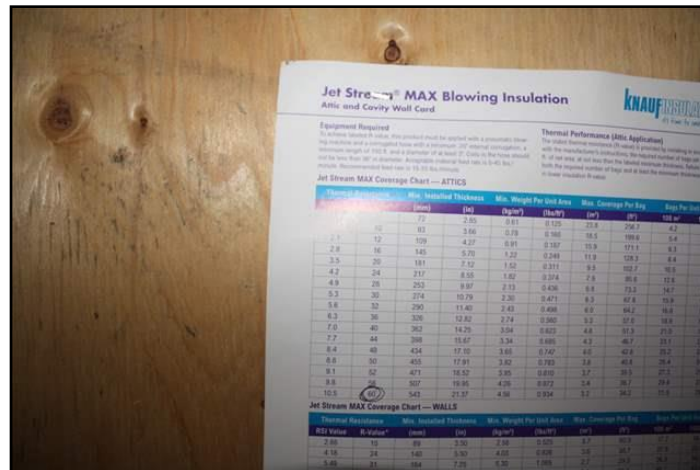
17.

Attic/roof insulation material: • [Glass fiber](#)

Attic/roof insulation amount/value: • R-60. Above modern standards
