YOUR INSPECTION REPORT

1234 Main Street
Sioux Falls, SD 57104

Thursday, November 5, 2020

RE: Report No. 1001, v.7
1234 Main Street
Sioux Falls, SD
57104

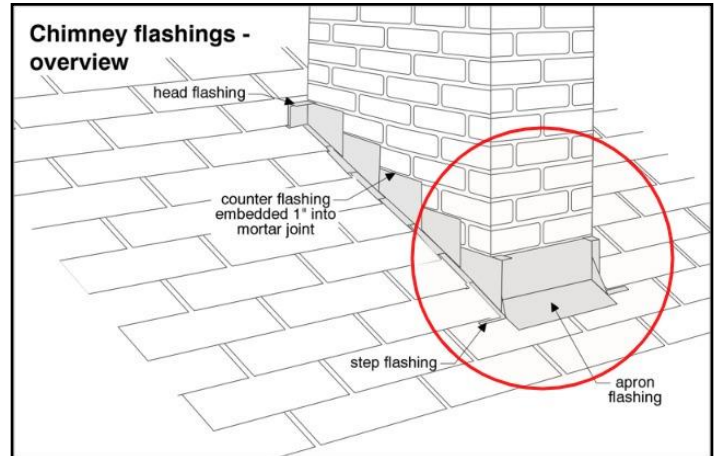
Chimney flashing detail

1. Condition: • Flashing not set into shingles properly

Implication(s): Chance of leaking, Chance of moisture damage to structure and finish

Task: Repair

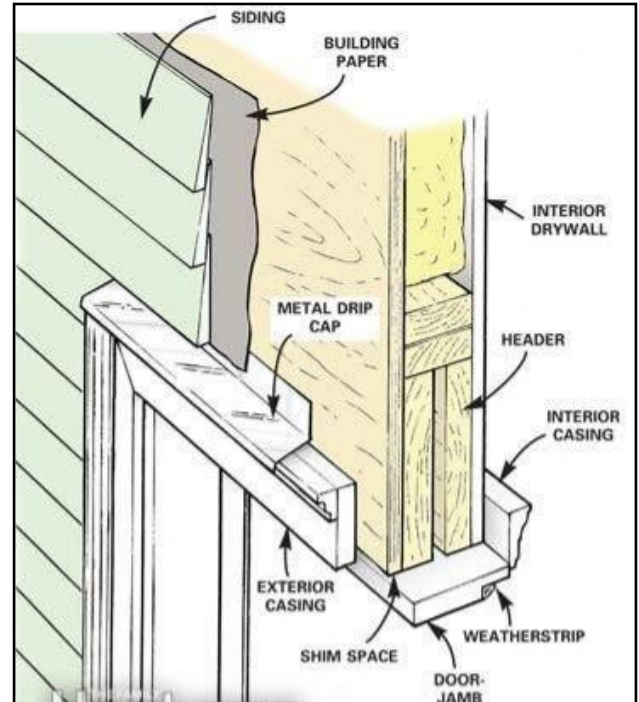
Drip cap detail

4. Condition: • Dripcap(s) missing

Implication(s): Chance of moisture damage to structure and finishes

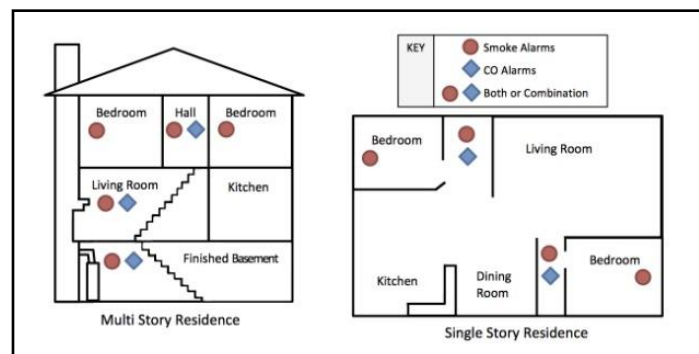
CO detector location recommendations

**DISTRIBUTION SYSTEM \ Carbon monoxide (CO) alarms (detectors)****10. Condition:** • Missing Carbon monoxide detector(s)

Implication(s): Life safety hazard

Task: Install

Time: Less than 1 year

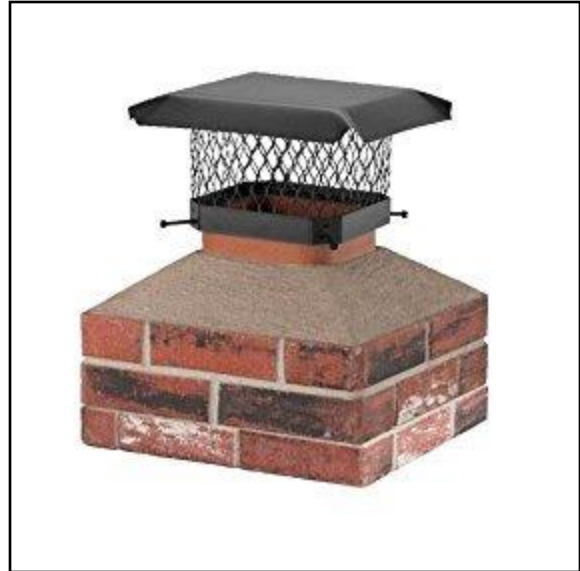
Chimney cap detail

12. Condition: • Missing chimney cap

Implication(s): Chance of water damage to structure, finishes and contents | Shortened life expectancy of material

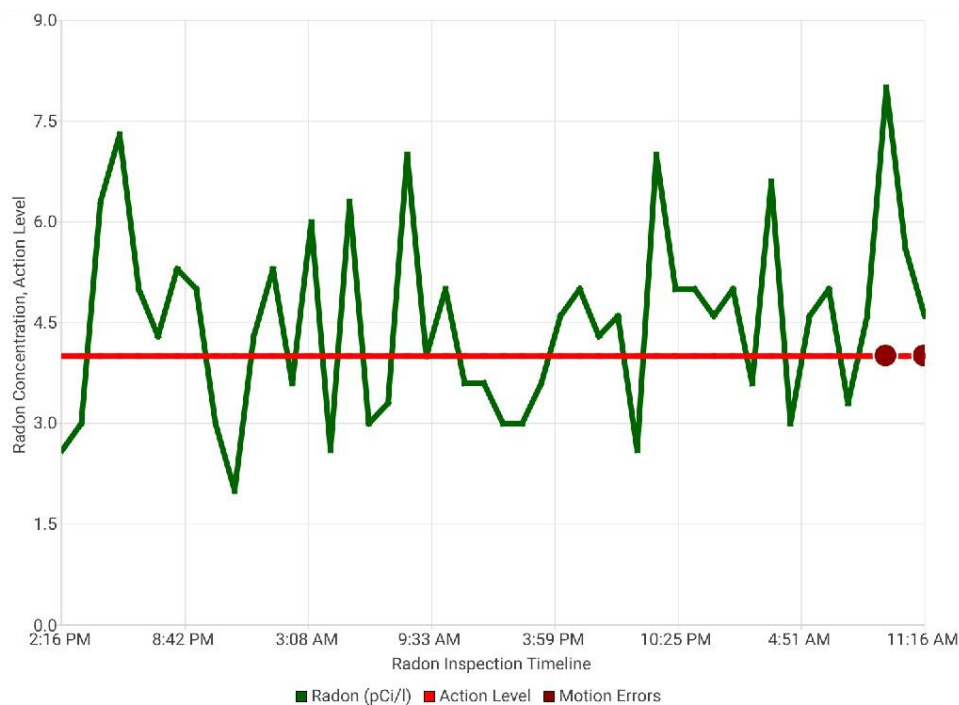
Radon Inspection Chart

Test Result: Fail
