INSPECTION REPORT

For the Property at:
123 RAINY STREET
FARGO, ND 58103

Prepared for: JOHN DOE
Inspection Date: Monday, February 11, 2019
Prepared by: Cody Lewis

RE: Report No. 1193, v.2
123 Rainy Street
Fargo, ND
58103

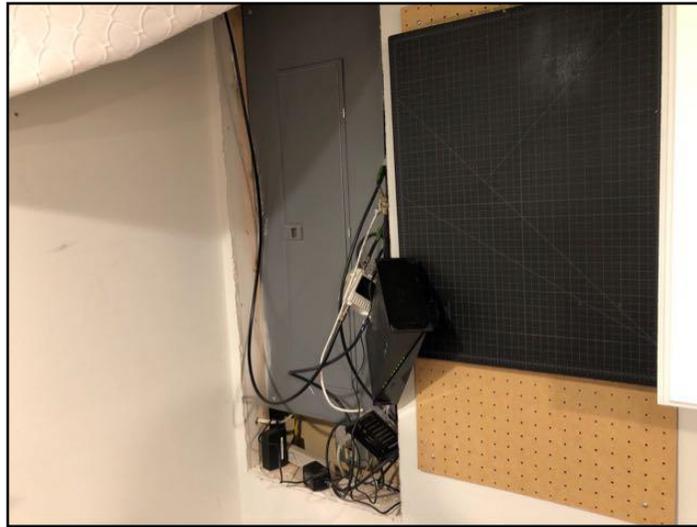
Condition: • [Poor access](#)

Poor access to service panel due to router and coax cable. Recommend re mounting network equipment away from the panel to allow clear access.

11. Condition: • [Poor access](#)

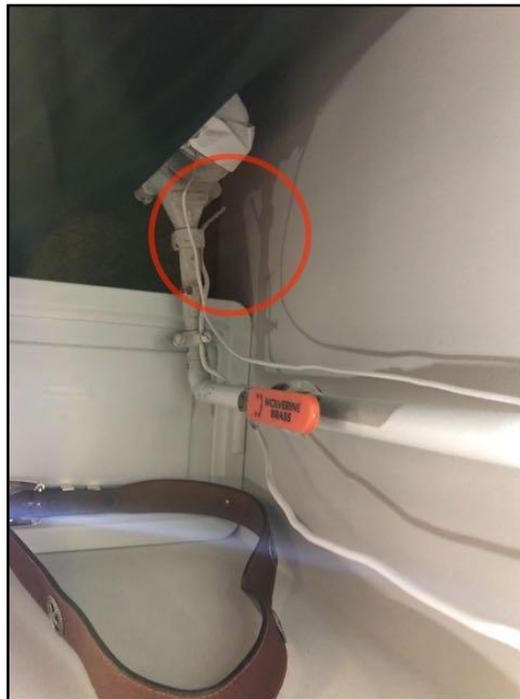
No jumper for meters and valves

Condition: • [No jumper for meters and valves](#)

12. Condition: • [No jumper for meters and valves](#)

Implication(s): Electric shock

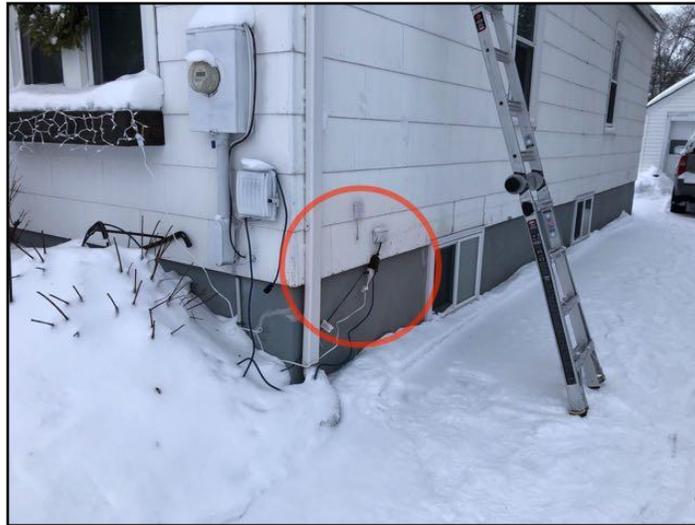
Test faulty on GFCI/GFI (Ground Fault...

Condition: • [Test faulty on GFCI/GFI \(Ground Fault Circuit Interrupter\)](#)

Exterior GFCI receptacle does not trip. Consult electrician to replace faulty unit.

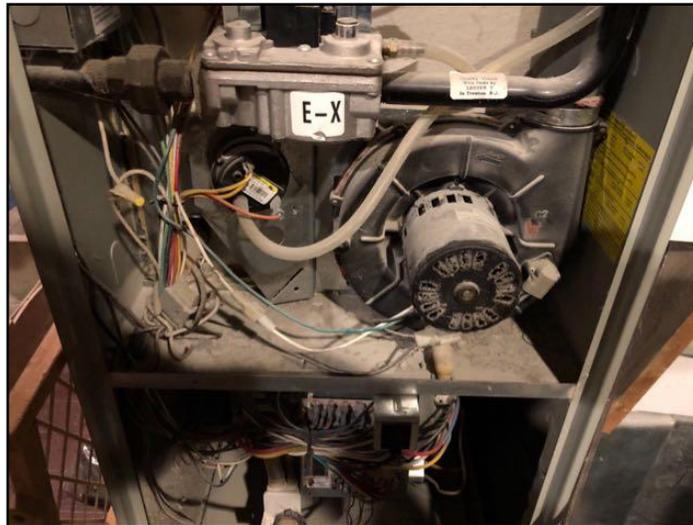
Condition: • Service Furnace

Dust accumulation noted on the inducer fan an inside furnace cabinet. Recommend the furnace is cleaned and serviced if not performed recently.

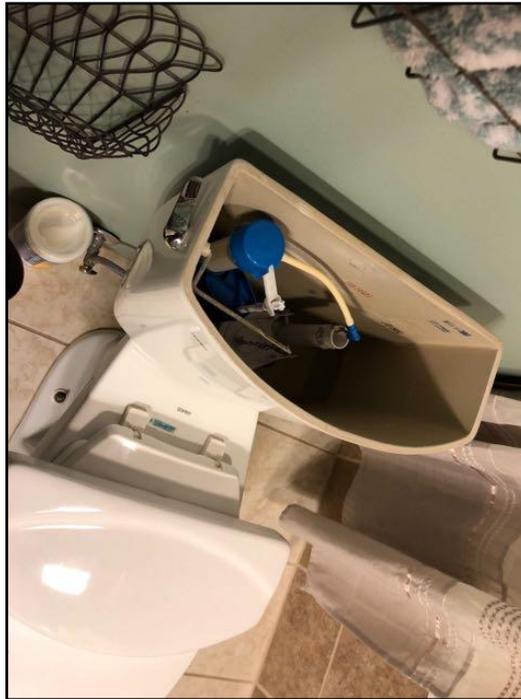
Loose

Condition: • [Loose](#)

Main floor toilet is very loose. Consult a plumber to secure and, if necessary, replace the wax ring to prevent leaks

Implication(s): Chance of water damage to contents, finishes and/or structure | Sewage entering the building

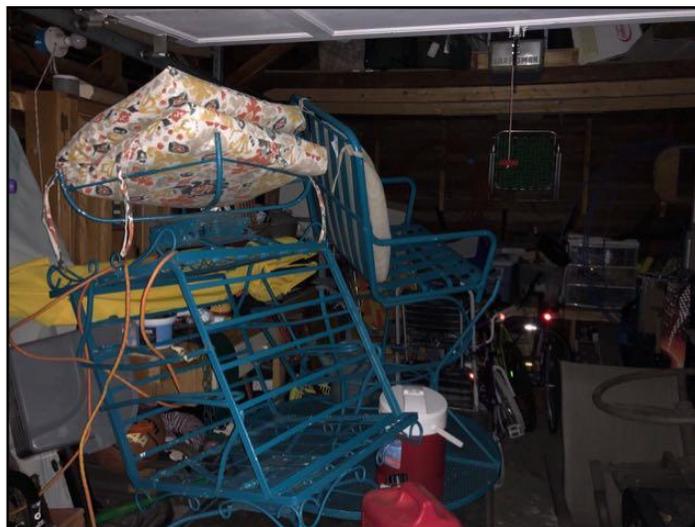
• Garage

Garage is full of storage. Inspection is limited to accessible areas.

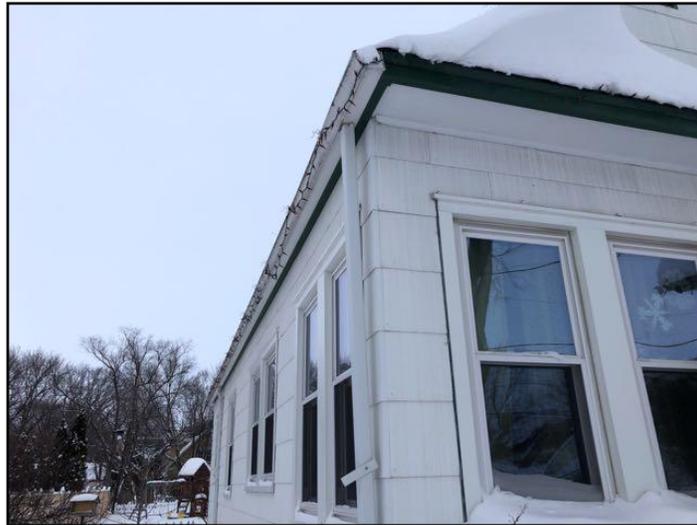
Not well secured

2. Condition: • [Not well secured](#)

Implication(s): Leakage

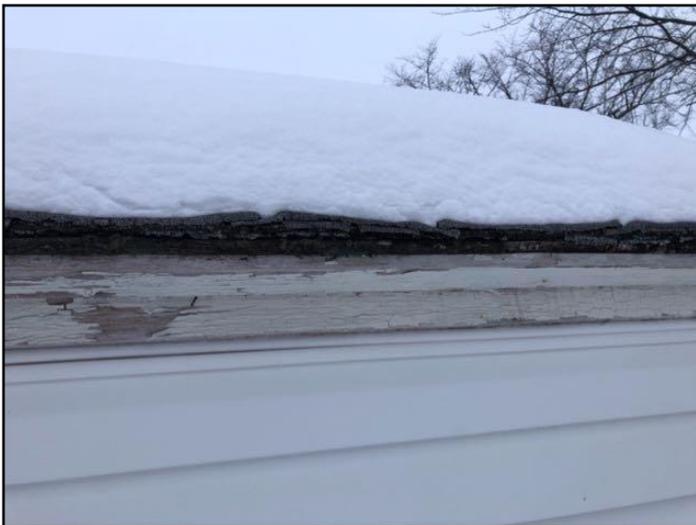
7. Condition: • Typical low quality structure

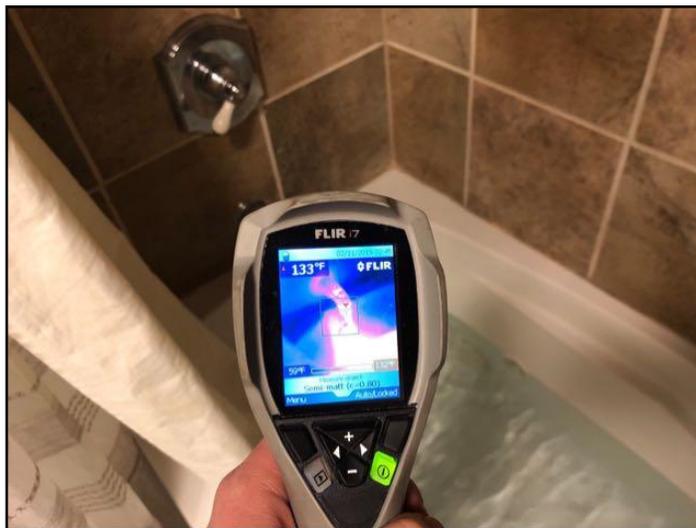
- Water supply source:** • Public
- Service piping into building:** • [Copper](#)
- Supply piping in building:** • [Copper](#)
- Main water shut off valve at the:** • Basement
- Water heater type:** • Tank
- Water heater fuel/energy source:** • [Gas](#)
- Water heater manufacturer:** • A.O. Smith
- Water heater tank capacity:** • [40 gallons](#)
- Water heater approximate age:** • 19 years
- Hot water temperature (Generally accepted safe temp. is 120° F):**
- 135° F
