# INSPECTION REPORT

For the Property at:  
**123 EXAMPLE WAY**  
CENTRAL POINT, OR 97502

Prepared for: JOHN DOE  
Inspection Date: Friday, March 9, 2018  
Prepared by: Zach Macormic

RE: Report No. 1028, v.5  
123 Example Way  
Central Point, OR  
97502

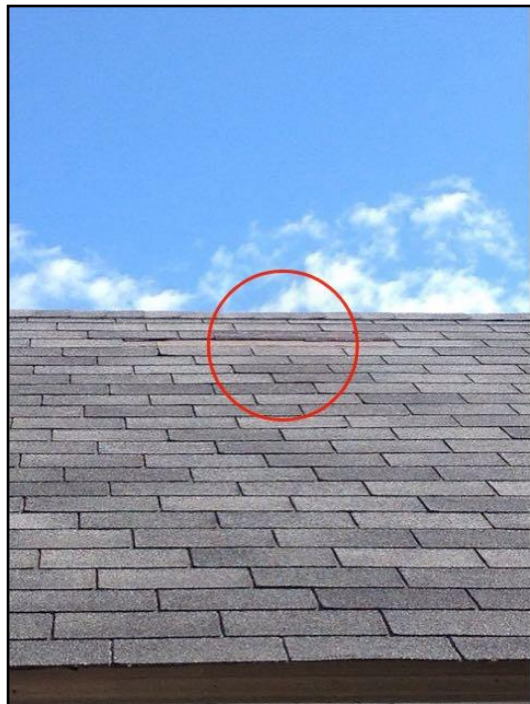
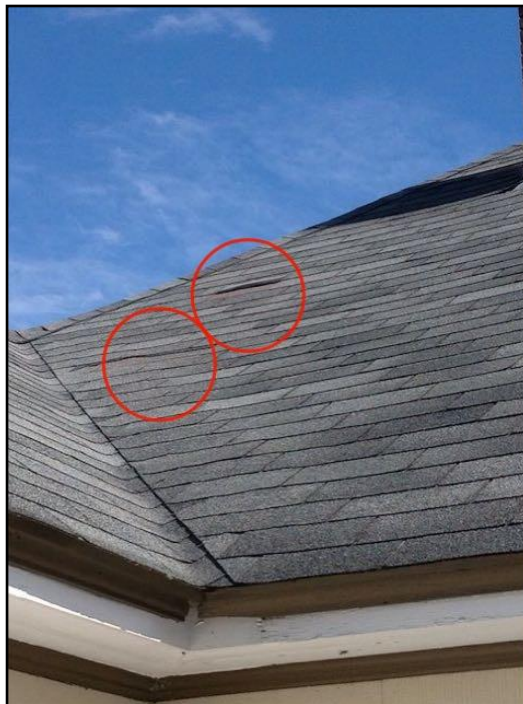
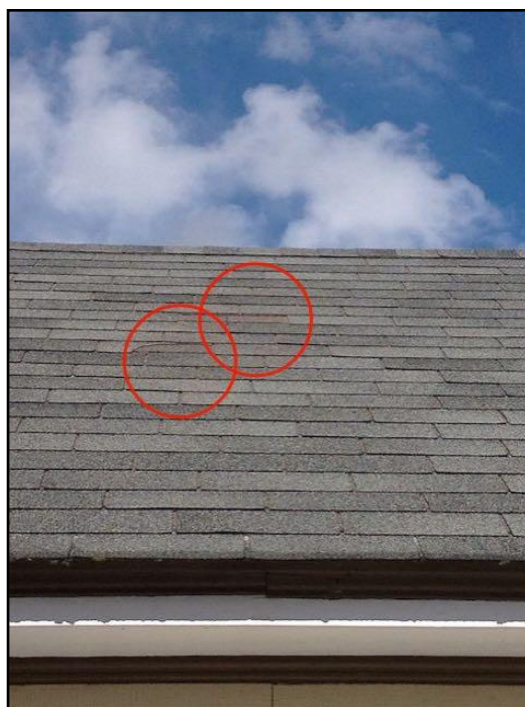
I noted about 7 missing shingles on the roof. It was raining at the time of inspection and I did not note any active leaking in the home's attic space. In my opinion, I believe the roof has about 5 years of useful life left if repairs are made. I recommend a professional roofer replace the missing shingles and give a more exact useful life estimation.

1. Missing Shingles

2. Missing Shingles

3. Missing Shingles

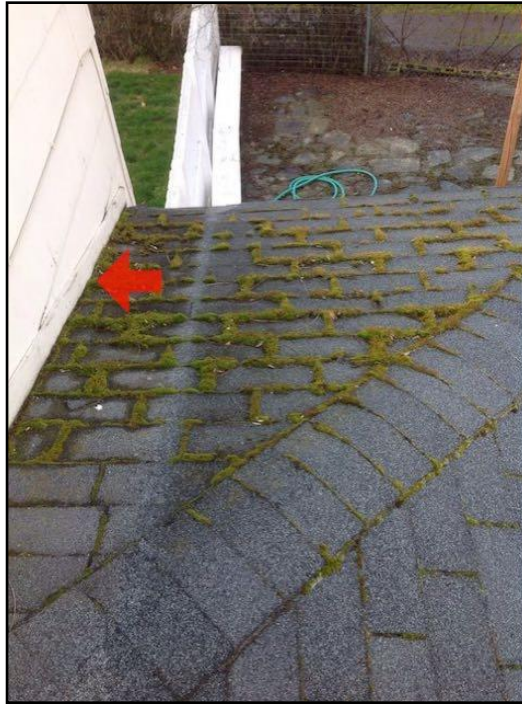
I noted moss growth on the East side of the roof. This moss growth prevents proper drainage and shortens the life of the roof. I recommend the moss be removed by a qualified person to prevent further deterioration. The moss against the

home will dam water and begin to deteriorate the wood trim. This condition may be noted by an appraiser.

4. Moss on East side of Home

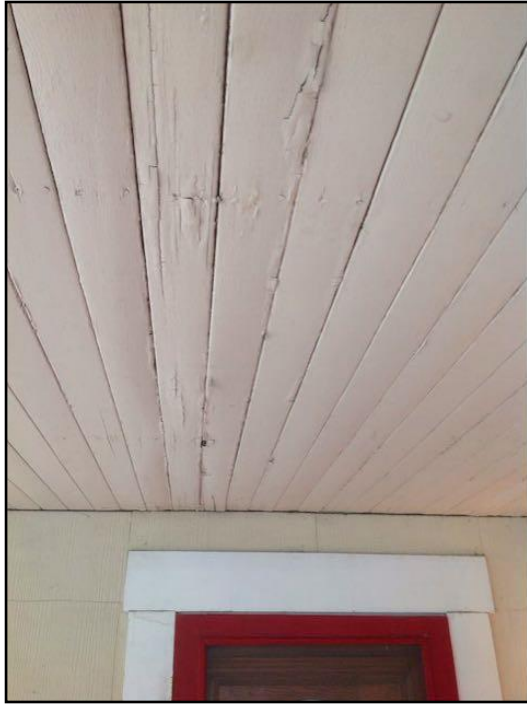
I noted a small leak over the porch. I believe the leak was caused by the lack of proper flashing on the flat roofing above. I used my laser level and found that the ceiling was sagging four inches in the middle. The flat roofing appeared to be recently recoated to possibly fix this condition. I believe the moisture had aided the ceiling sagging, but the patio (not the home) framing appears to be structurally questionable. I recommend consulting with a qualified roofer for repairing the leak and consulting with a qualified framing contractor for repairing the sagging porch.

5. Sagging 4"

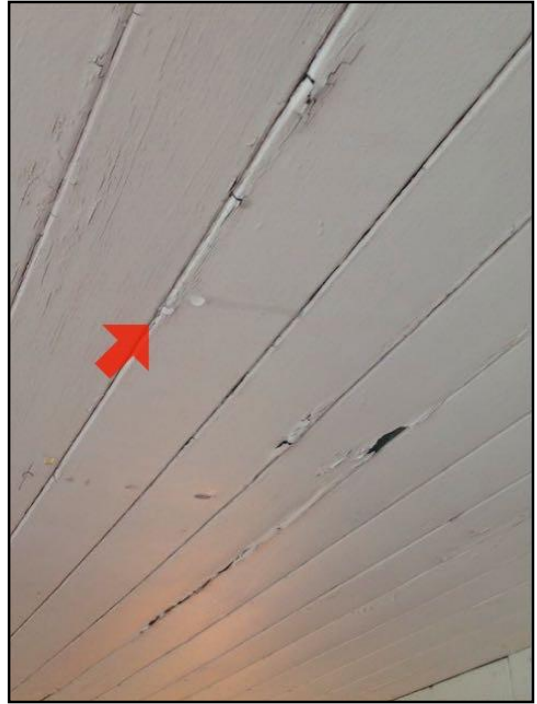
6. Leak over porch

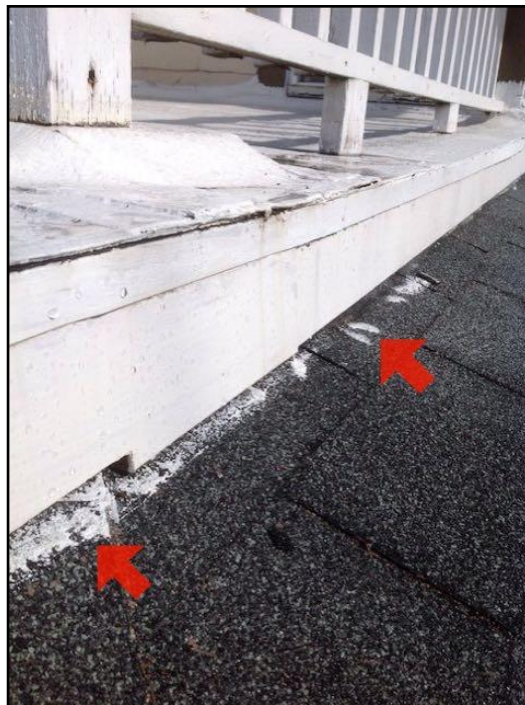
7. Recent Coating

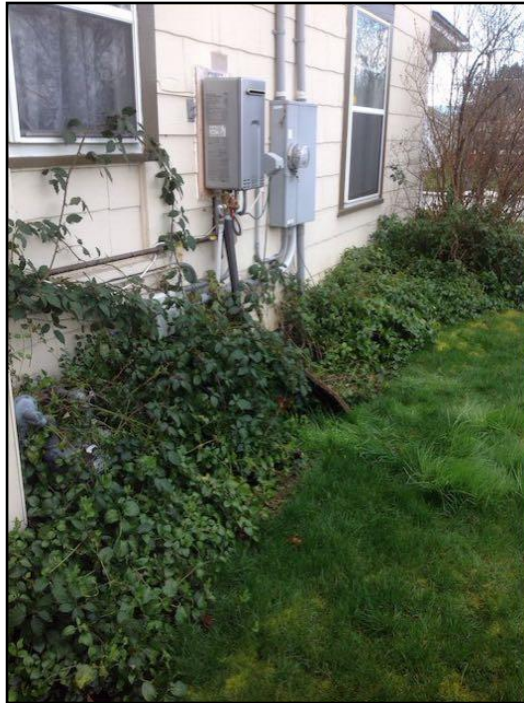
**Condition:** • I noted vegetation has been allowed to grow next to the home. This condition may allow for damage to the side of the home. I recommend all vegetation be trimmed back to avoid this condition. This condition may be noted by an appraiser as a condition of lending.

8. *Vegetation too close to the home*

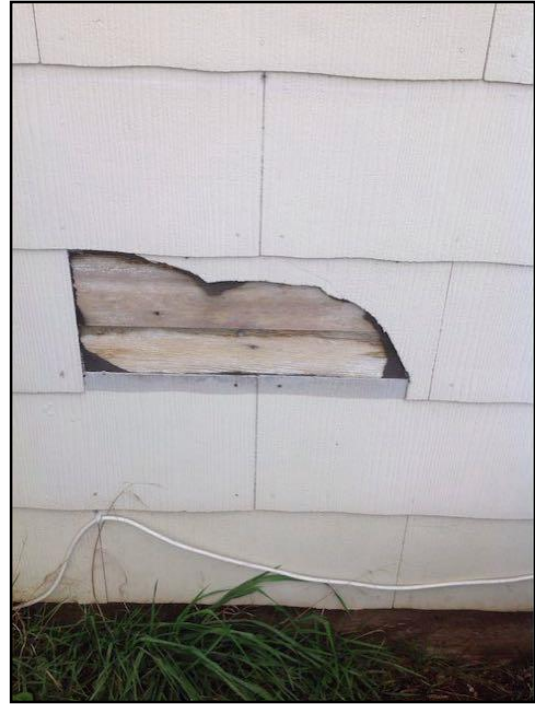
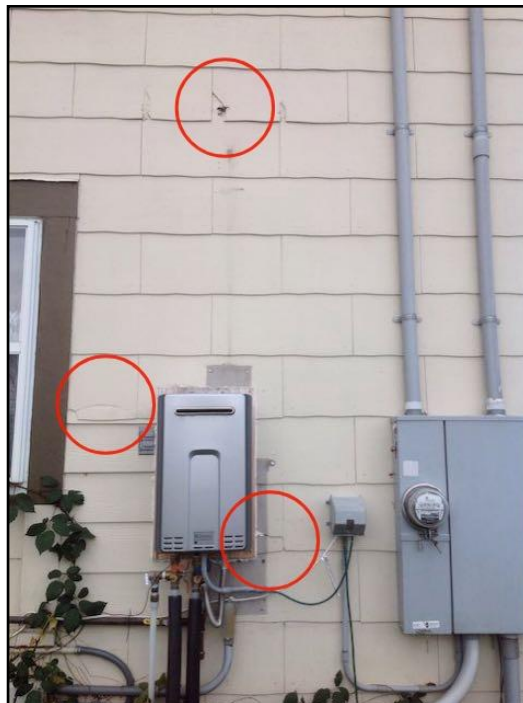
I noted several areas of the home with missing pieces of siding. This condition may allow water to enter the wall space and cause moisture damage. I recommend a qualified person install new siding to prevent this condition. This condition may be noted as a condition of lending by an appraiser. I believe this siding to be Transite asbestos cement siding. I recommend taking adequate precautions when repairing replacing it.

10. Siding - incomplete / missing

11. Siding - incomplete / missing

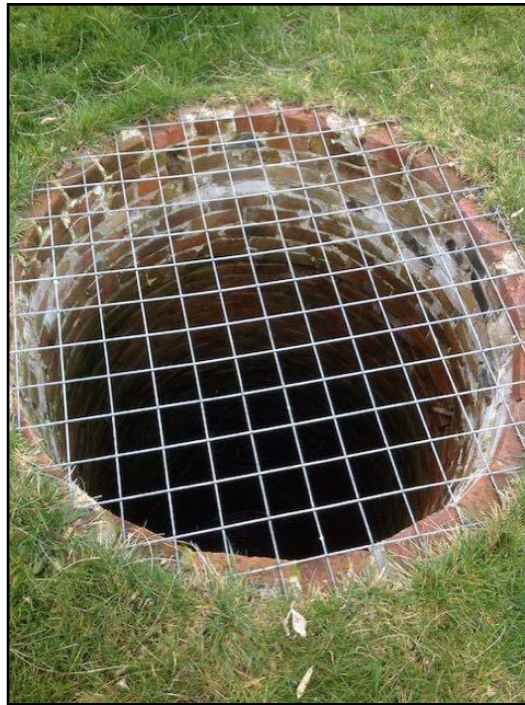
**Condition:** • I noted a large hand dug well in the backyard. The grate over it seemed inadequate at preventing a fall if a person or large animal were to walk over it. I highly recommend some kind of strong fall protection be installed over the

well. This condition has a chance of being called out by an appraiser as a condition of lending.

12. Fall Hazard

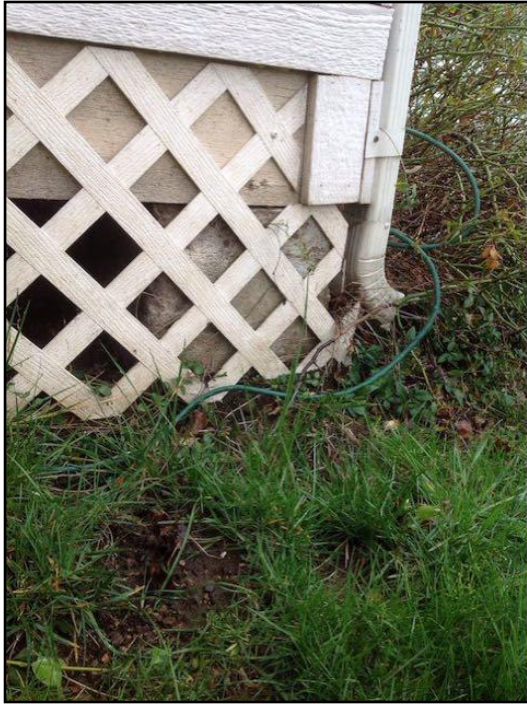
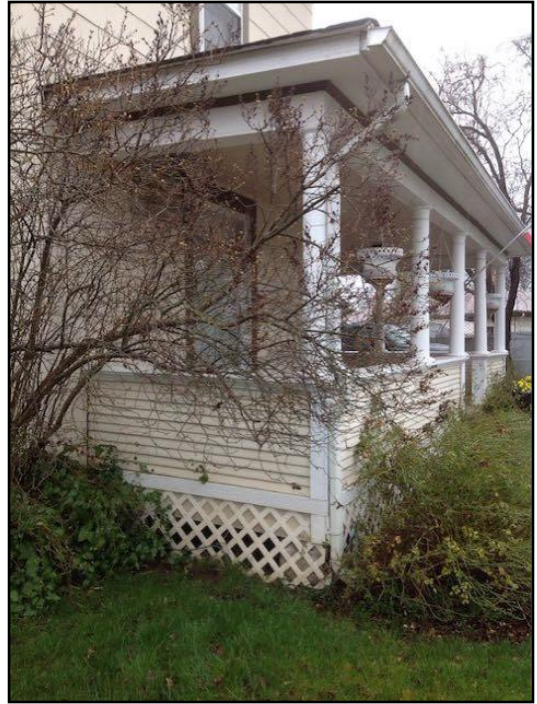
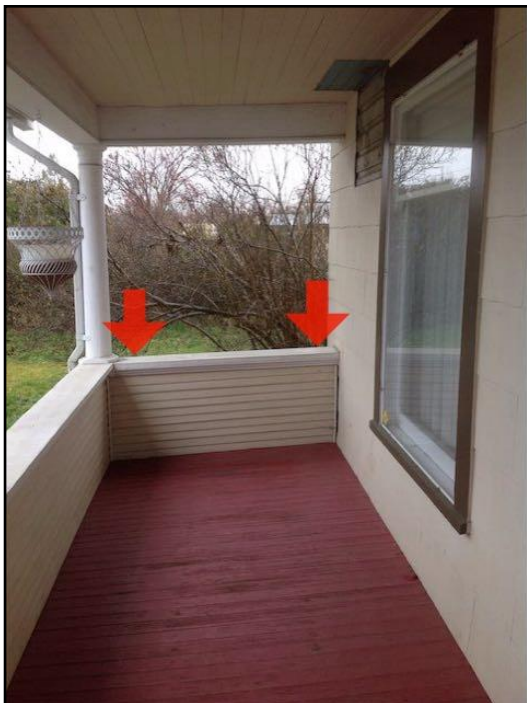
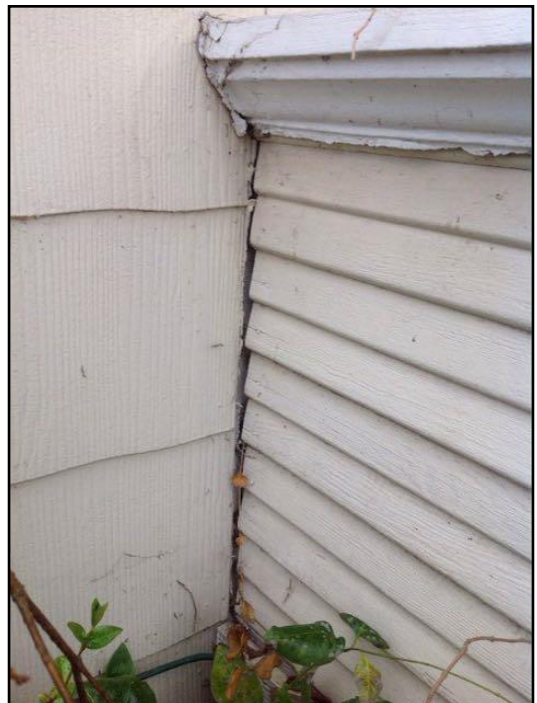
**Condition:** • I noted the front porch has settled 2 inches. I believe this is from inadequate footings and excessive water. The gutter discharges right next to the footing and has likely softened the soil and caused the footing to sink. I recommend discharging the gutter 6 feet away from the structure and consulting a qualified contractor for possible remedy and releveling.

13. Small footing

14. Settled porch

15. 2" drop

16. Pulling away from home

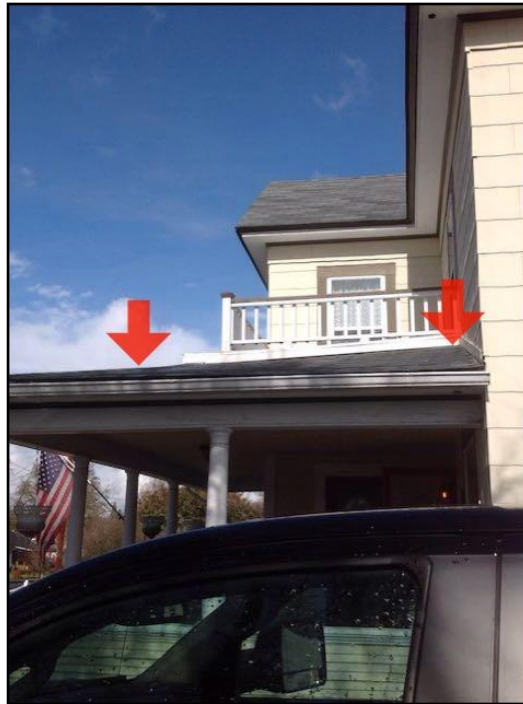
17. Sag and twist

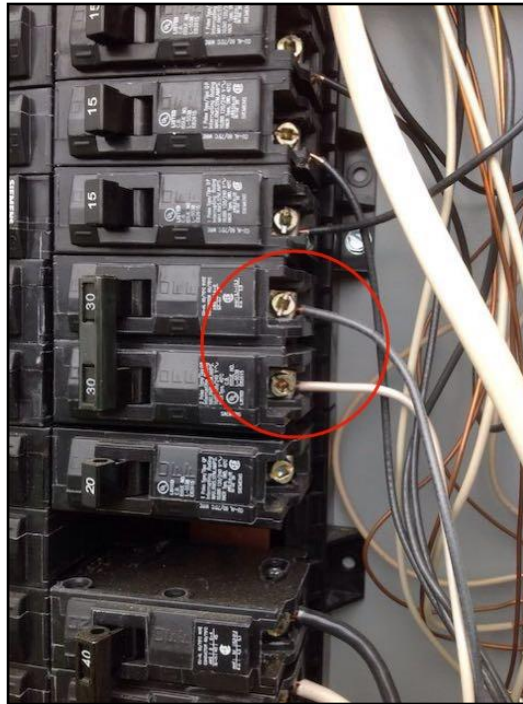
I noted a 30amp breaker with undersized wires going to it. This condition can cause the wires to heat up dangerously. I recommend having the panel inspected by a professional electrician to remedy this condition.

19. Fuses or breakers too big

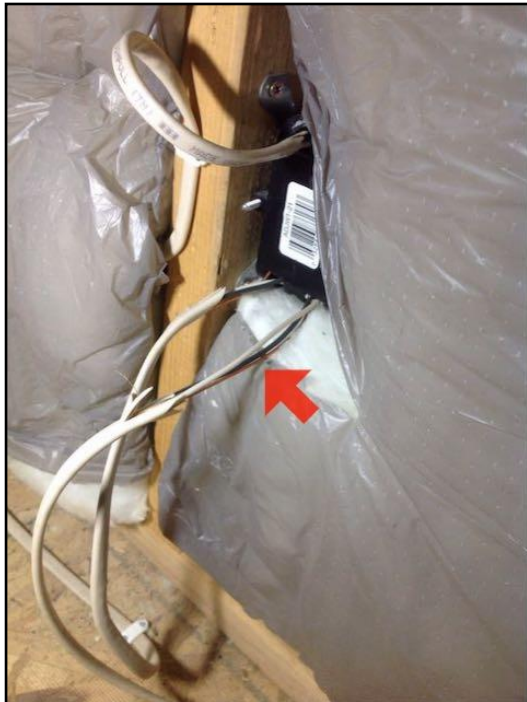
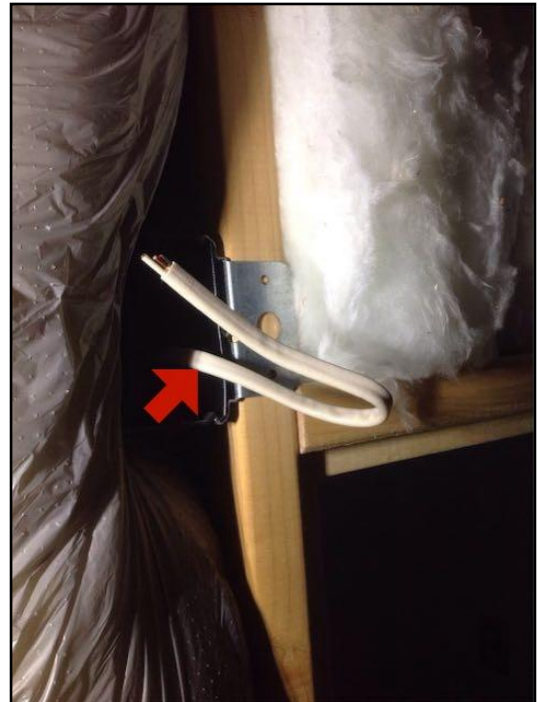
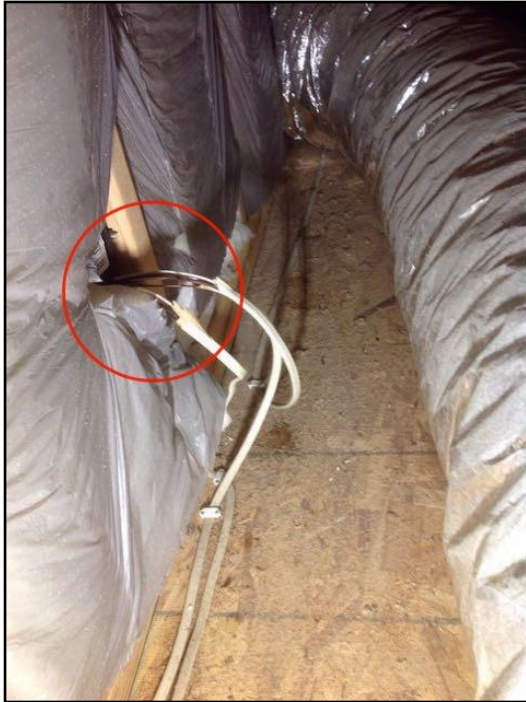
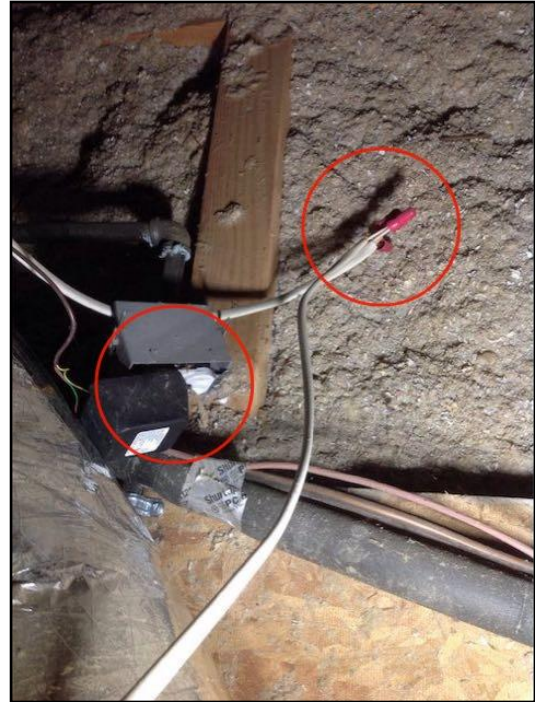
I noted several areas with exposed wires. All wires connections should be inside an approved junction box, the protective wire jacket needs to extend all the way into the junction box, and all wires within the living space should be protected from damage. I recommend a qualified electrician fix all of these conditions to avoid a possible shock and fire hazard.

20. Exposed Jacketing

21. Abandoned Wire

22. Exposed Jacketing

23. Exposed wire Junction

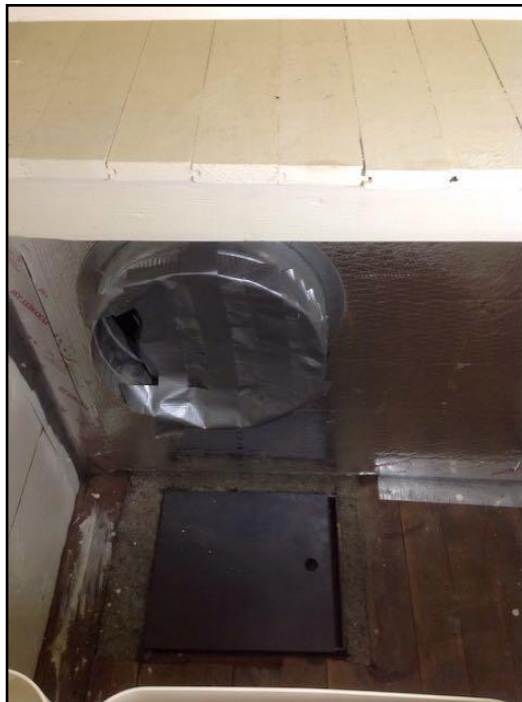
**Condition:** • I found an air return under the stairs that had been closed off. I did not find another air return for the downstairs unit. This condition may be restricting the air flow to the unit and may shorten its life. I recommend this condition be evaluated by an HVAC technician to prolong the life of the unit.

26. Air Return

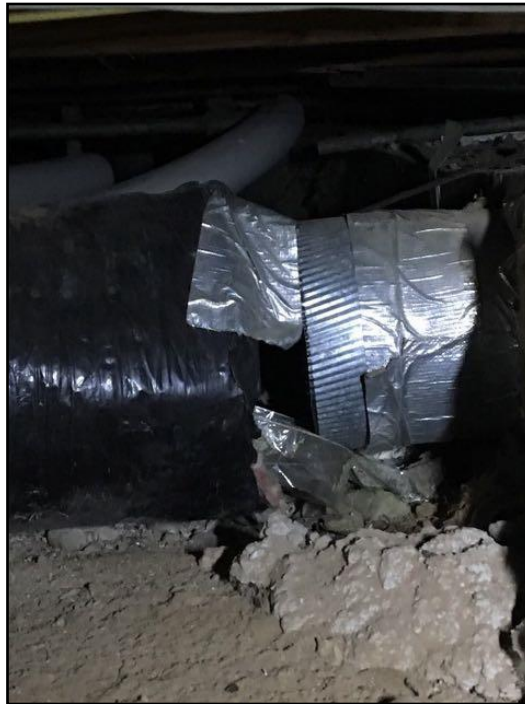
I noted one duct in the crawlspace that was completely disconnected and actively blowing air into the crawlspace. I recommend this be reconnected to help with energy efficiency.

27. Disconnected duct

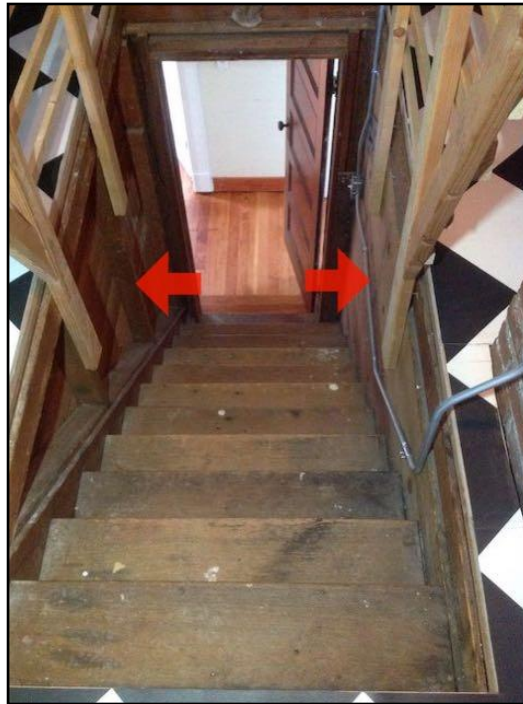
I noted the upper stairwell does not have a handrail. I recommend one be installed to help prevent an accidental fall. This condition has a good chance of being noted as a condition of lending by an appraiser.

28. Missing Handrail

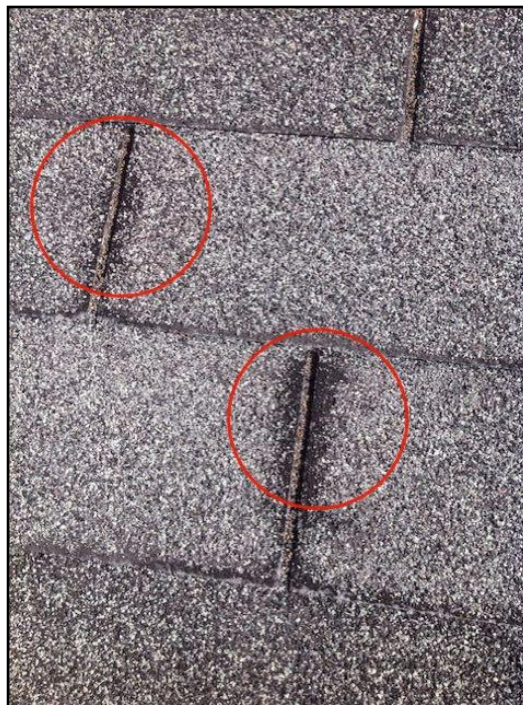
1. Condition: • [Granule loss](#)

29. Granule loss

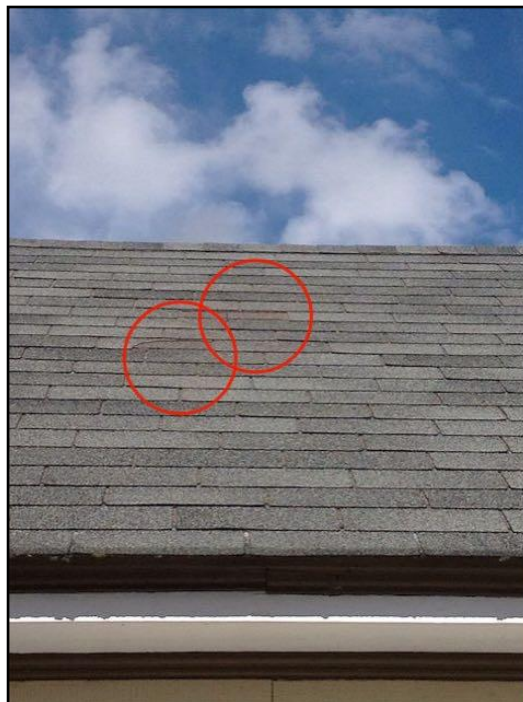
32. Missing Shingles

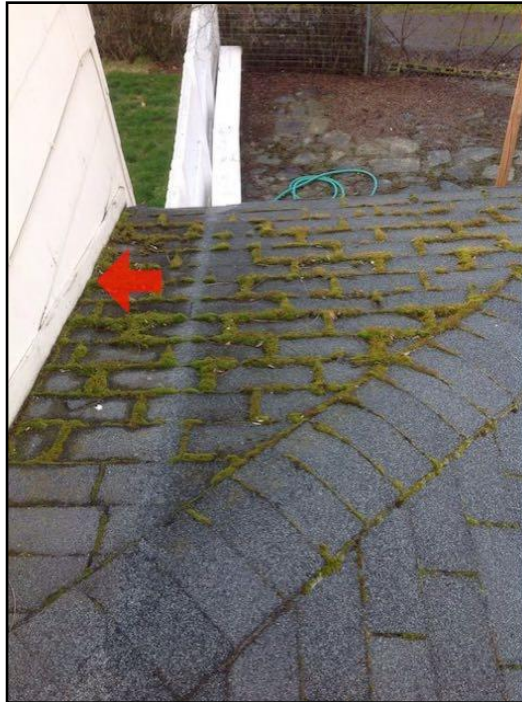
I noted moss growth on the East side of the roof. This moss growth prevents proper drainage and shortens the life of the roof. I recommend the moss be removed by a qualified person to prevent further deterioration. The moss against the home will dam water and begin to deteriorate the wood trim. This condition may be noted by an appraiser.

33. Moss on East side of Home

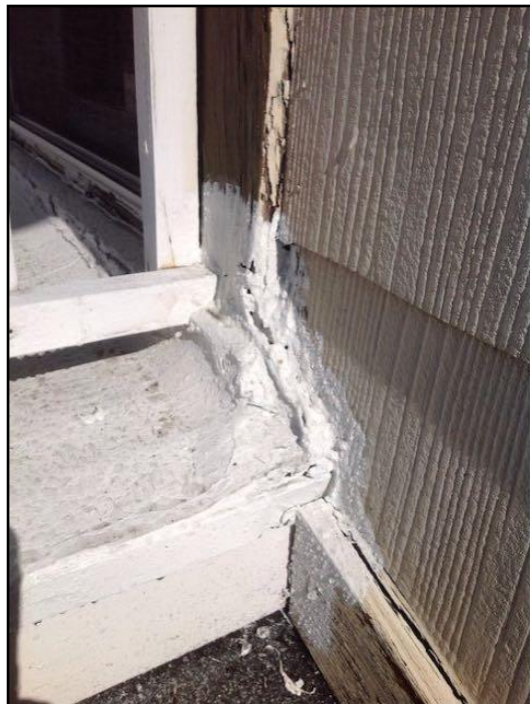
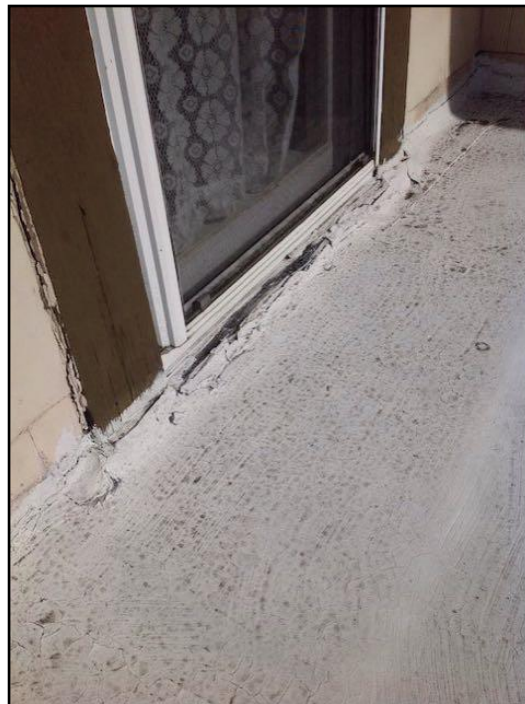
37. Questionable Flashing

38. Questionable Flashing

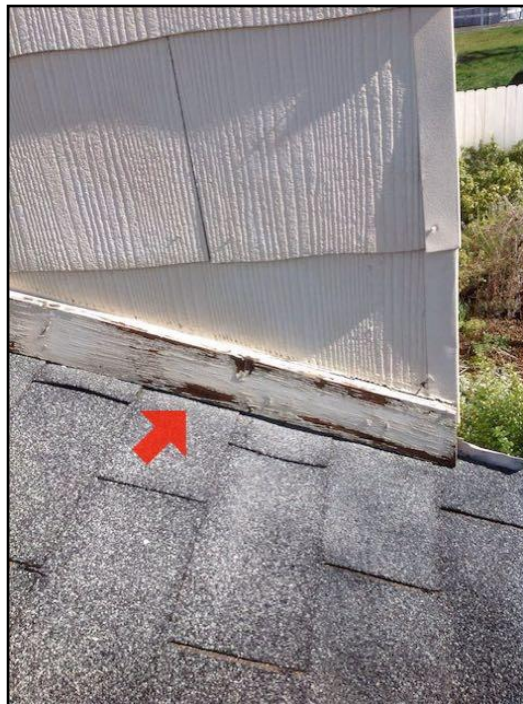
40. Improper Flashing

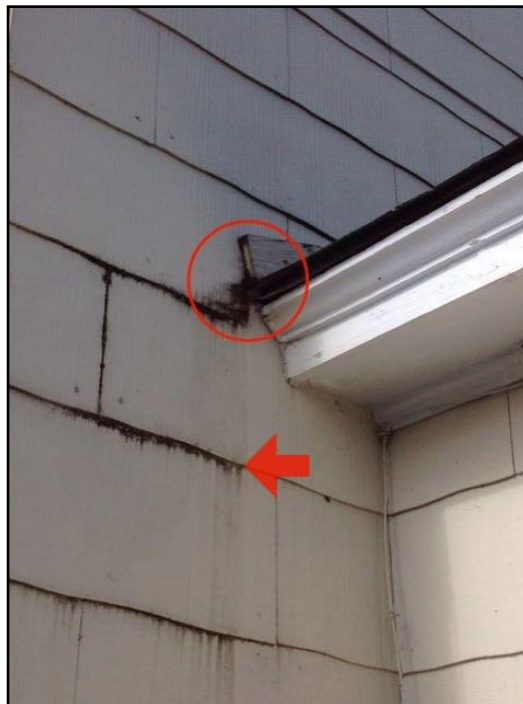
**41. No kickout flashing**

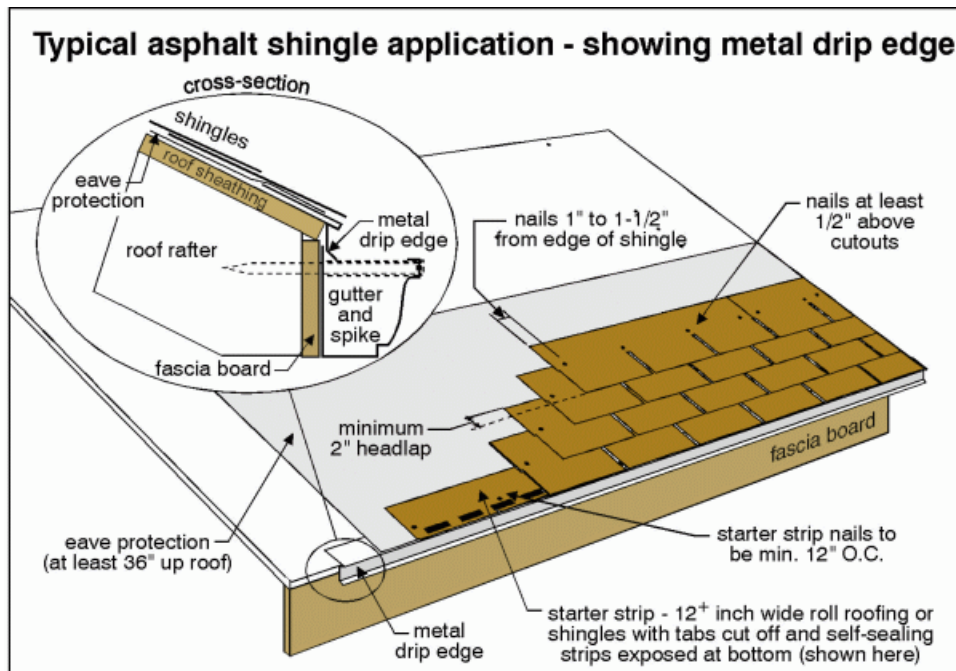
I did not note any drip edge installed on the home. The wood sub-sheeting was wet and will eventually allow the moisture to decompose the edge. I recommend drip edge be installed to help prevent moisture damage to the home.

42. Missing Dripedge

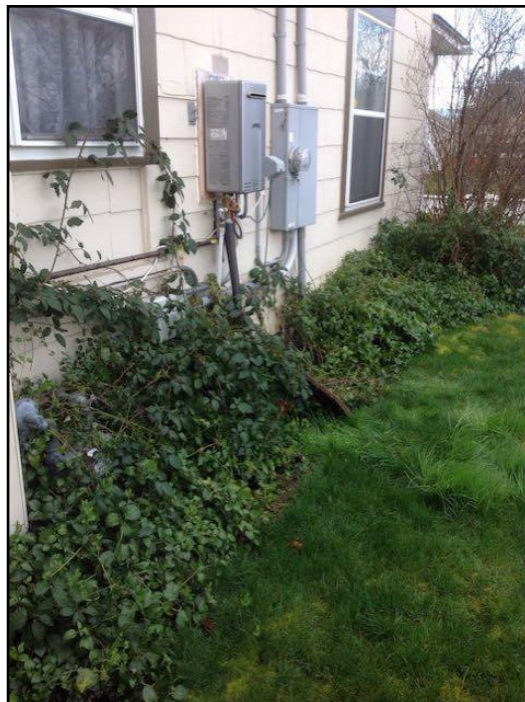
**11. Condition:** • I noted vegetation has been allowed to grow next to the home. This condition may allow for damage to the side of the home. I recommend all vegetation be trimmed back to avoid this condition. This condition may be noted by an appraiser as a condition of lending.

48. Vegetation too close to the home

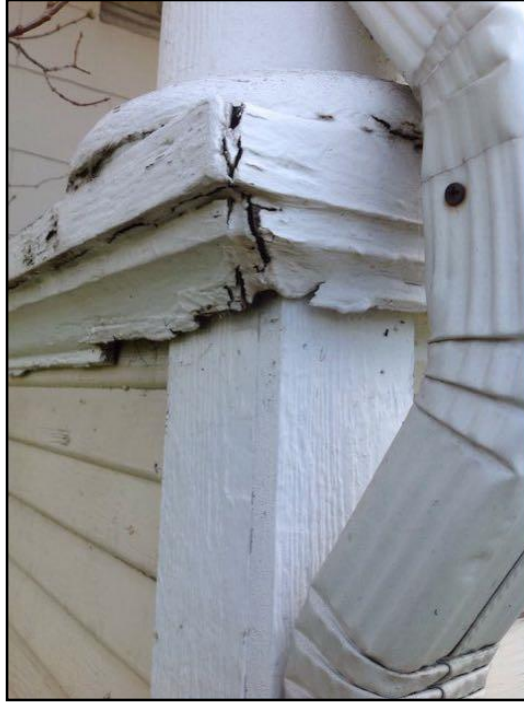
49. Damage

## 12. Condition: • Damage

I noted moisture damage to the corner of the front porch. It was dry at the time of inspection but it is likely this was caused by a leaky gutter at some point.

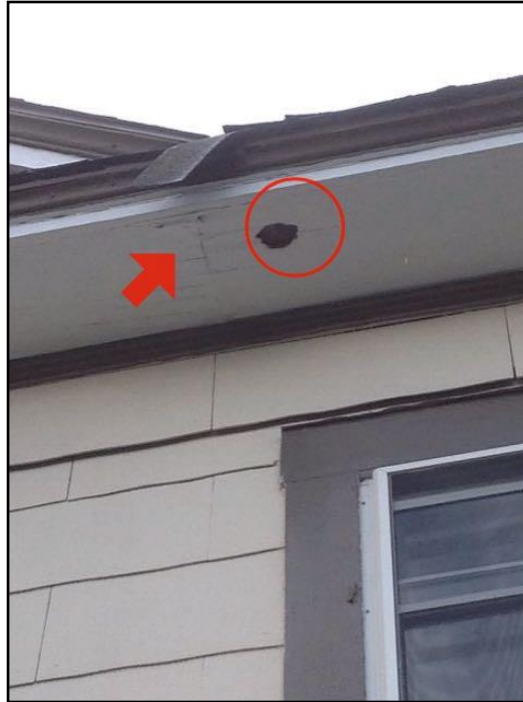
54. Moisture damage

### 15. Condition: • [Rot](#)

I noted a section of soffit that appears to have moisture damage. The paint is flaking off and there is a loose shingle

above it. The hole in the soffit appears to be from an old non-functioning built-in gutter system. I recommend the roof be professionally evaluated to remedy this condition.

**Implication(s):** Weakened structure

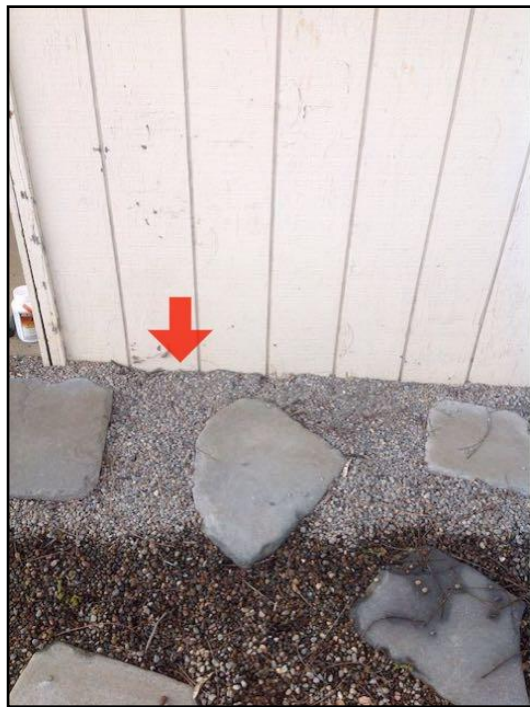
56. Too close to grade

**18. Condition:** • [Too close to grade](#)

I noted the attached shed in the back and the garage siding are touching the ground in the back. There should be a gap between the bottom of the siding and the grade to prevent moisture damage. Because the grade is made of rocks that allow drainage, this condition may not be as bad.

**Implication(s):** Chance of water damage to contents, finishes and/or structure | Material deterioration | Rot | Insect damage

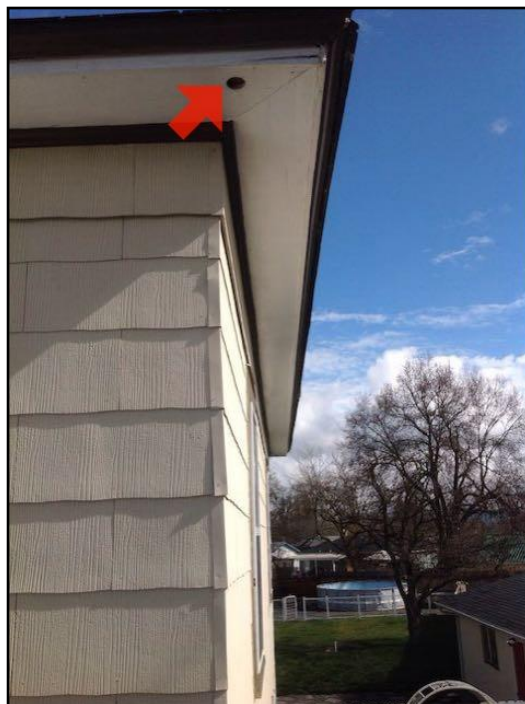
60. No Gutters Installed

## Gutter & downspout type: • No Gutters Installed

*Note:* No gutters are installed on the 2nd floor roof. There are holes on each corner from an old built-in gutter system I believe.

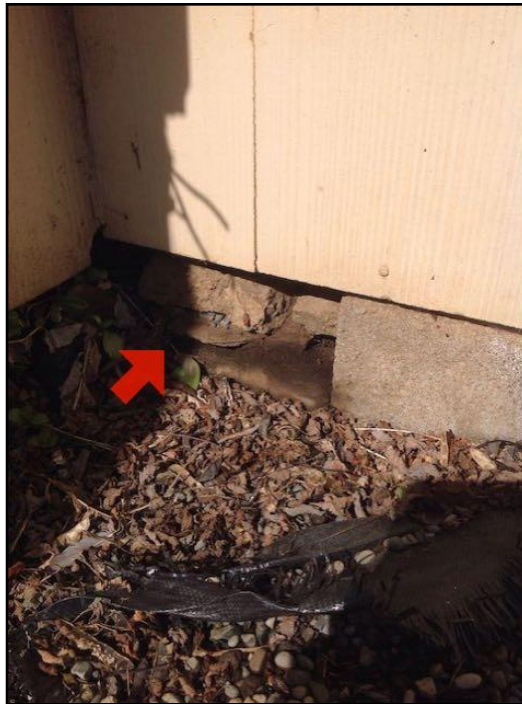
61. Cinder blocks

**Patio:** • The rear bathroom and laundry room appears to have been a patio at one point and has the same construction methods as the front porch. It appears it has undersized footings that have sunk into the ground a little at the very end. The ends of the patio foundation have cinderblocks used to fill in the void at the ends of the patio but I do not believe these are meant to support any weight.

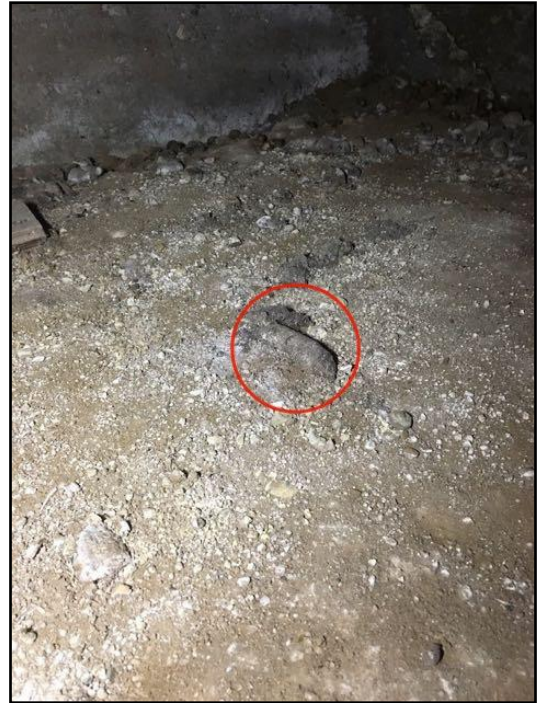
63. Pest Evidence

**20.** • I noted a fair amount of animal activity in the crawlspace. I found lots of mice droppings and what appear to be small animal droppings. I highly recommend inclosing all vents with a fine mesh screen to prevent rodents from entering the home and causing damage.

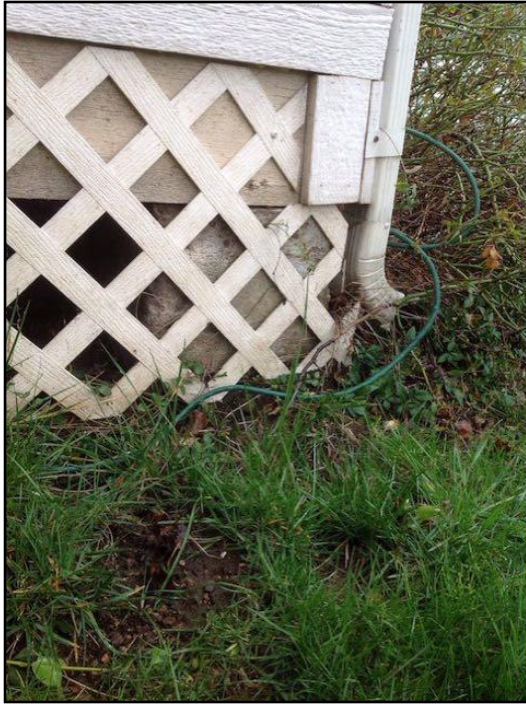
64. Small footing

**21. Condition:** • I noted the front porch has settled 2 inches. I believe this is from inadequate footings and excessive water. The gutter discharges right next to the footing and has likely softened the soil and caused the footing to sink. I recommend discharging the gutter 6 feet away from the structure and consulting a qualified contractor for possible remedy and releveling.

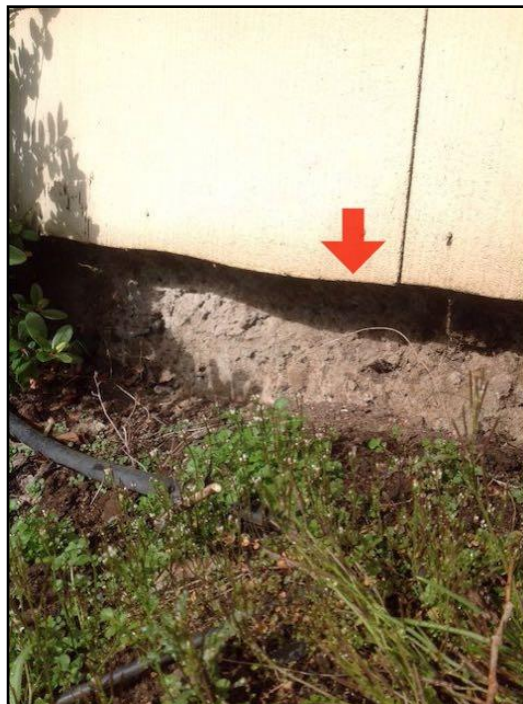
70. Spalling, crumbling or broken material

**23. Condition:** • [Spalling, crumbling or broken material](#)

The foundation looked good overall, however, in this location on the South end of the home, I noted some concrete deterioration. It does not appear to structurally affect the home at the moment.

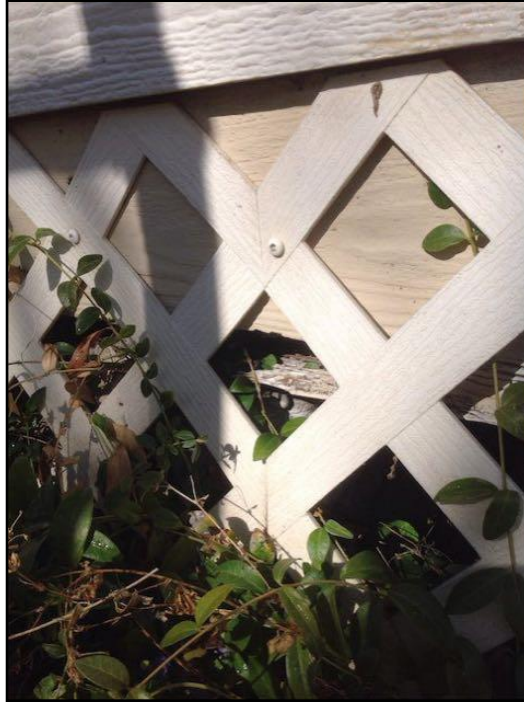
*71. Rot damage*

### **25. Condition:** • [Rot, insect or fire damage](#)

The outside of the floor beam on the front porch has some rot at the foundation pier. This may be contributing to the sagging floors.

**Implication(s):** Weakened structure | Chance of structural movement

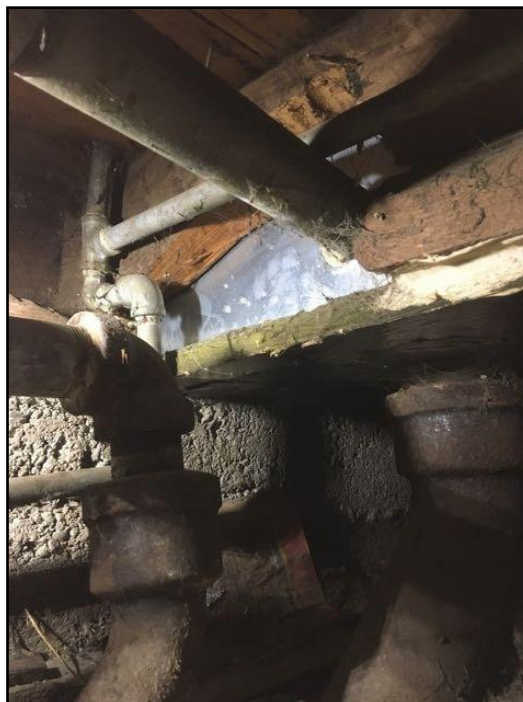
72. Notched Joist

### **26. Condition:** • [Notches or holes](#)

I noted a notched joist that has structurally compromised the joist. I did not notice that it was sagging or that the floor was spongy. The easiest solution will be to provide a concrete pier to support this joist individually by a qualified contractor.

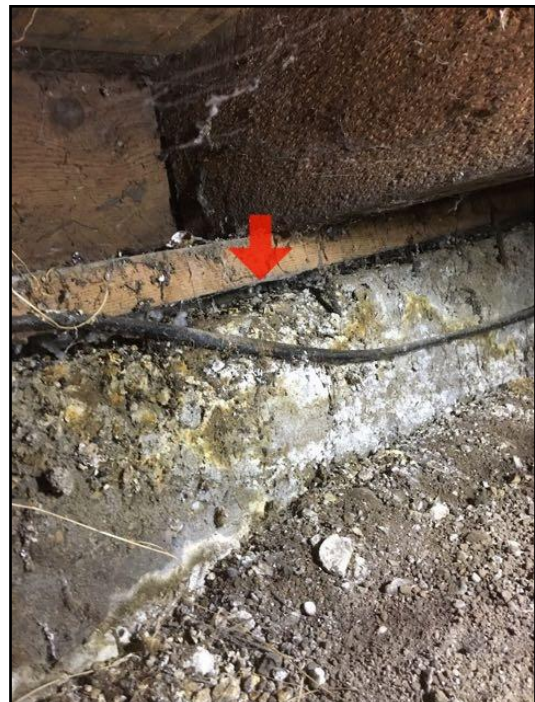
74. Gaps under sills

#### 27. Condition: • [Gaps under sills](#)

I noted the east side mudsill has been shimmed up about an inch and has gaps under it. The interior pony wall has also

been shimmed up in some locations. Each joist should have direct bearing to the foundation to support the load of the house. It appears this condition has existed for years (if not original). I do recommend providing a shim under each individual joist to provide direct load bearing.

**Implication(s):** Weakened structure | Chance of structural movement

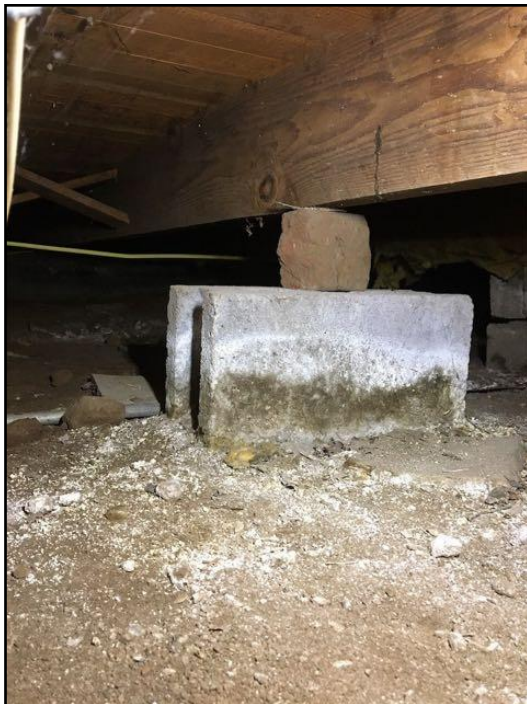
76. Sag or springy

### 28. Condition: • [Sag or springy](#)

I noted several floor joists that have been given extra support in the south side of the crawlspace. I believe this is due to the 2x8 floor joists being over-spanned and feeling spongy.

**Implication(s):** Chance of structural movement | Bouncy, springy floors

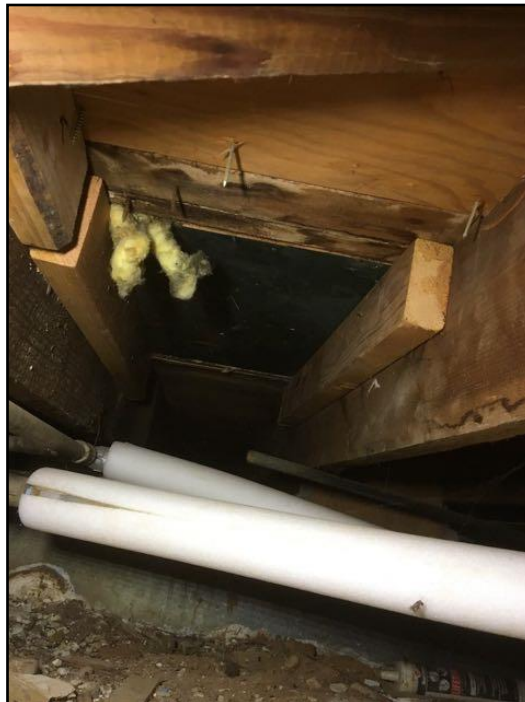
79. Past repair

**29. Condition:** • I noted a past repair to the subflooring under what I believe is the kitchen. There was some water staining at this location. Everything appeared to be structurally intact.

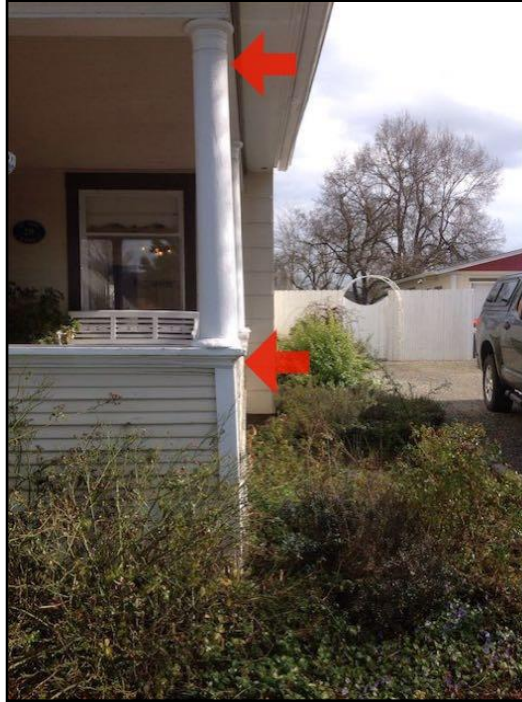
80. Leaning

### **30. Condition:** • [Leaning, bowing, buckling](#)

This post on the front porch was leaning in about 2 inches out of plumb. Its possible the sagging of the roof has pulled the corner of the roof in some. I recommend consulting with a qualified contractor for a possible repair.

**Implication(s):** Chance of structural movement

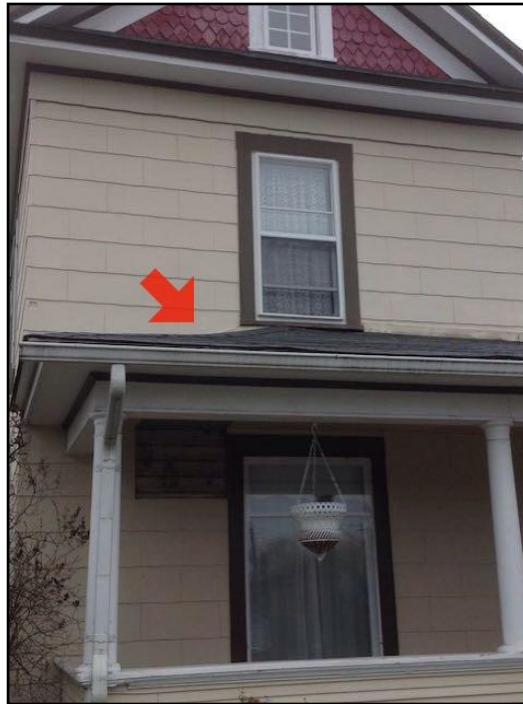
83. Sagging hip

## 32. Condition: • [Sagging](#)

I noted the porch hip showed obvious signs of sagging. This is likely due to insufficient roof joist framing. I recommend consulting a professional contractor to discuss a possible remedy.

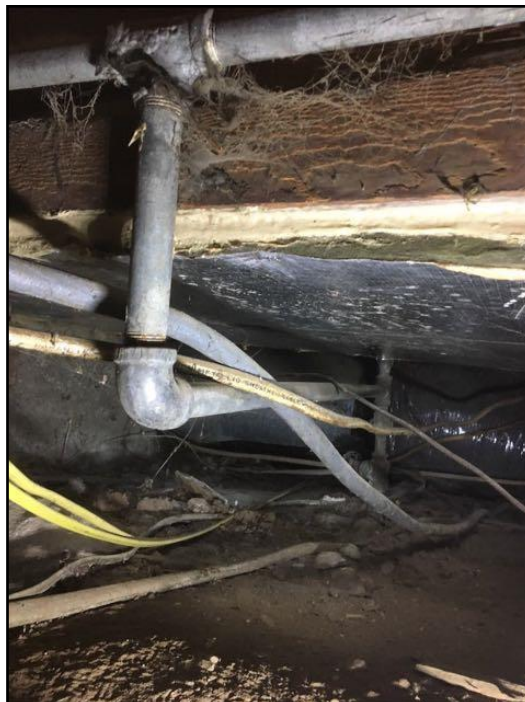
85. Entered but access was limited

- Entered but access was limited

Despite the low clearance, I was able to inspect the majority of the crawlspace. However, I was not able to gain access to the Northeast corner of the home due to a large metal air duct completely blocking access.

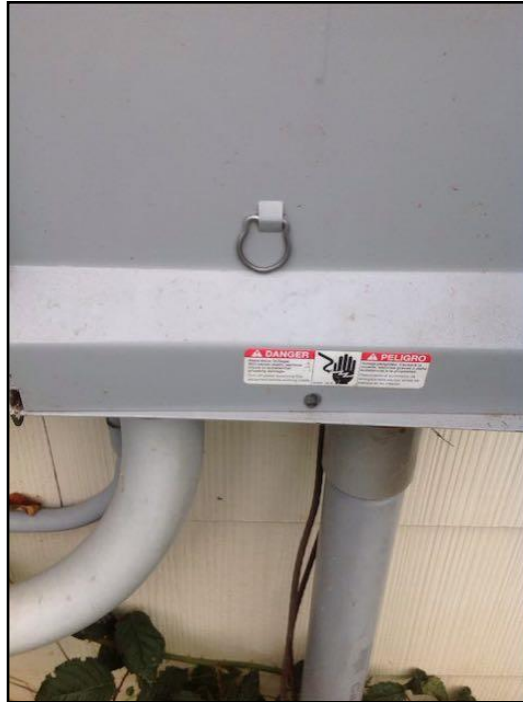
**86.** *Loose panel*

**33. Condition:** • [Loose panel](#)

**Implication(s):** Electric shock | Fire hazard

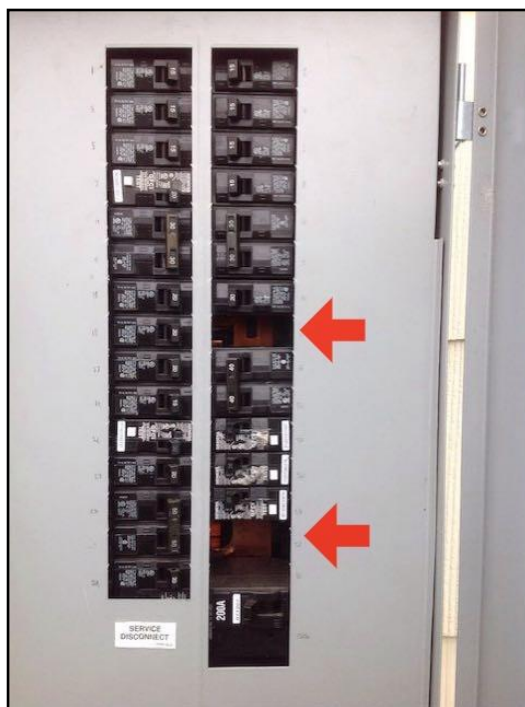
87. Openings in panel

**34. Condition:** • [Openings in panel](#)

There are several openings in the panel. I recommend a qualified electrician plug these holes to prevent foreign objects from entering the panel.

**Implication(s):** Electric shock | Fire hazard

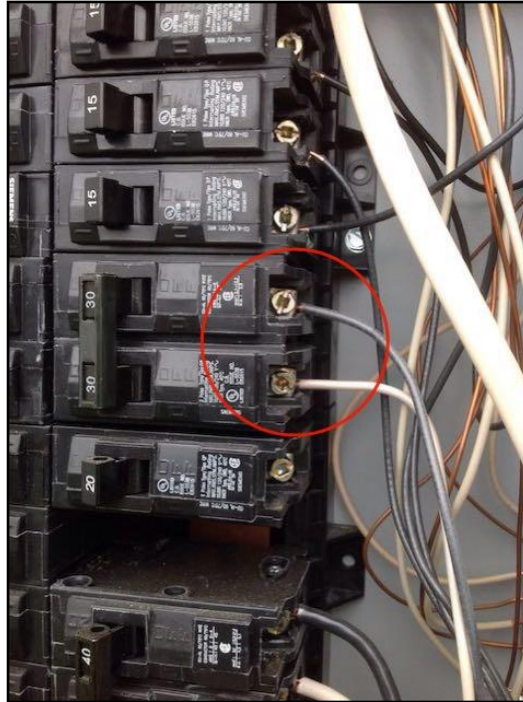
**88.** Fuses or breakers too big

35. Condition: • [Fuses or breakers too big](#)

I noted a 30amp breaker with undersized wires going to it. This condition can cause the wires to heat up dangerously. I recommend having the panel inspected by a professional electrician to remedy this condition.

**Implication(s):** Equipment overheating | Fire hazard
