# INSPECTION REPORT

For the Property at:  
**123 EXAMPLE WAY**  
CENTRAL POINT, OR 97502

Prepared for: JOHN DOE  
Inspection Date: Friday, March 9, 2018  
Prepared by: Zach Macormic

RE: Report No. 1028, v.5  
123 Example Way  
Central Point, OR  
97502

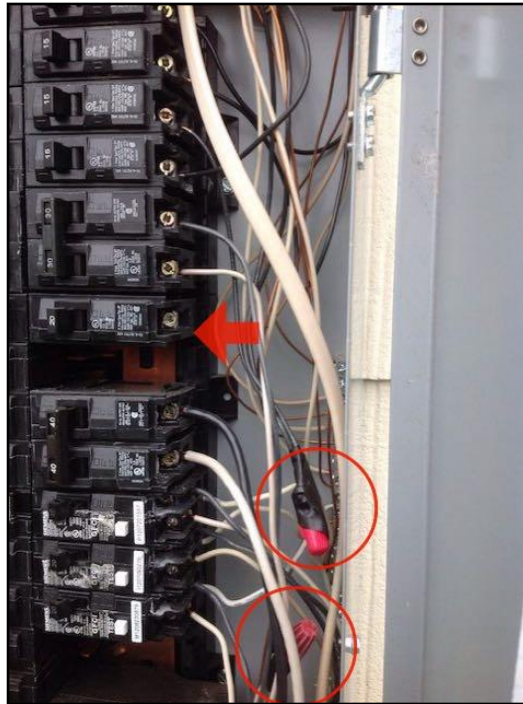
89. Pig tail

**36. Condition:** • I noted a couple pigtail connections in the panel where one circuit breaker is feeding two wires (with one wire connecting to the breaker). I don't think this condition is inherently unsafe, but there are a couple breakers being completely unused and several openings for new breakers in the panel to accommodate the extra wire. I recommend an electrician evaluate the condition.

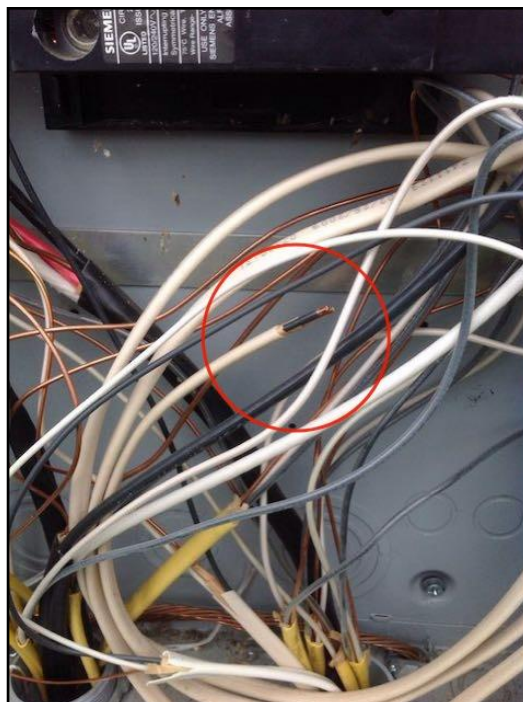
90. Abandoned wires in panel

## 37. Condition: • [Abandoned wires in panel](#)

I noted an abandoned wire in the panel. I was unable to determine where the wire leads to. There are several dead circuits in the home and its possible it goes to one of these.

**Implication(s):** Electric shock

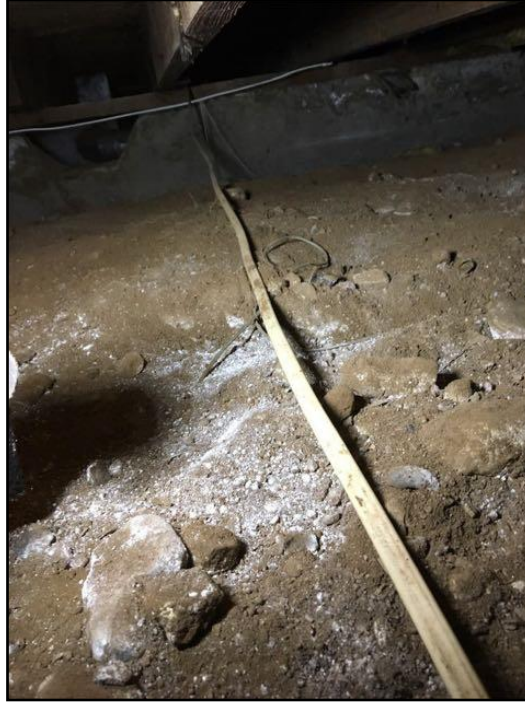
91. Loose wire

**38. Condition:** • I noted a loose wire that is resting on the ground and should be affixed to the bottom of the joist to help prevent a shock hazard.

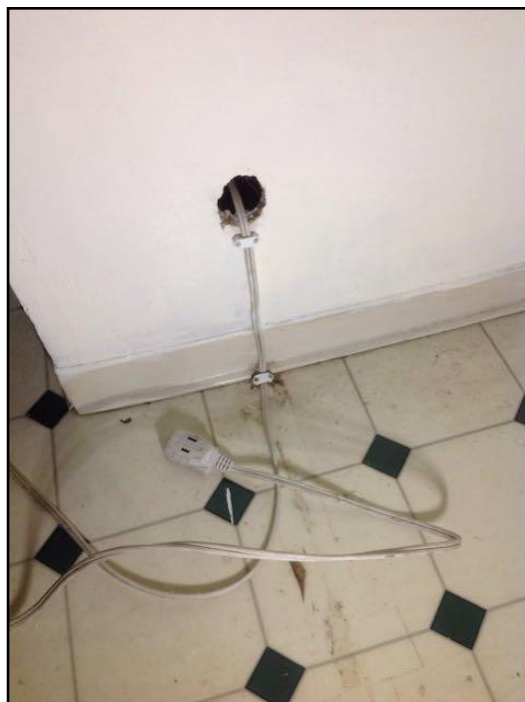
93. Extension cord used as permanent wiring

**40. Condition:** • [Extension cord used as permanent wiring](#)

In the bathroom by the laundry, I noted an ungrounded extension cord supplying power through a hole in the wall. The cord is plugged into a GFCI outlet, however I recommend this condition be remedied by a qualified electrician.

**Implication(s):** Electric shock | Fire hazard

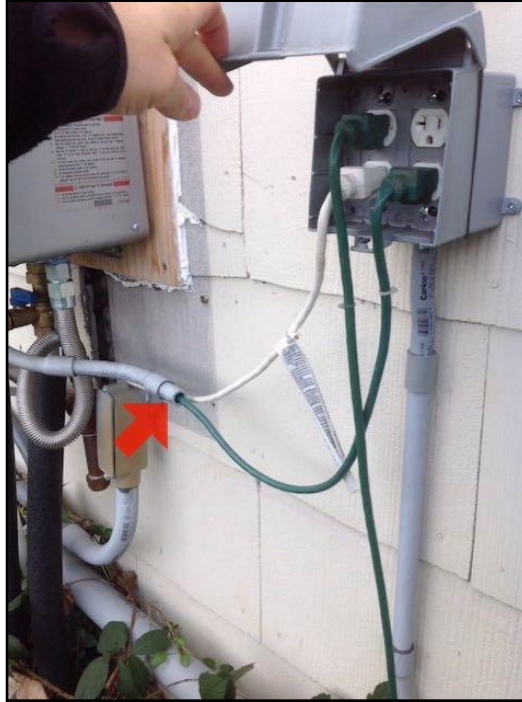
94. Extension cord used as permanent wiring

## 41. Condition: • [Extension cord used as permanent wiring](#)

I noted the instant water heater was permanently plugged into an adjacent outside outlet. This condition may allow water to find its way into the electrical box. I recommend this condition be evaluated by a qualified electrician to determine if this condition is unsafe.

**Implication(s):** Electric shock | Fire hazard

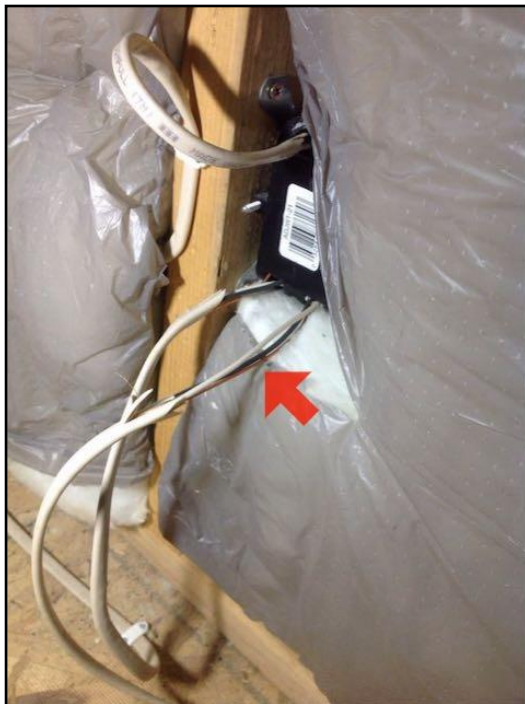
**96. Exposed Jacketing**

## 43. Condition: • [Exposed on walls or ceilings](#)

I noted several areas with exposed wires. All wires connections should be inside an approved junction box, the protective wire jacket needs to extend all the way into the junction box, and all wires within the living space should be protected from damage. I recommend a qualified electrician fix all of these conditions to avoid a possible shock and fire hazard.

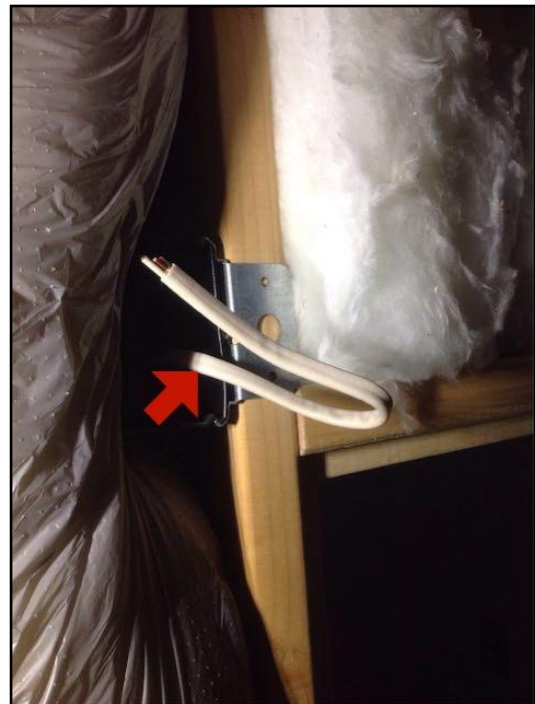
**97. Abandoned Wire**

**39. Condition:** • [Abandoned wire](#)

I noted an abandoned wire under the kitchen sink. It did not have power at the time of inspection. I recommend this wire be placed inside a junction box by a qualified electrician.

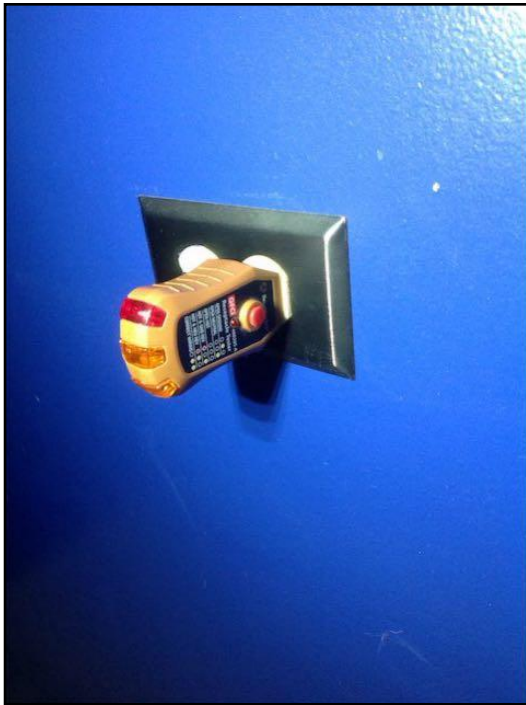
**102.** *Inoperative Outlet in Laundry*

### 44. Condition: • Inoperative

I noted several inoperative outlets in the home.

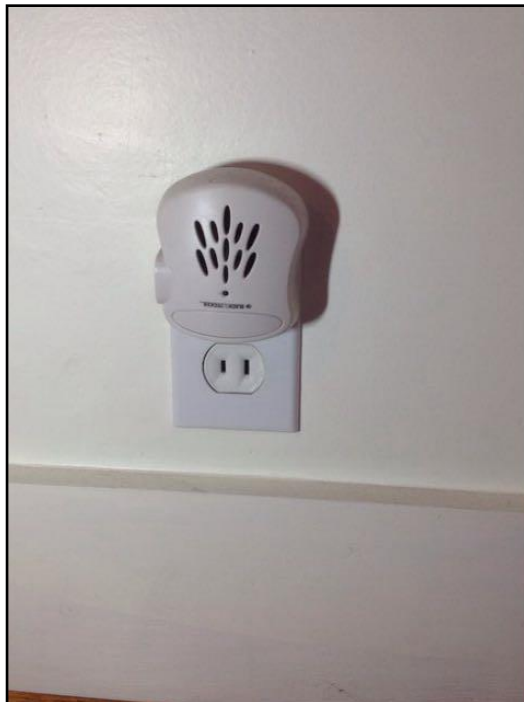
**107.** *Ungrounded*

**45. Condition:** • [Ungrounded](#)

**Implication(s):** Electric shock

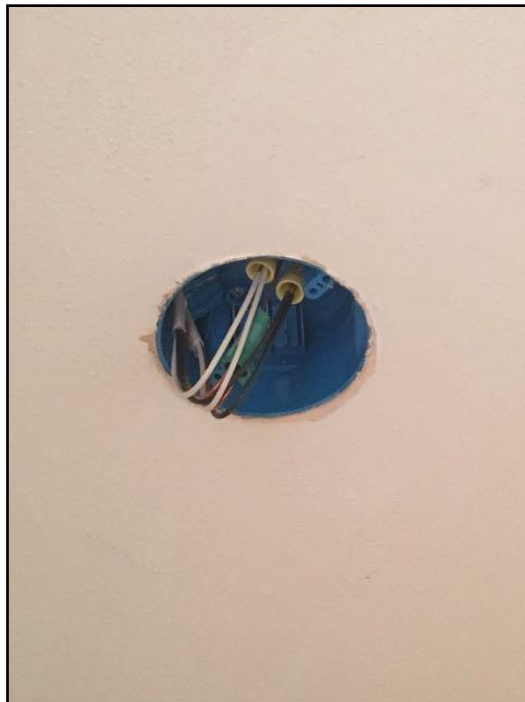
111. Missing

48. Condition: • [Missing](#)

Implication(s): Inadequate lighting

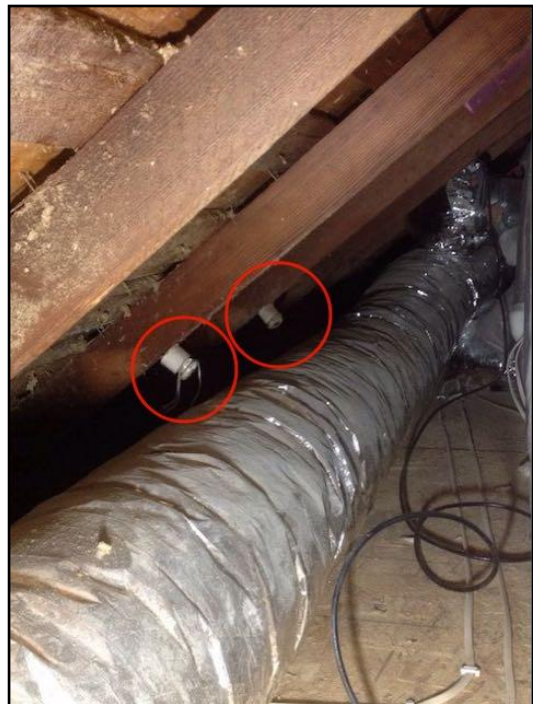
113. Old Knob and Tube Remnant

**General:** • I noted old knob and tube remnants that are not currently in use.

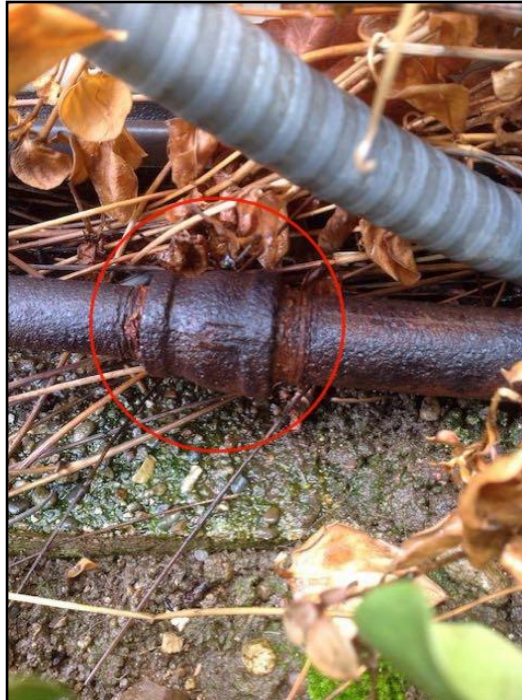
**121.** *Rust at Gas line*

#### **50. Condition:** • [Rust](#)

The gas line supplying the outside furnace appears to be corroded. I highly recommend this condition be evaluated by a licensed plumber to determine if this condition is unsafe and suggest a possible remedy.

**Implication(s):** Fire or explosion

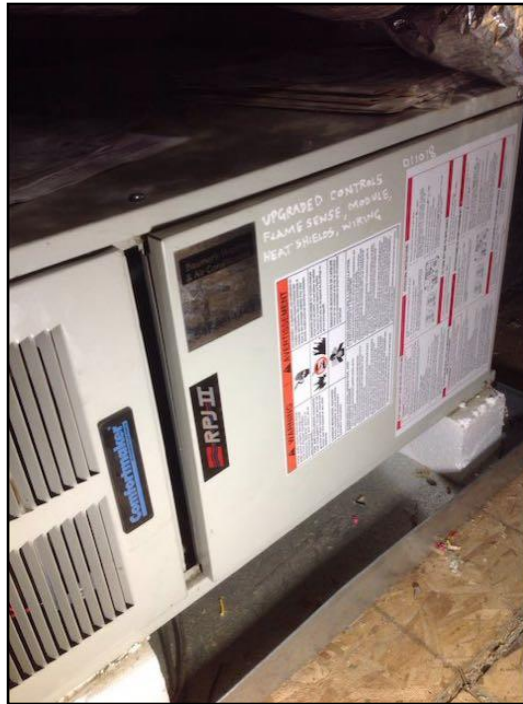
122. Attic Furnance

**51. Condition:** • The gas furnace in the attic is supplying the 2nd and 3rd floors. I believe the right door of the furnace belongs to a different unit as it did not want to fit correctly. The furnace was functional at the time of inspection.

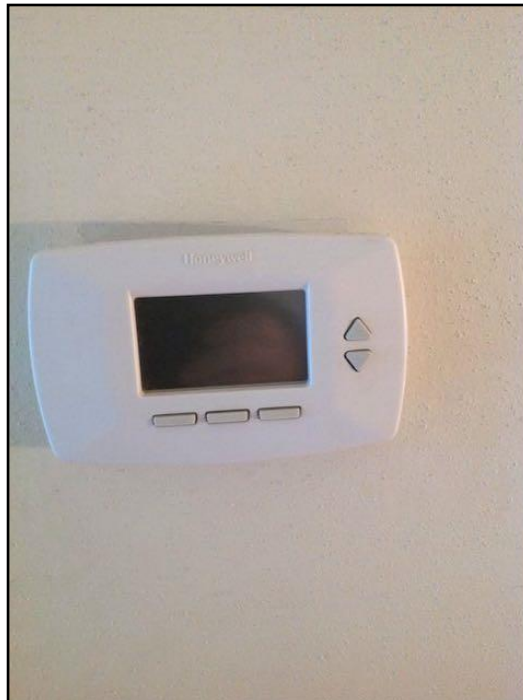
123. Dead Battery

**52. Condition:** • The upstairs furnace was functional at the time of inspection, however the thermostat flashed "low Battery" and died when I tried to adjust it. I recommend replacing the batteries.

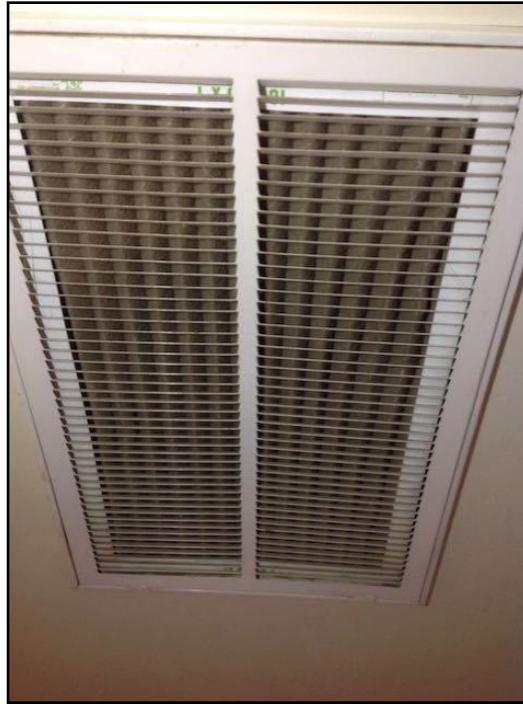
**124.** *Dirty Filter*

### **53. Condition:** • [Dirty](#)

I recommend the upstairs air return filter be replaced immediately as it is very dirty. It is recommended you check your air filter once a month to see if a replacement is needed.

**Implication(s):** Increased heating costs | Reduced comfort

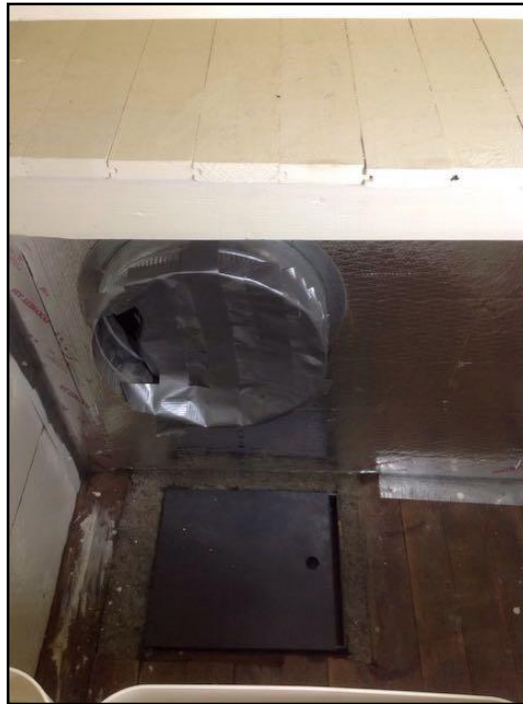
125. Air Return

**54. Condition:** • I found an air return under the stairs that had been closed off. I did not find another air return for the downstairs unit. This condition may be restricting the air flow to the unit and may shorten its life. I recommend this condition be evaluated by an HVAC technician to prolong the life of the unit.

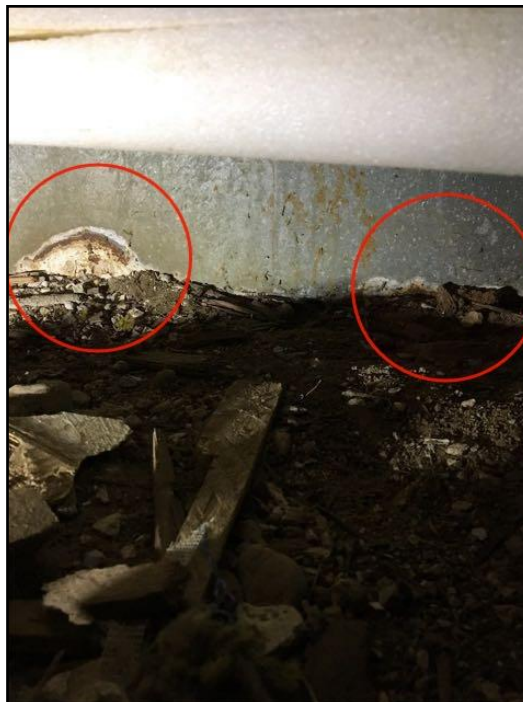
126. Dirty

## 55. Condition: • [Dirty](#)

I noted the HVAC ducting has been allowed to rest directly on the soil and this condition has allowed the metal to rust. I noted a few locations where rust spots were visible. I did not see any holes corroded all the way through. It may be a good idea to have this condition evaluated by an HVAC technician.

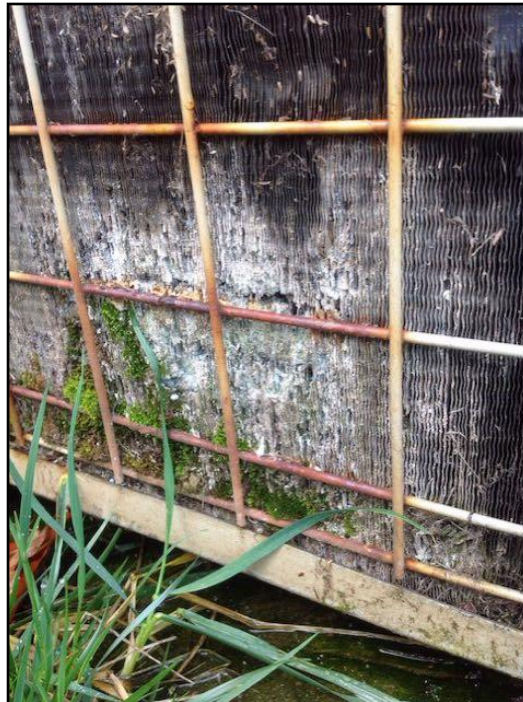
**139.** *Corrosion*

#### **59. Condition:** • [Corrosion](#)

The upstairs heat pump evaporator coil has corrosion on one side due to excessive moisture. I recommend the systems be further evaluated by a qualified HVAC technician.

**Implication(s):** Reduced system life expectancy | Increased cooling costs | Reduced comfort

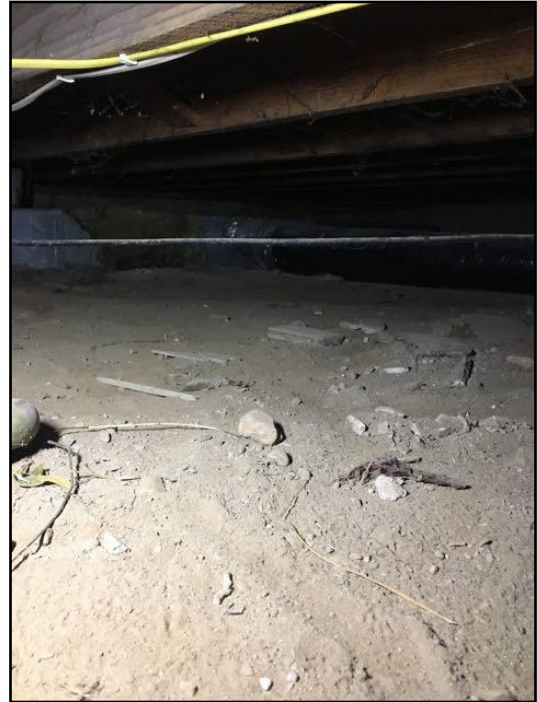
145. No vapor barrier

62. **Condition:** • [No vapor barrier](#)

I noted there was not a vapor barrier installed in the crawlspace. This can allow excess moisture in the crawlspace and invite mold and rot to form. I recommend installing a 6mil plastic vapor barrier throughout the crawlspace to help prevent damage to the structure due to moisture. This condition may be noted by an FHA appraiser.

**Implication(s):** Chance of condensation damage to finishes and/or structure

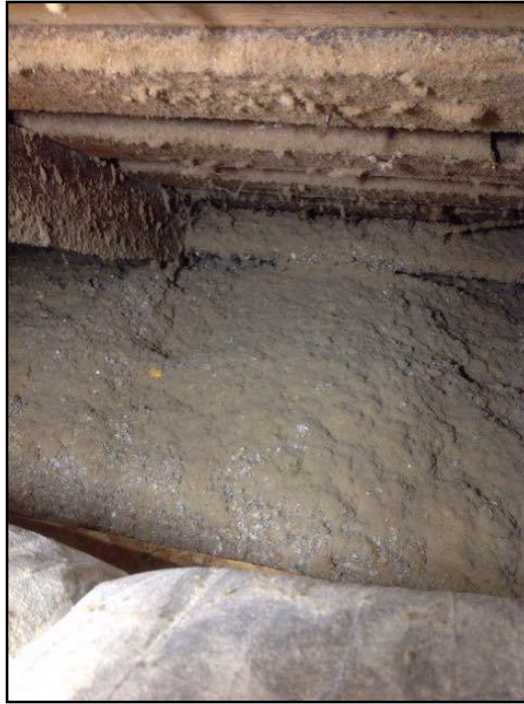
146. Blown-In Insulation

*Note:* I believe this is cellulose blown-in insulation, which may not have asbestos. However, I highly recommend having it tested before disturbing it for any reason.

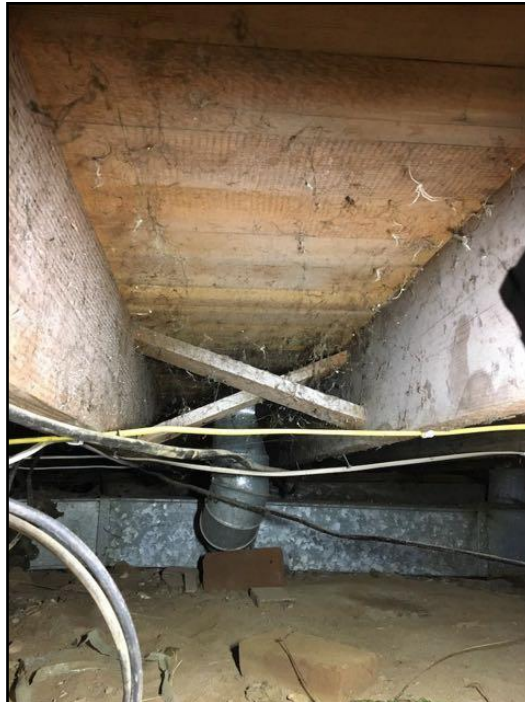
**148.** *No Crawlspace Insulation*

**Floor above basement/crawlspace air/vapor barrier:** • None found

**Crawlspace ventilation:** • Inadequate

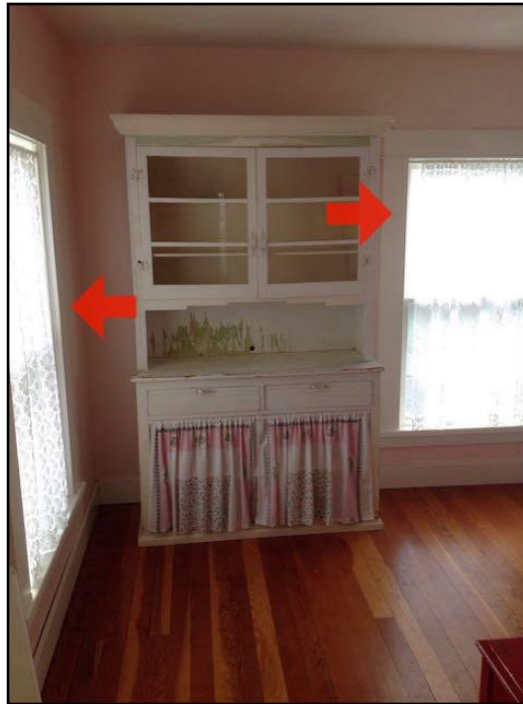
164. Inoperative Windows

### 65. Condition: • Inoperative

Both of these windows are unable to be opened due to being painted shut along with several windows downstairs. I checked all rooms for a means of egress in case of a fire emergency and all rooms have at least one window that operates functionally. However, I recommend these windows be corrected to allow egress onto the porch roof.

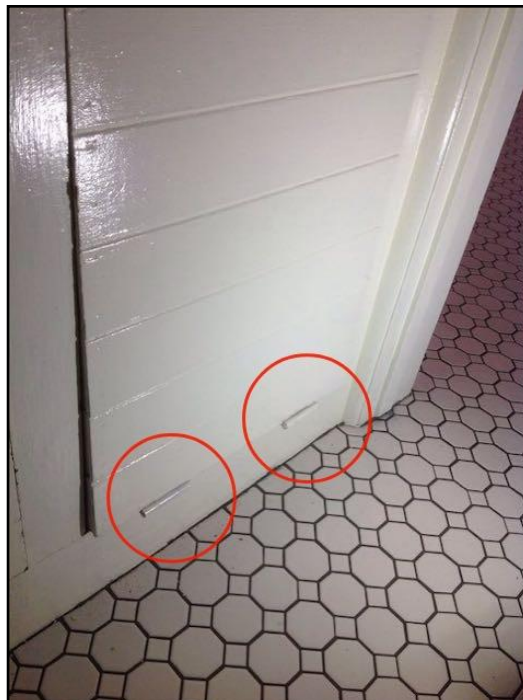
165. Doors or drawers missing or loose

The hinges on the pull-out drawer in the kitchen storage were broken.

**Implication(s):** Nuisance | Damage or physical injury due to falling materials

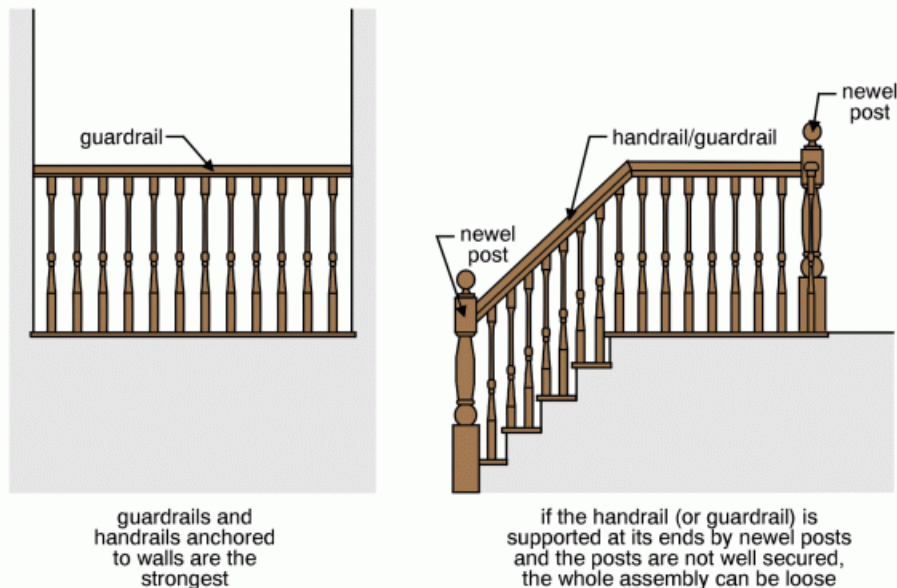
### 67. Condition: • [Loose](#)

The handrail at on the 3rd floor felt fairly frail and has several loose screws. I recommend a more secure handrail be installed to prevent an accidental fall into the stairwell. This condition has a chance of being noted as a condition of lending by an appraiser.

**Implication(s):** Fall hazard

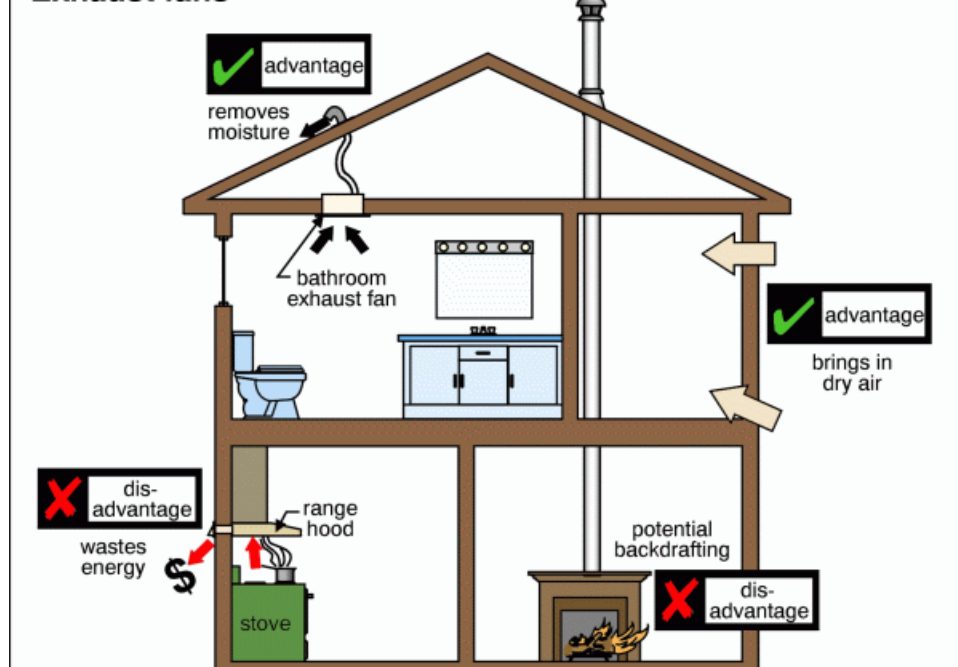
### 69. Condition: • [Missing](#)

I noted the laundry room bathroom does not have a ventilation fan installed. I recommend one be installed to help prevent moisture damage to the interior of the bathroom.

**Implication(s):** Chance of condensation damage to finishes and/or structure
