# Prism Home

## YOUR INSPECTION REPORT

100 N. Main Street  
My Village, GA

Wednesday, June 27, 2018

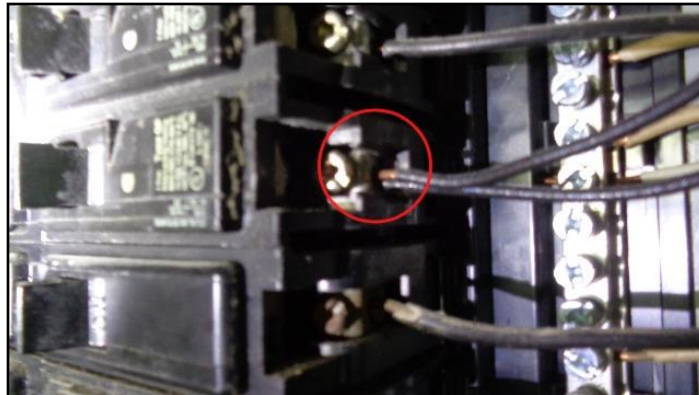
**Condition:** • [Double taps](#)

Breaker is housing two wires. Recommend an electrician add an additional breaker to house the extra wire.

**Implication(s):** Fire hazard

*Double taps*

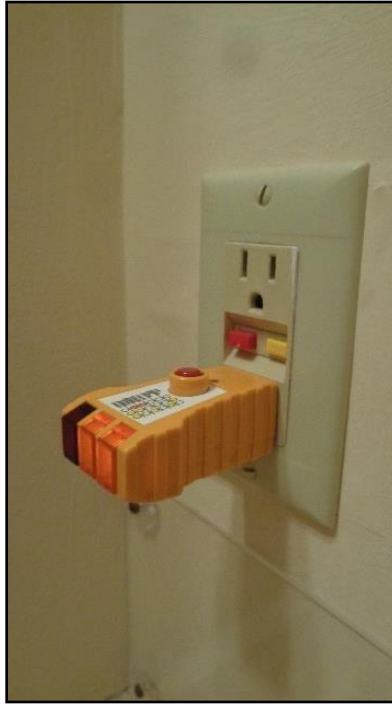
**Condition:** • [Test faulty on GFCI/GFI \(Ground Fault Circuit Interrupter\)](#)

*Test faulty on GFCI/GFI (Ground Fault...*

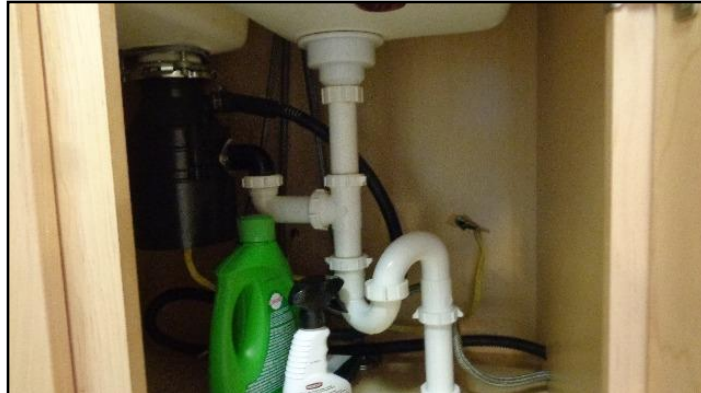
*Wrong type*

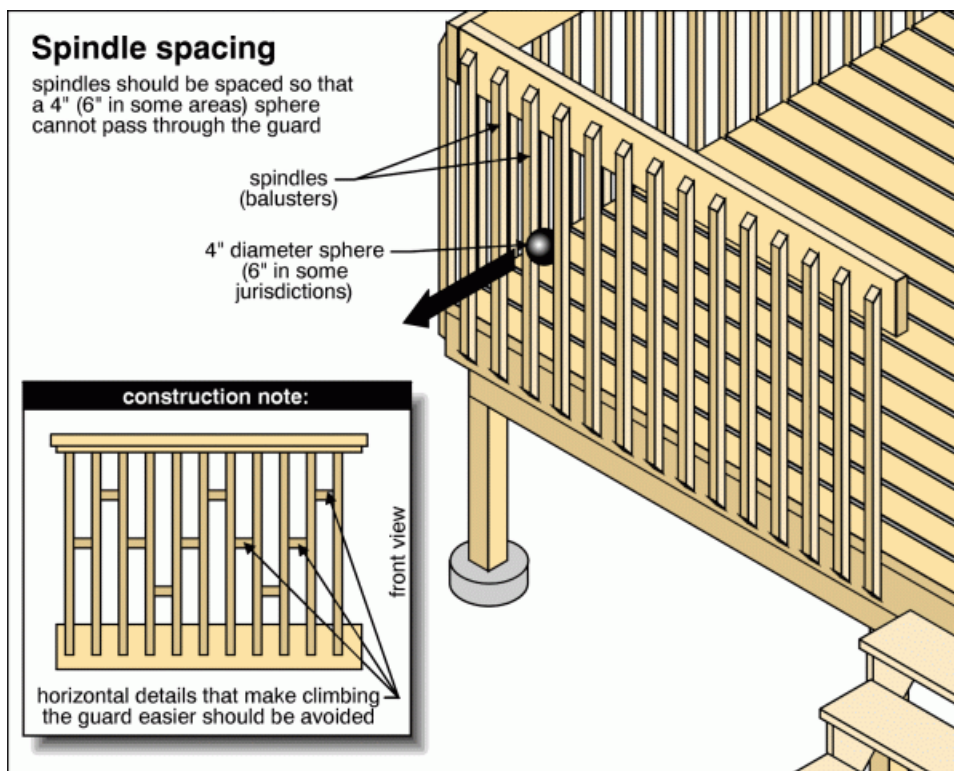
## Spindle spacing

**Condition:** • [Openings between spindles \(balusters\) too large](#)

The opening between the pickets to the balcony railing are too far apart. Recommend adding pickets to decrease opening size to no more than 4 inches as required by building code to reduce risk of fall injury to small child or pet.

**Implication(s):** Fall hazard

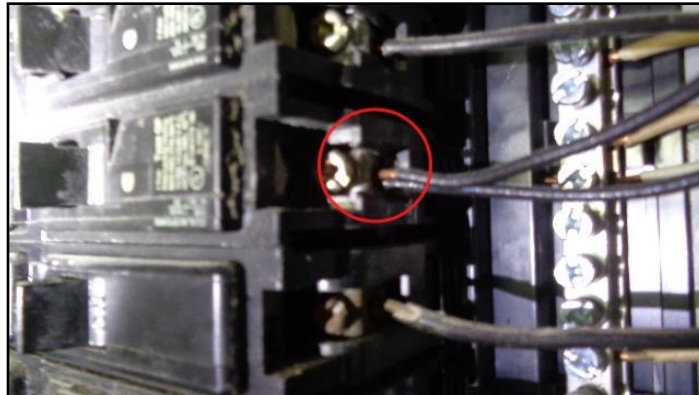
Double taps

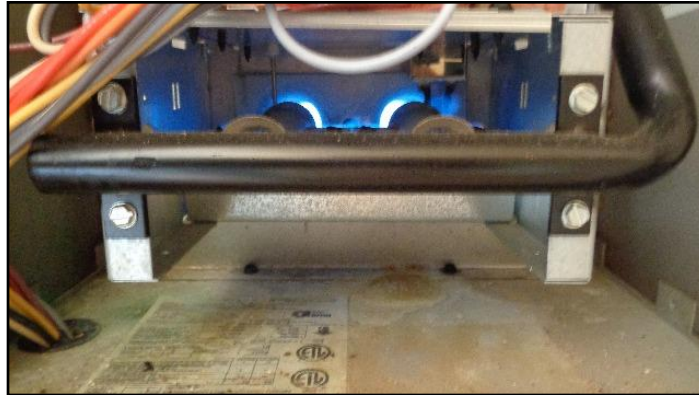
**15. Condition:** • Furnace tested, clean burn, operating as designed. Recommend annual service by local HVAC contractor.

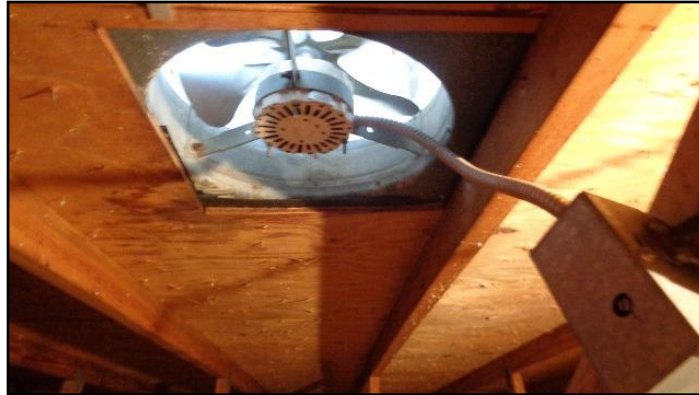
*Inoperative in summer*

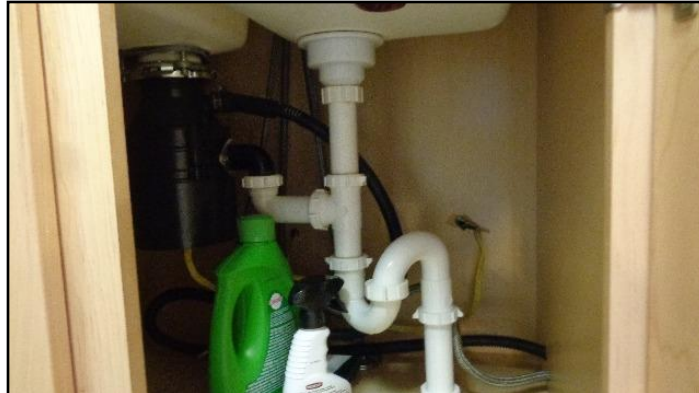
*Wrong type*

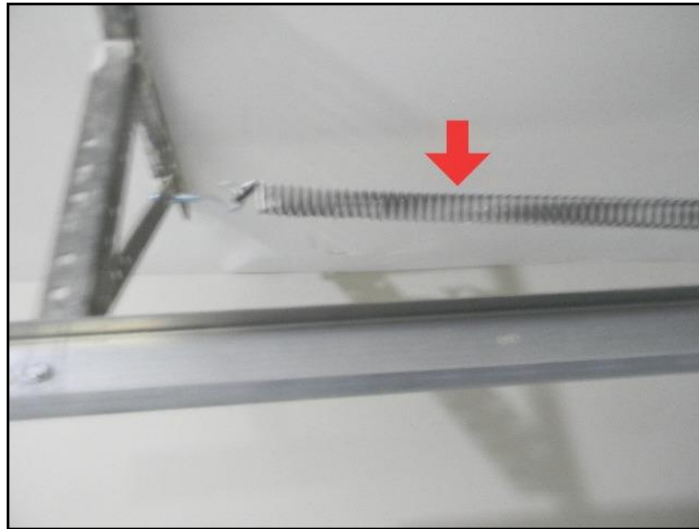
## 26. Condition: • [Difficult to open or close](#)

The auto door opener for the garage would not function to close the door, suspect safety equipment is out of alignment. Recommend a garage door specialist review and correct.
