YOUR INSPECTION REPORT

FOR THE PROPERTY AT:
915 Ossington Avenue
Toronto, ON M6G 3V3

INSPECTION DATE:
Friday, February 18, 2022

RE: Report No. 7026, v.2
915 Ossington Avenue
Toronto, ON
M6G 3V3

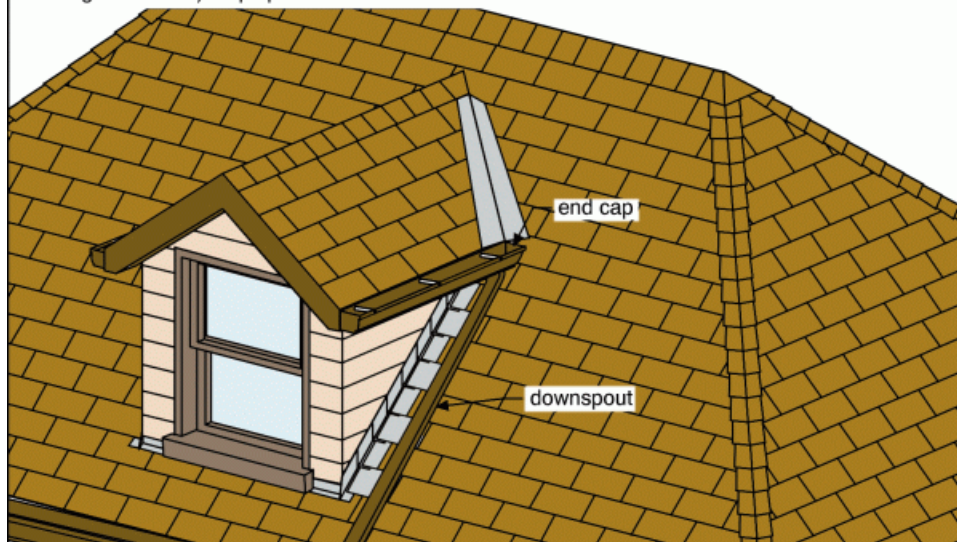
Condition: • [Discharge onto roofs](#)

Downspout running across roof

installing a downspout (from the secondary roof to the main gutter below) helps prevent localized roof wear

Improvement recommendation. Extend Downspout to lower gutter to protect roof from premature wear.

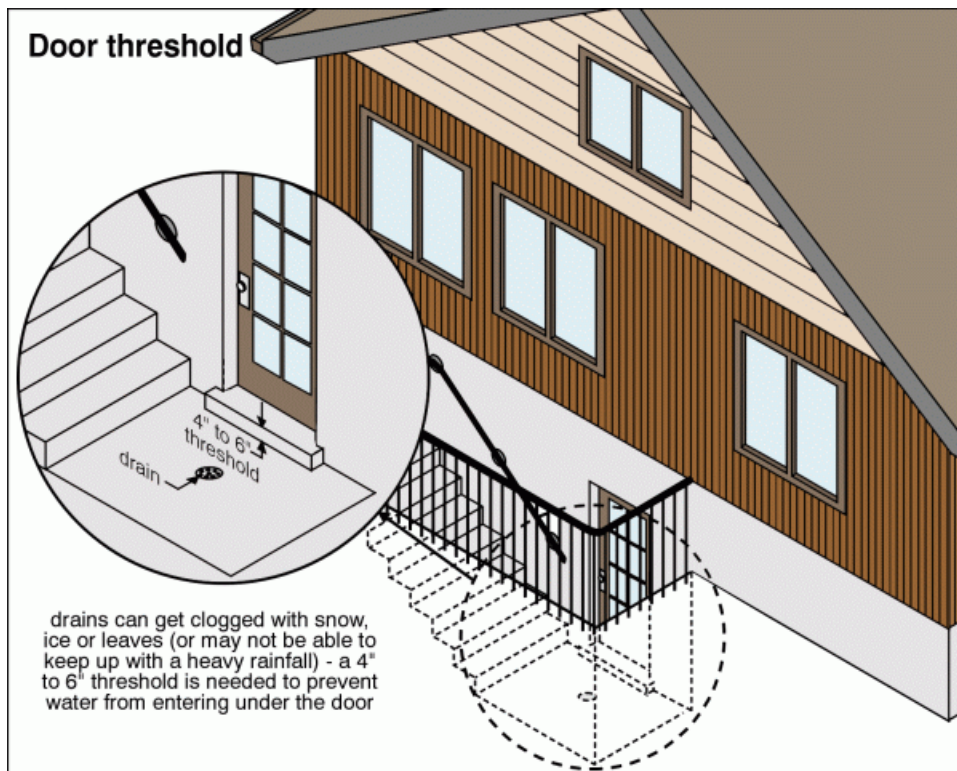
Condition: • [Door threshold missing, too low, not watertight](#)

Task: Monitor / Improve
