Your Inspection Report

1380 Lincoln Road
Windsor, ON N8Y 2J1

RE: Report No. 5469
1380 Lincoln Road
Windsor, ON
N8Y 2J1

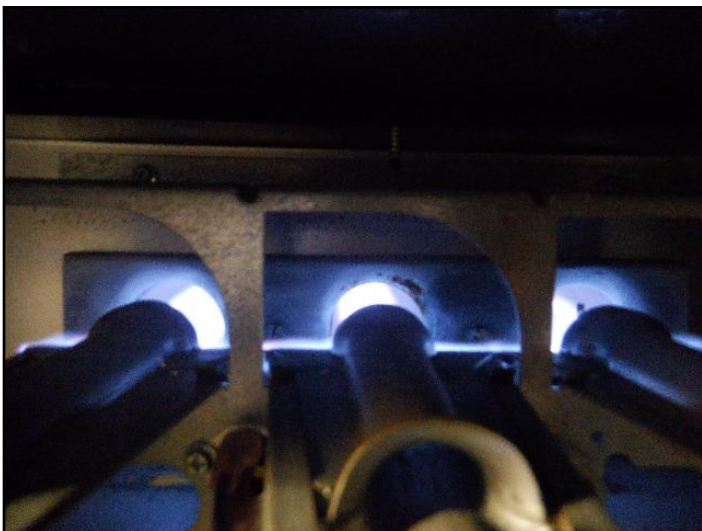
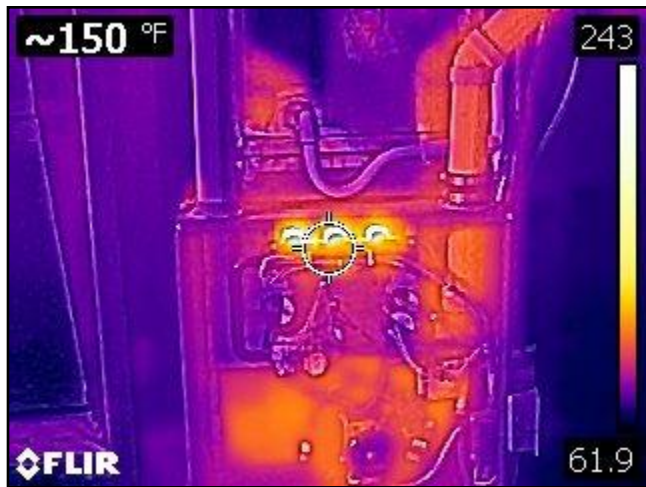
• Main heating is done with a forced air gas furnace that was turned on with normal thermostatic controls. It was responsive to these controls and the furnace was working and doing it's intended functions at the time of inspection. The client is aware of the typical lifespan of these units and was well aware of the age and condition of this furnace. Any issues found will be noted at the end of this section under recommendations.

49. Operational

50. Operational

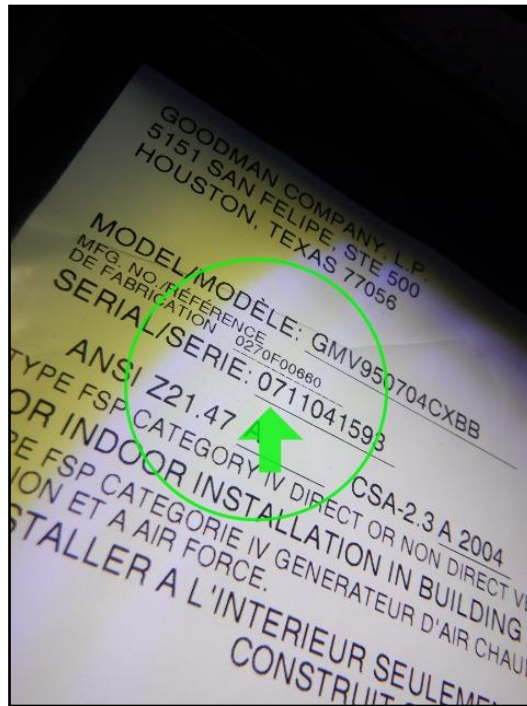
55. 19 years

Typical life expectancy: • Furnace (high efficiency) 15 to 20 years

Based on age and not condition

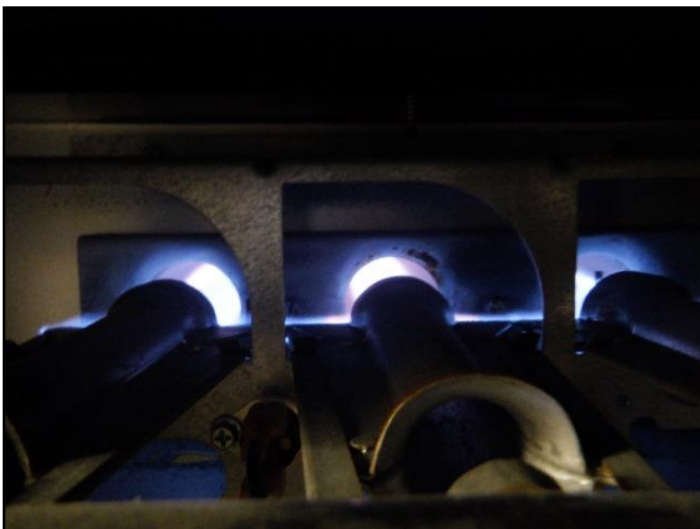
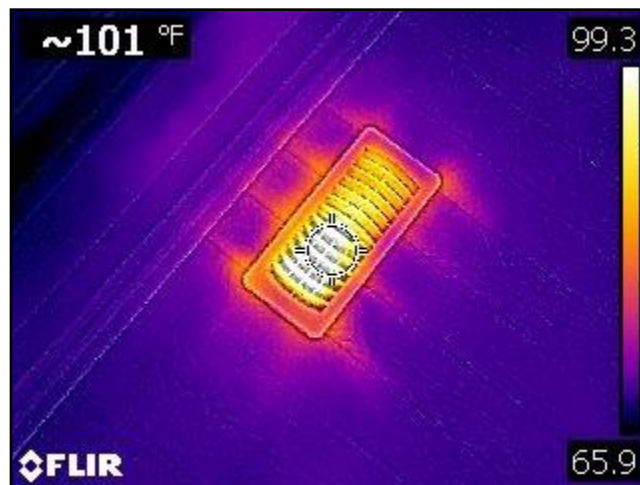
15. Condition: • The heating system was operational at the time of inspection and doing it's normal intended functions. The client was aware of the age and condition of this furnace as it was discussed at the time of inspection.

58. Operational

59. Operational

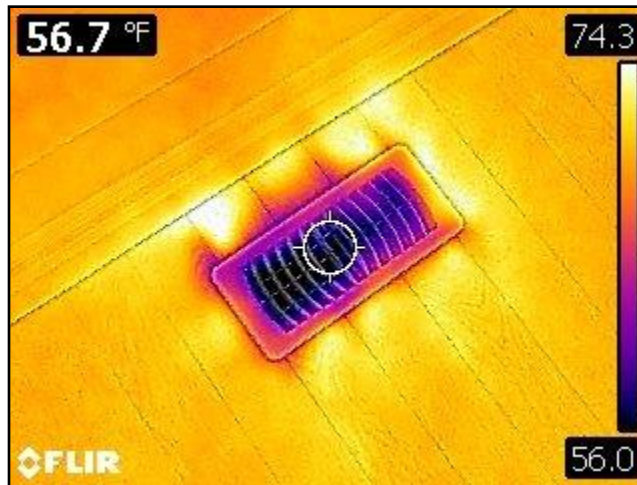
- The cooling in this home is done with a central air type system that was turned on with normal thermostatic controls. This system was working at the time of inspection and the client was aware of it's age and condition at the time of inspection.

60. Was Operational

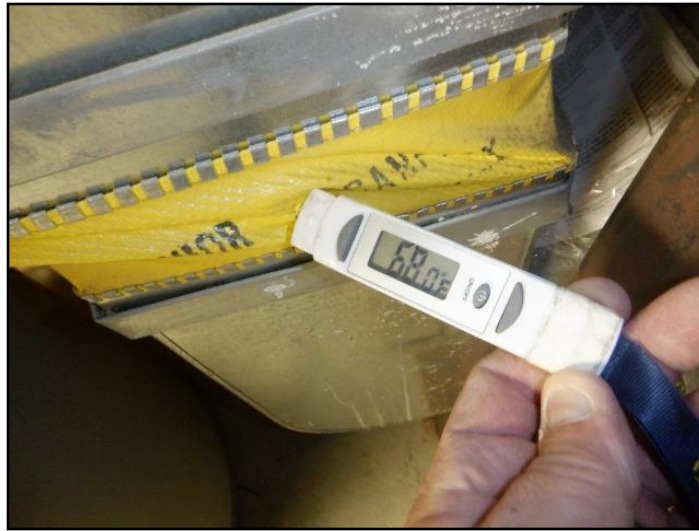
65.68 F

Temperature difference across cooling coil: • 24° • This suggests good performance.

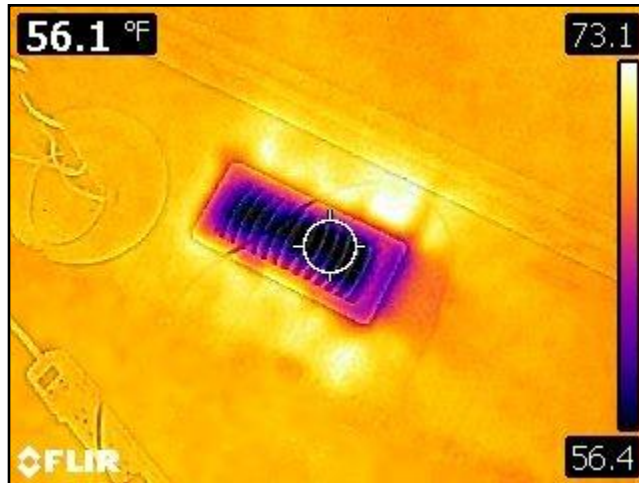
23. Condition: • This cooling system was working and doing it's intended functions at the time of inspection. Any issues found will be noted at the end of this section under recommendations.

66. Was Operational

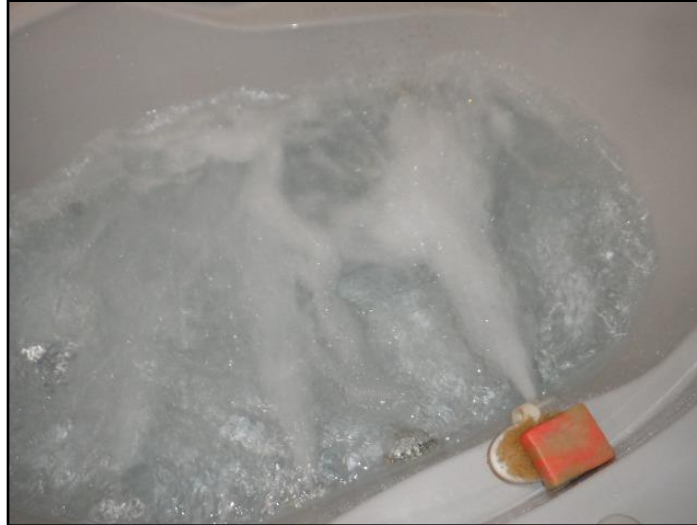
General: • The jacuzzi tub was tested and was operational. It also was protected with afci breaker in the panel box.

74. Tested and operational

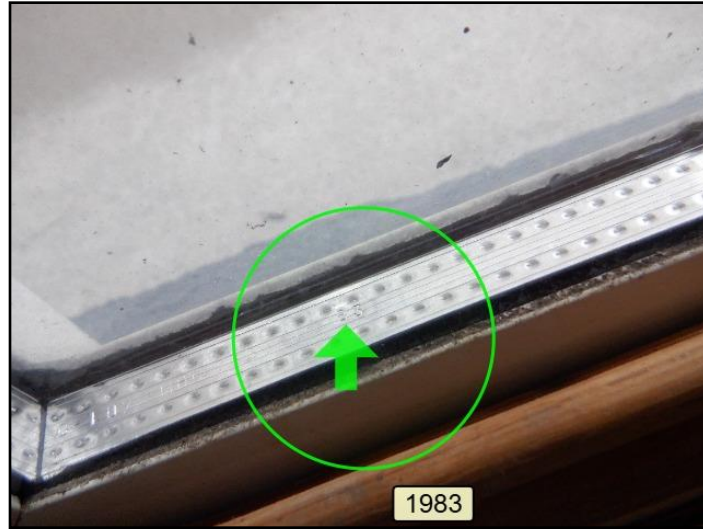
86. 1983

General: • Basement windows have been updated in 1983.

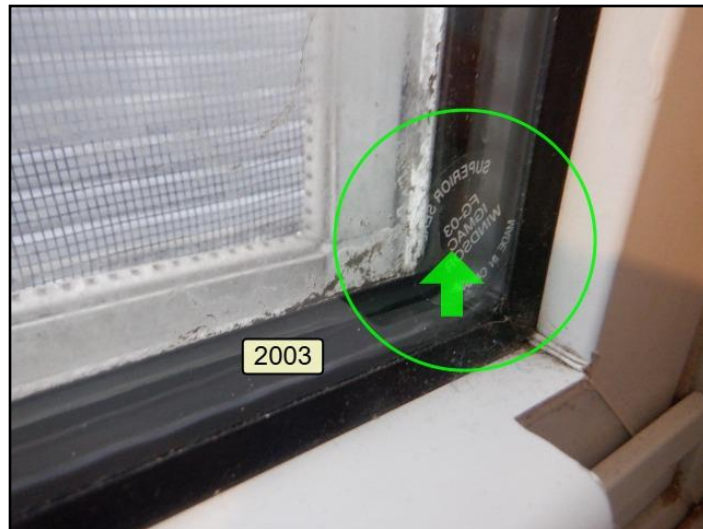
87. 2003

General: • Main floor windows updated in 2003.

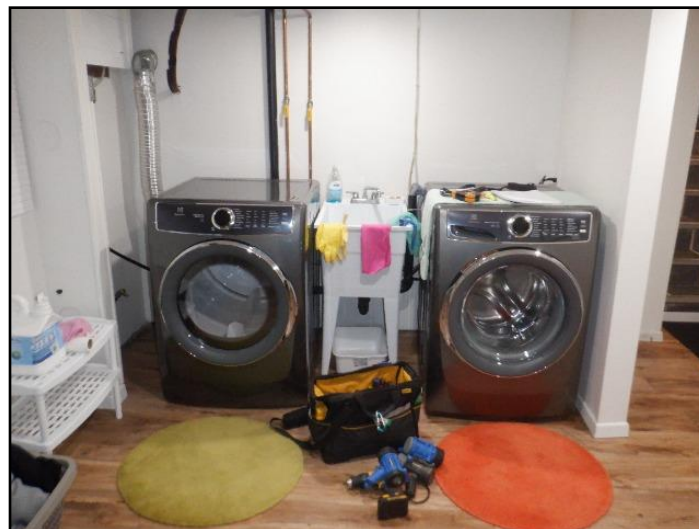
93. Basement Laundry

Laundry facilities: • Basement laundry
