INSPECTION REPORT

For the Property at:
1234 NEW HOME
SE WISCONSIN, WI

Prepared for: EXAMPLE REPORT
Inspection Date: Friday, December 11, 2020
Prepared by: David Gross

RE: Report No. 1143, v.5
1234 new Home
SE Wisconsin, WI

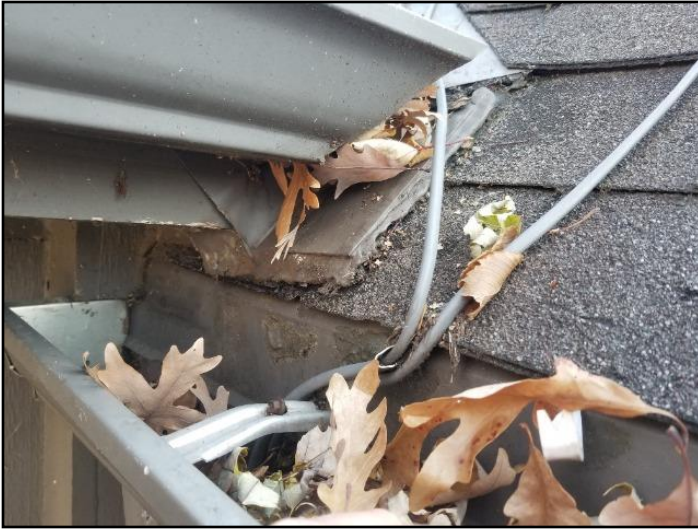
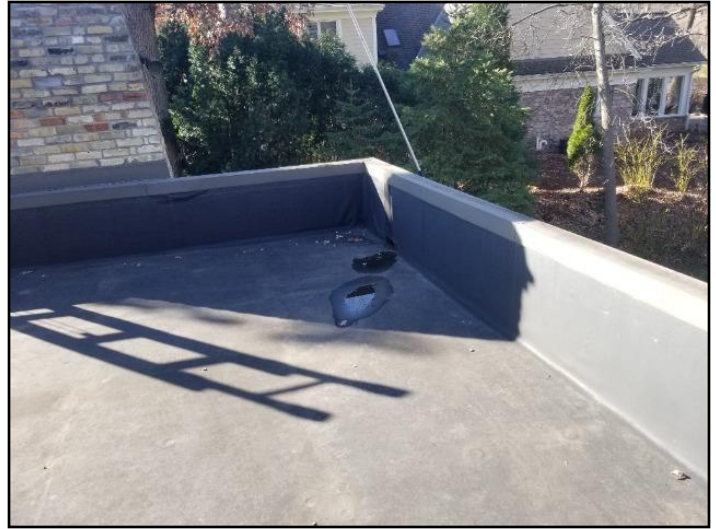
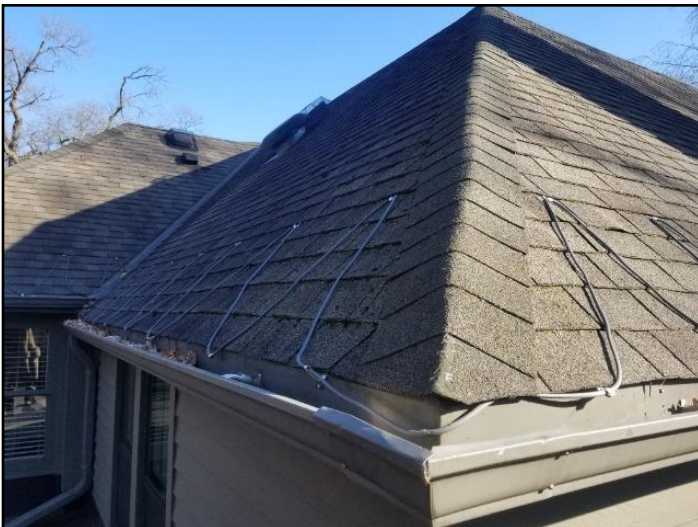
3. Vulnerable to ice damming

4. Vulnerable to ice damming

5. Vulnerable to ice damming

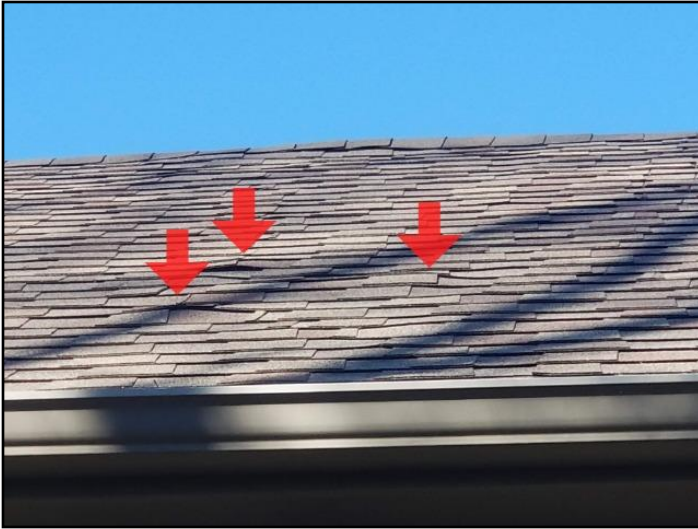
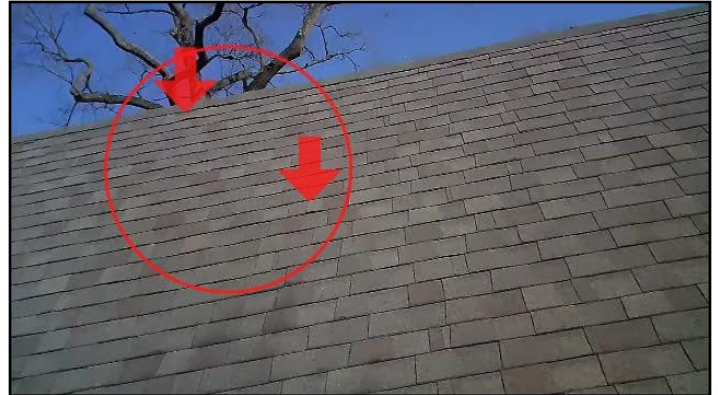
Condition: • Nail Pop Have roofer or handyman correct nail prior to having it back out through the shingle.

Noted various nail pops on roof. Have handyman or roofer repair as needed.

7. Nail Pop Have roofer or handyman correct...

8. Nail Pop Have roofer or handyman correct...

Task: Repair

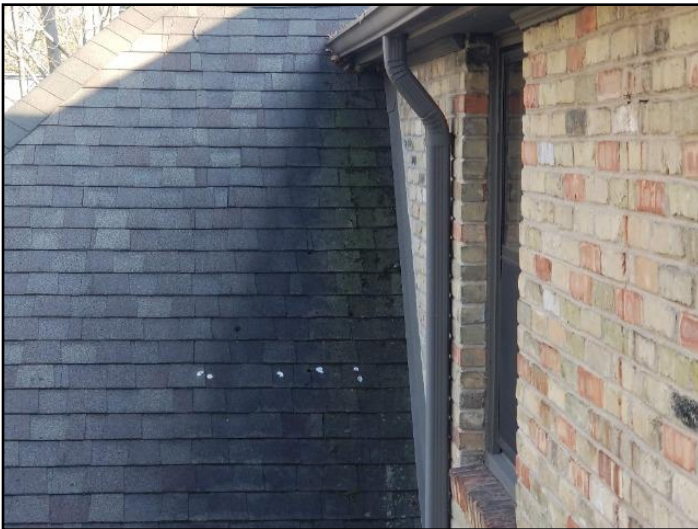
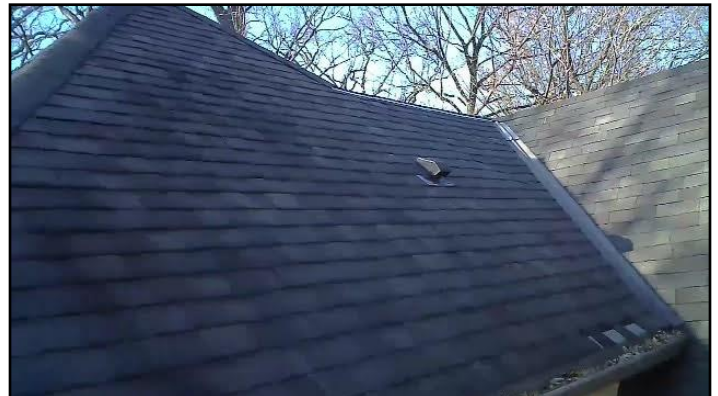
9.

6. Condition: • Noted multiple areas of previous repairs and shingle replaced. Monitor and inspect after wind and rain events to watch for changes.

Task: Monitor

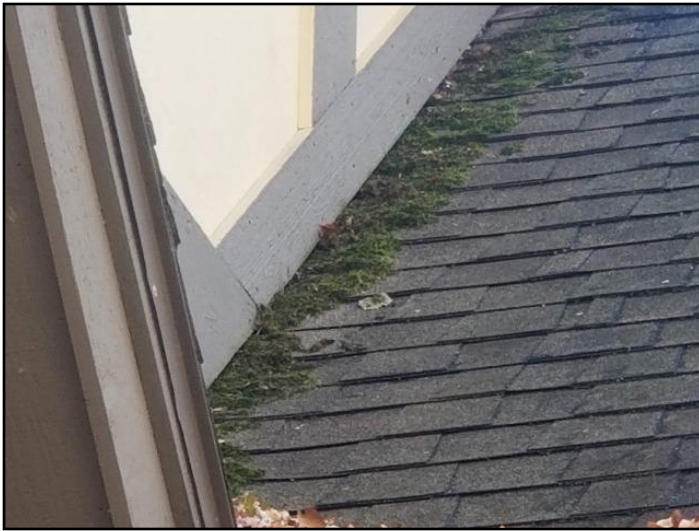
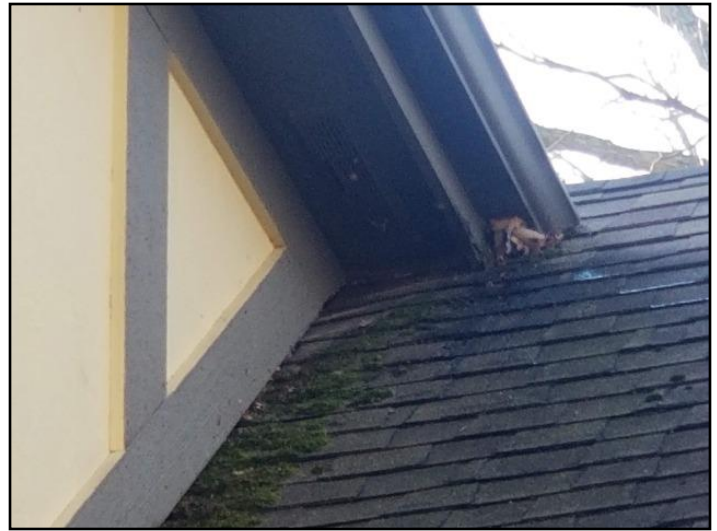
11.

7. Condition: • Organic growth on north side of roof. Clean with appropriate cleaners to extend roof life

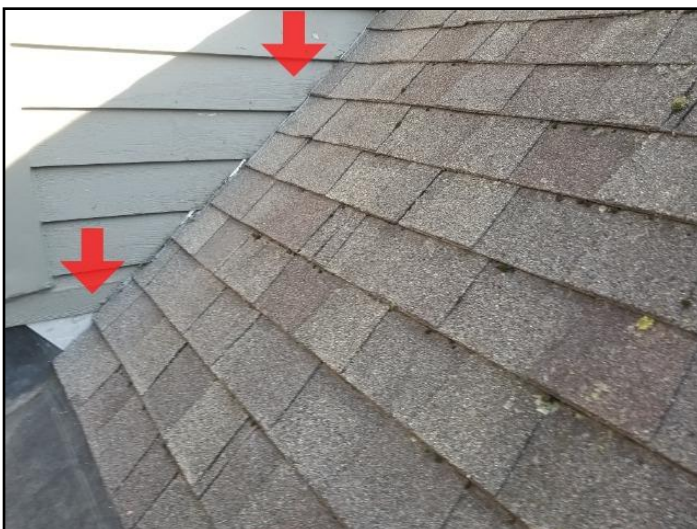
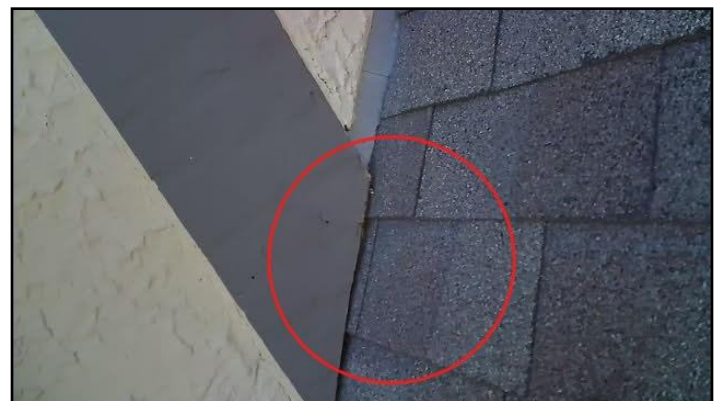
Condition: • [Siding not cut back](#)

Implication(s): Chance of water damage to structure, finishes and contents

15. Siding not cut back

16. Siding not cut back

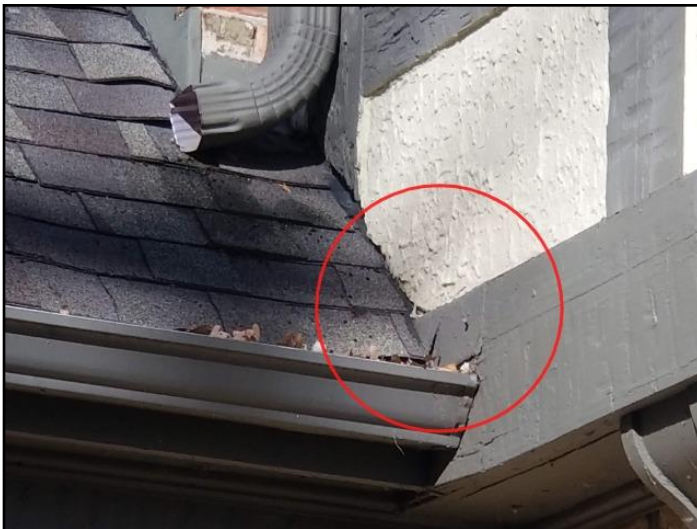
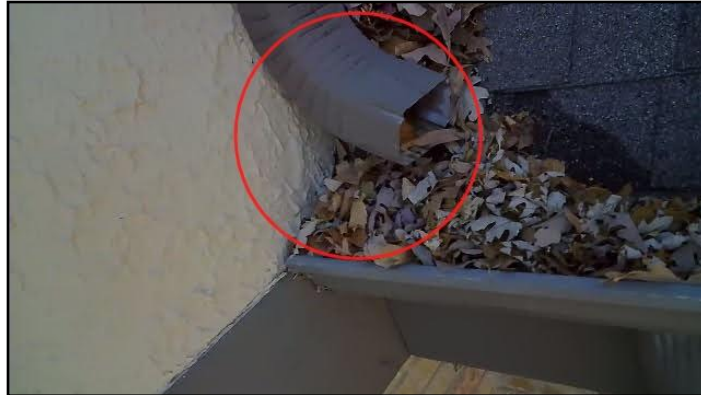
Condition: • [Kickout flashing - missing](#)

Implication(s): Chance of water damage to structure, finishes and contents

17. Kickout flashing - missing

19. Kickout flashing - missing

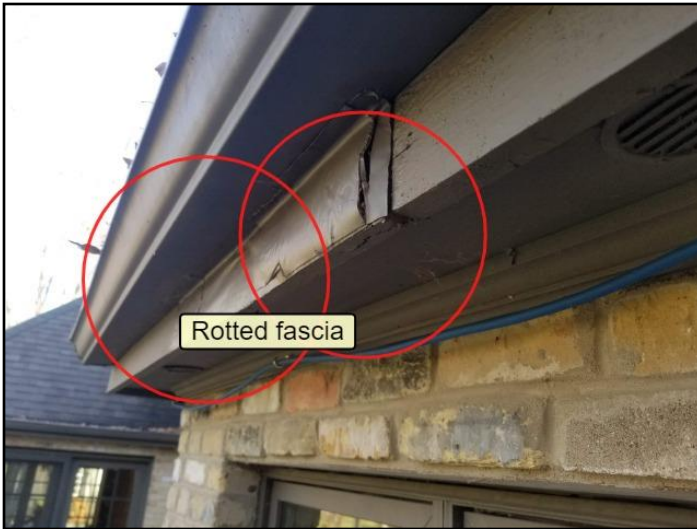
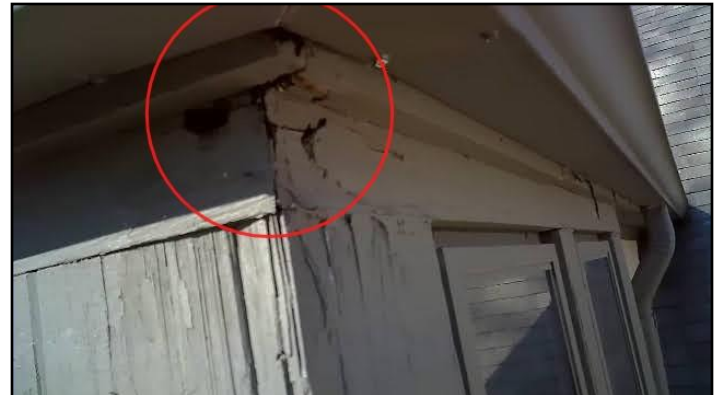
Condition: • [Damage](#)

Fascia on North side of home under scupper is rotted and needs replaced. Noted damage to corner on southside of home. Have carpenter replace or repair wood as necessary on these areas.

Implication(s): Chance of water damage to structure, finishes and contents

24. Damage

25. Damage

Task: Replace

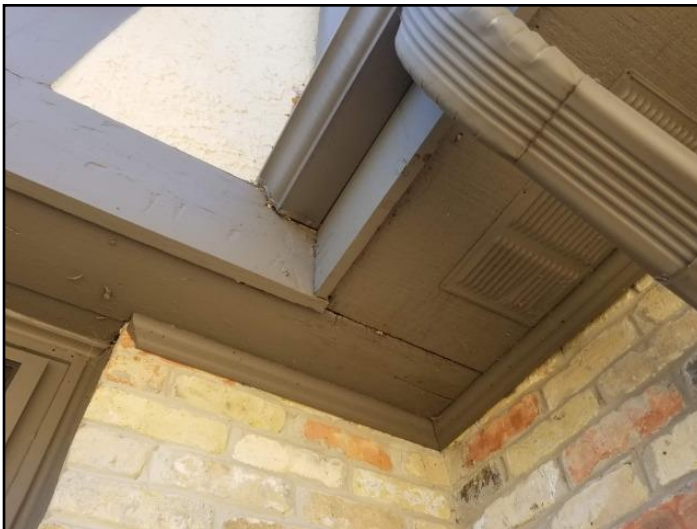
Condition: • [Rot or insect damage](#)

Noted areas of rot on soffit under the sidewall roof junctions by kitchen window. Recommend having contractor repairing rotted wood and installing kickout flashing above wood

Implication(s): Chance of water damage to structure, finishes and contents | Material deterioration

26. Rot or insect damage

Task: Repair or replace

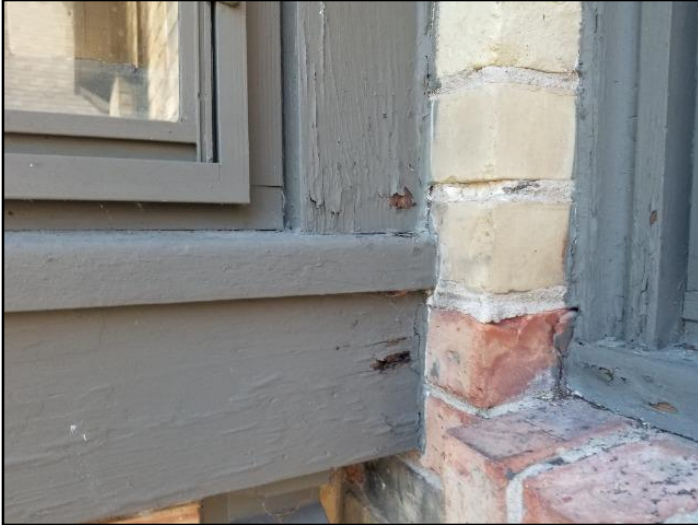
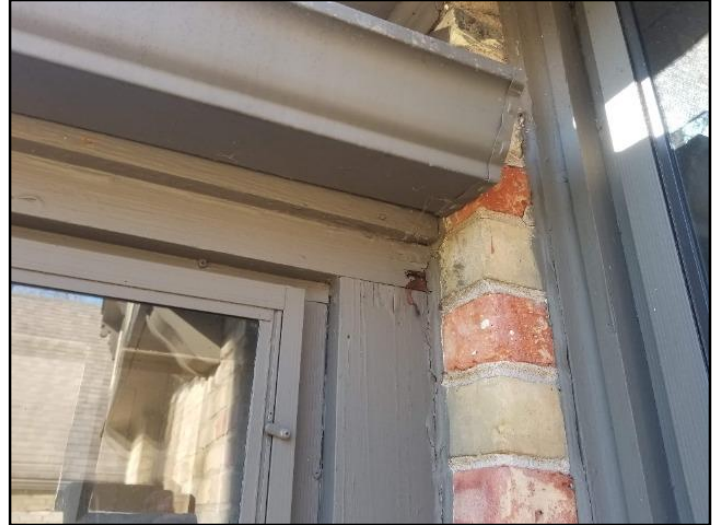
28. Paint

29. Paint

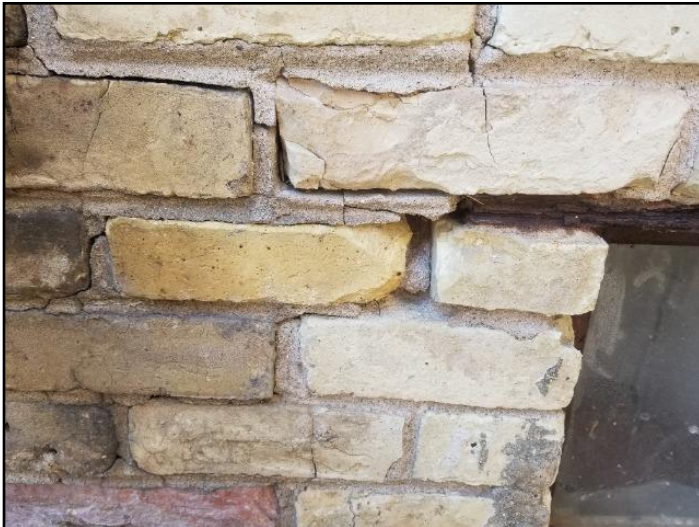
Condition: • [Masonry deterioration](#)

Noted motion of archway bricks over front door. Noted loose brick soldiers on West side of house. Have mason evaluate and repair as needed.

35. Masonry deterioration

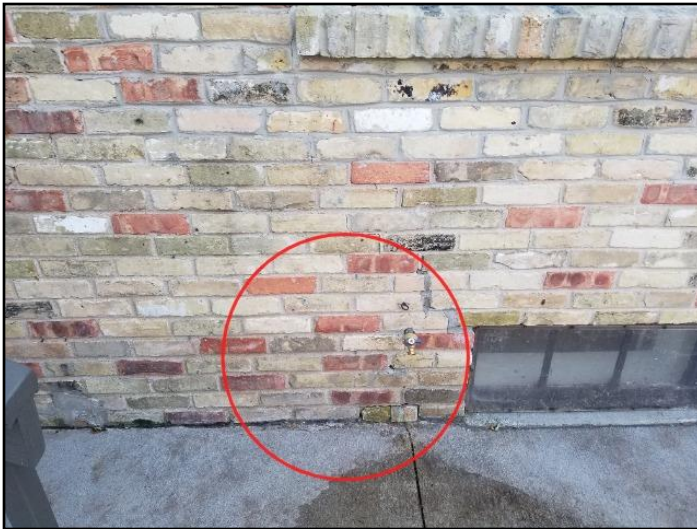
Condition: • [Mortar deterioration](#)

43. Mortar deterioration

Task: Repair

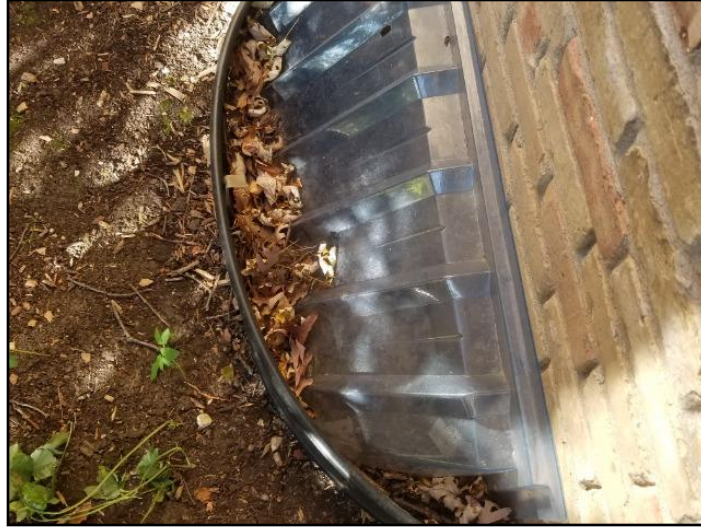
48. Clean out window wells of debris and dirt....

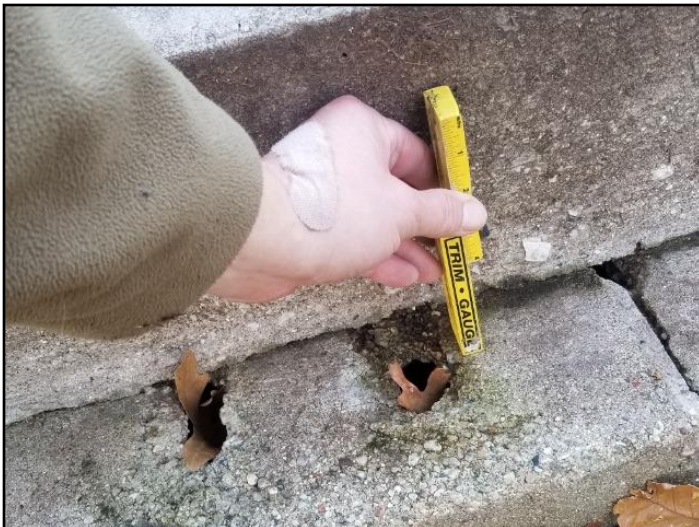
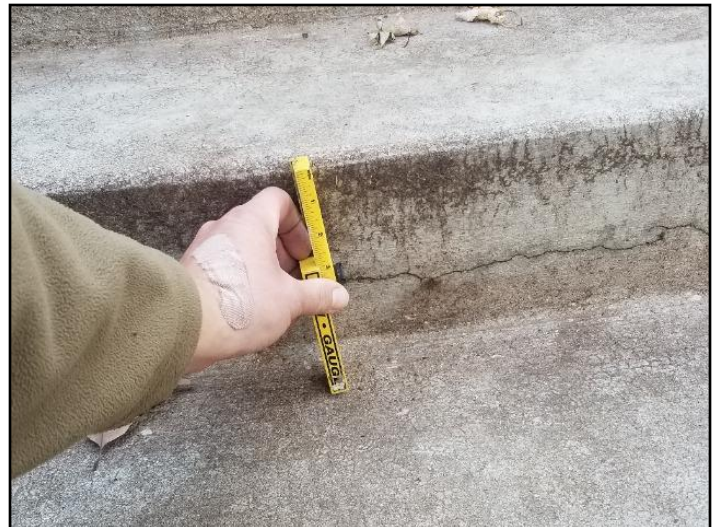
Condition: • [Stair rise too big or not uniform](#)

Implication(s): Trip or fall hazard

51. Stair rise too big or not uniform

52. Stair rise too big or not uniform

Task: Repair

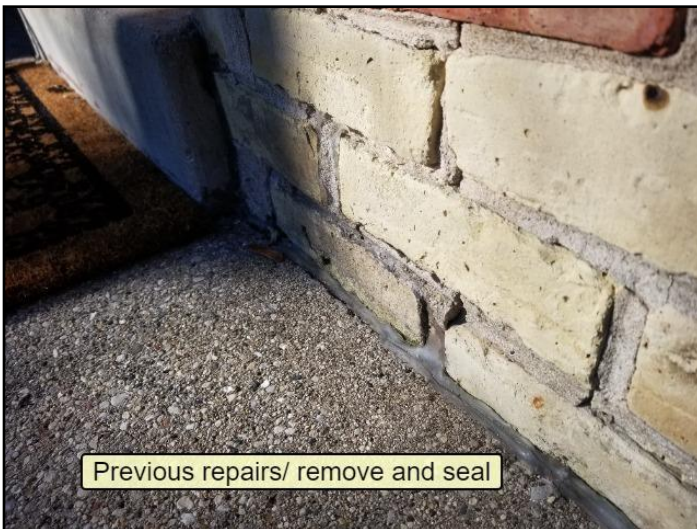
Condition: • Improper slope or drainage

Front porch pitched towards home. Seal gaps along home to decrease moisture intrusion. In future have contractor correct porch pitch as needed.

Implication(s): Chance of water damage to structure, finishes and contents

53. Improper slope or drainage

Task: Repair

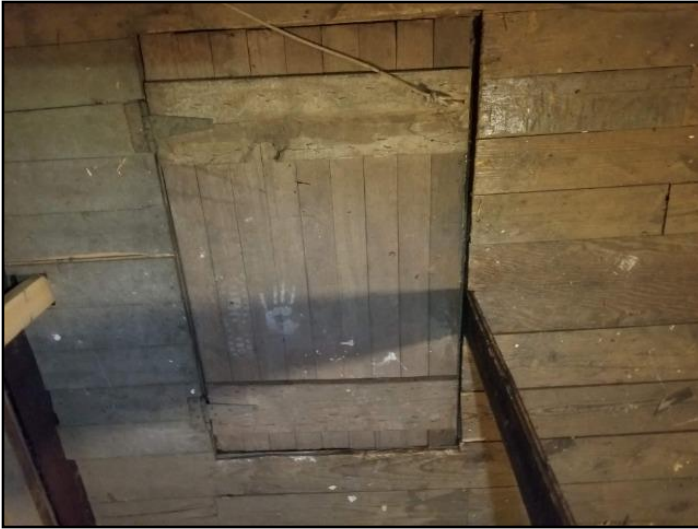
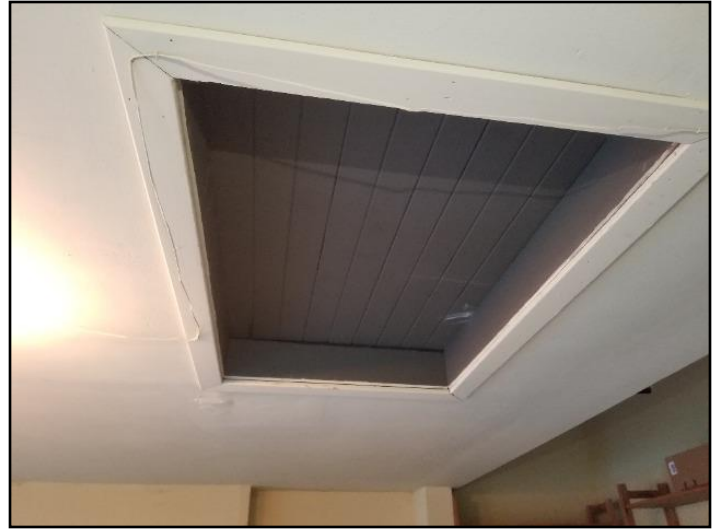
Condition: • Not fireproof

Implication(s): Fire hazard

55. Not fireproof

56. Not fireproof

Task: Repair or replace

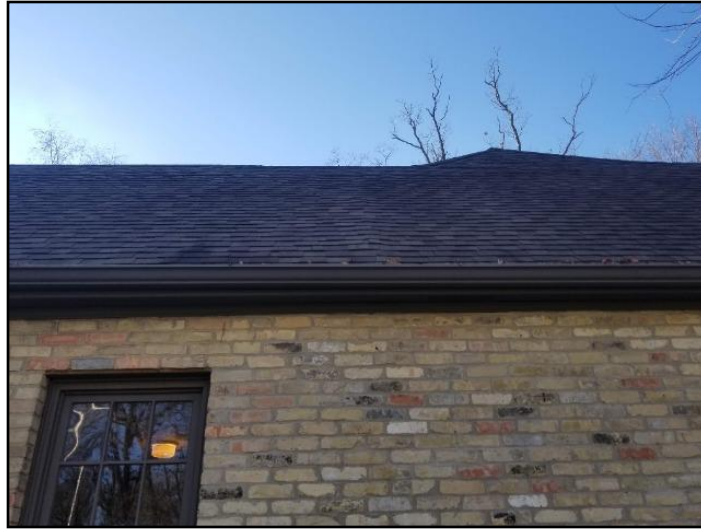
57.

41. Condition: • Roof decking is planking. Large gaps between boards. When having roof replaced it will need to have new sheathing/decking installed over the existing planks.

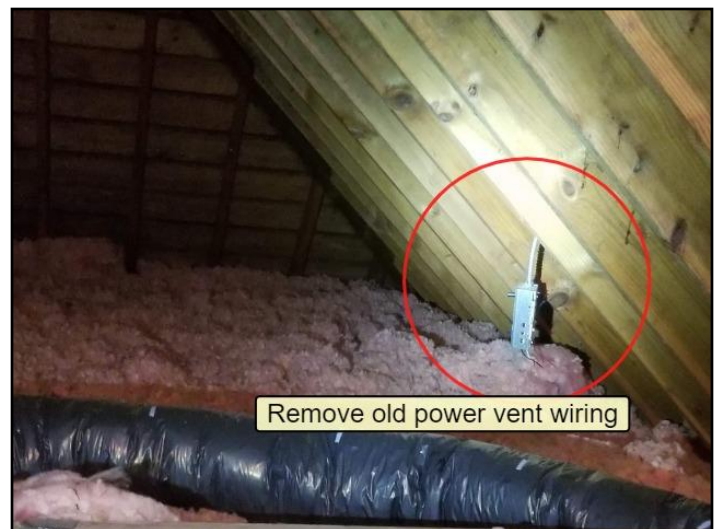
46. Condition: • [Exposed in attics](#)

67. Exposed in attics

Task: Repair

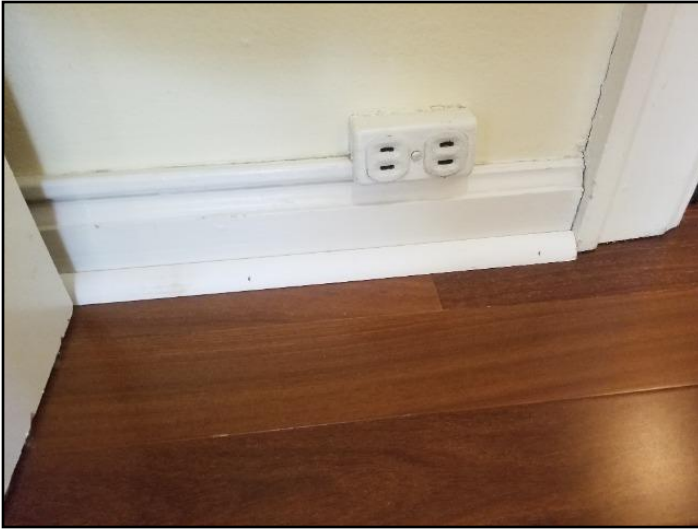
50. Condition: • [Ungrounded](#)

69. Ungrounded

Task: Repair or replace

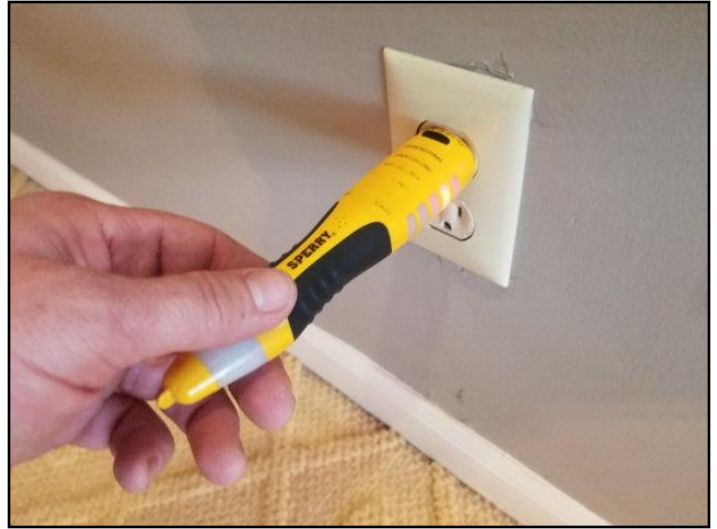
70. Ungrounded

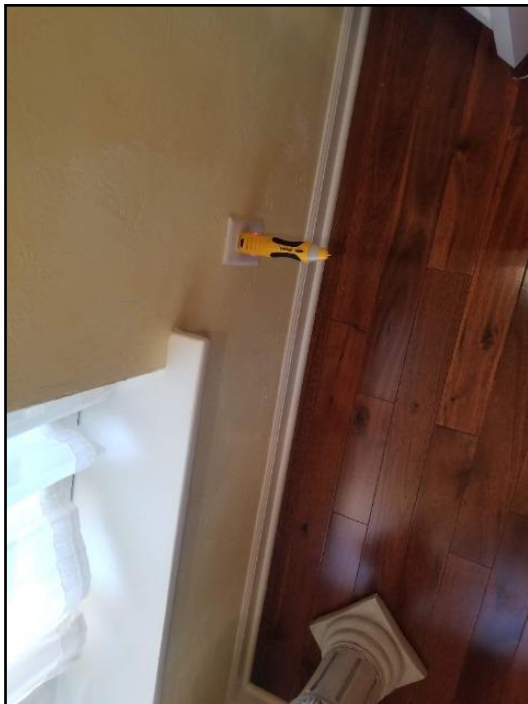
71. Ungrounded

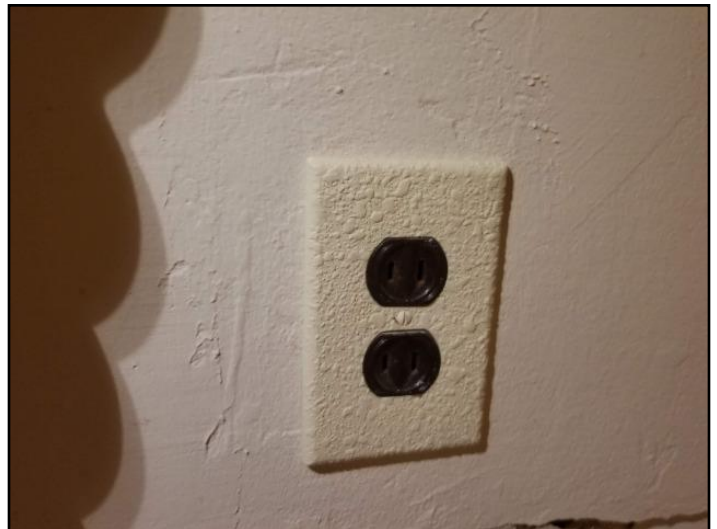
72. Ungrounded

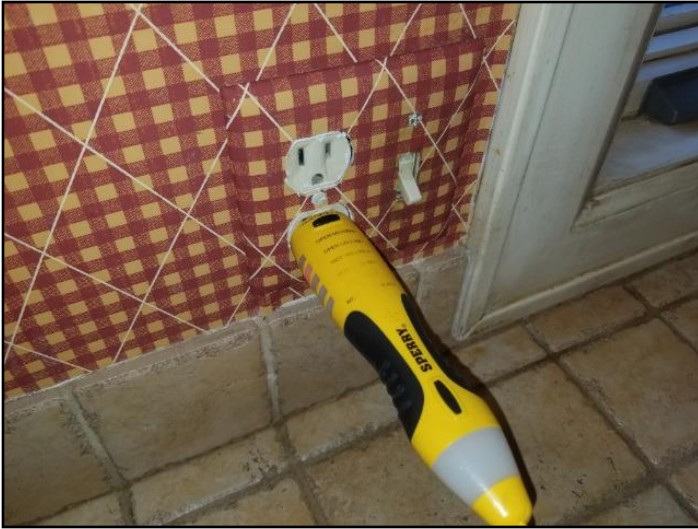
51. Condition: • [GFCI/GFI needed \(Ground Fault Circuit Interrupter\)](#)

74. GFCI/GFI needed (Ground Fault Circuit...

Task: Repair or replace

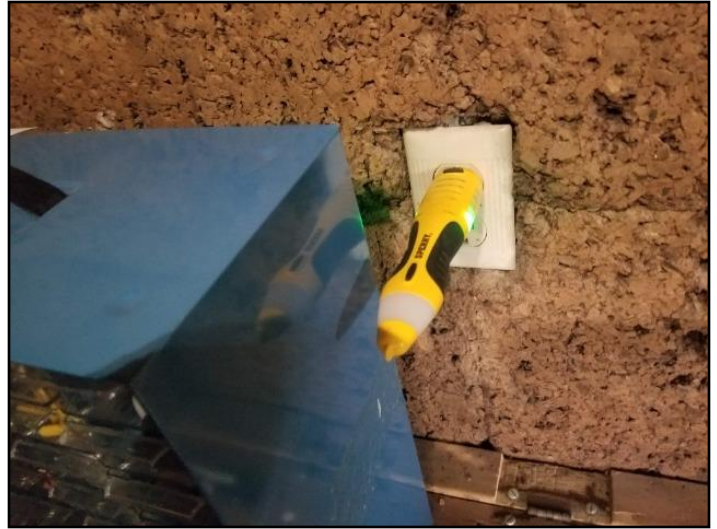
75. GFCI/GFI needed (Ground Fault Circuit...

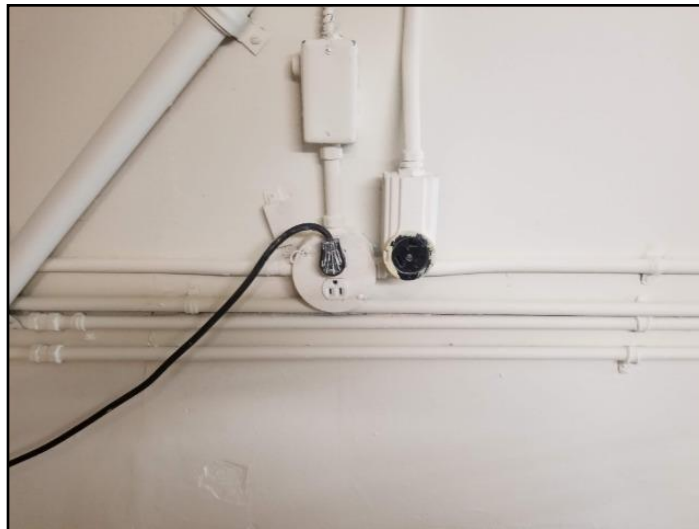
76. GFCI/GFI needed (Ground Fault Circuit...

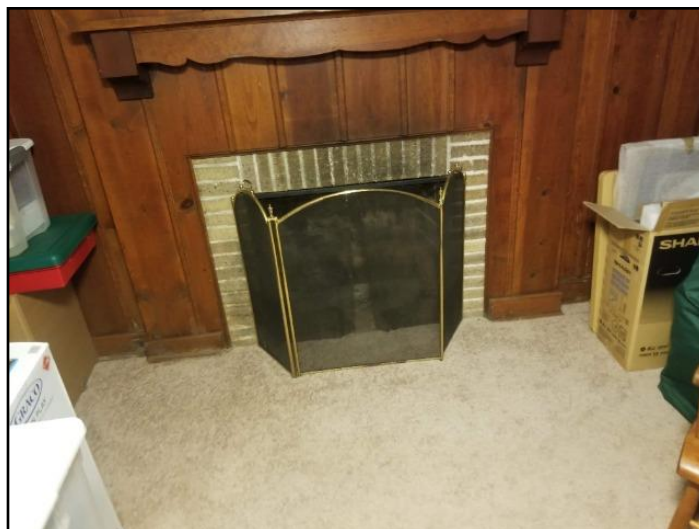
Basement and NW chimney liner were not visible. Have fireplaces inspected and correct any issues prior to using.

83. Not visible

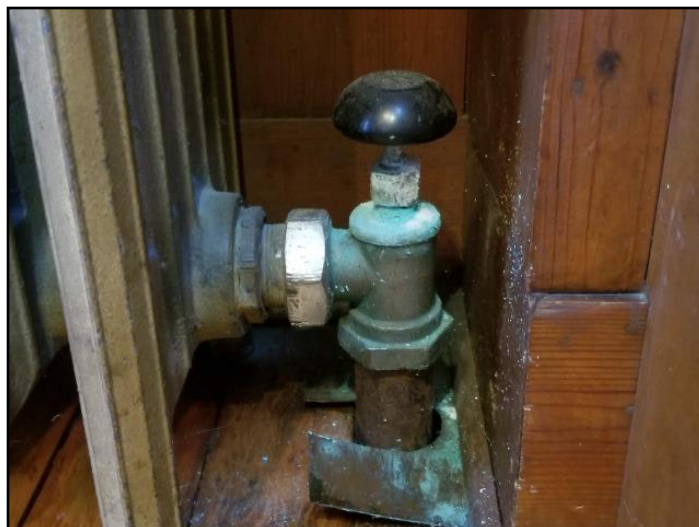
84.

59. Condition: • Evidence of past leaks on radiator valves. Monitor valves during heating season. Have boiler service technician rebuild or replace valves when necessary.

Task: Monitor

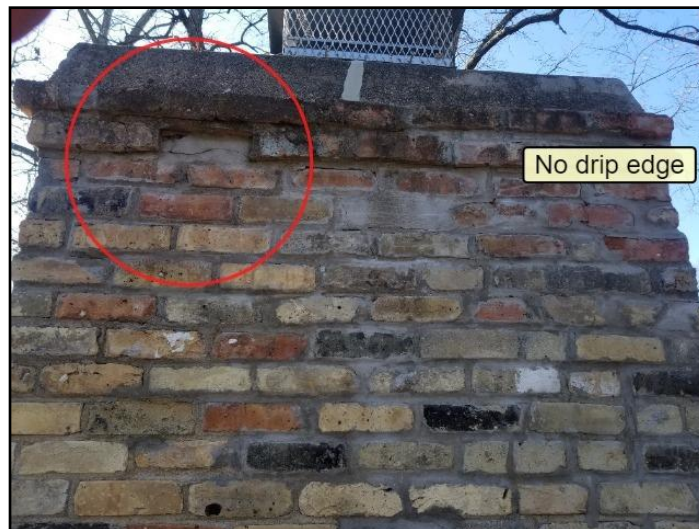
61. Condition: • [No drip edge on cap \(crown\)](#)

Chimney caps needs to have a drip edge to prevent further damage of brick chimney. Consult with chimney contractor on options for both masonry caps.

Implication(s): Chance of water damage to structure, finishes and contents | Shortened life expectancy of material |

85. No drip edge

Task: Further evaluation

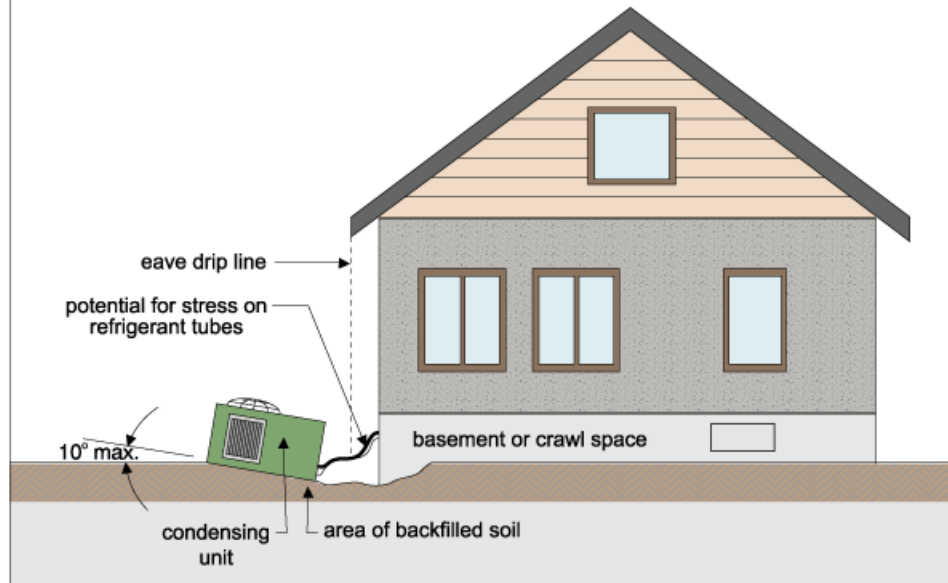
67. Condition: • [Out of level](#)

Implication(s): Reduced system life expectancy | Damage to equipment

90. Out of level

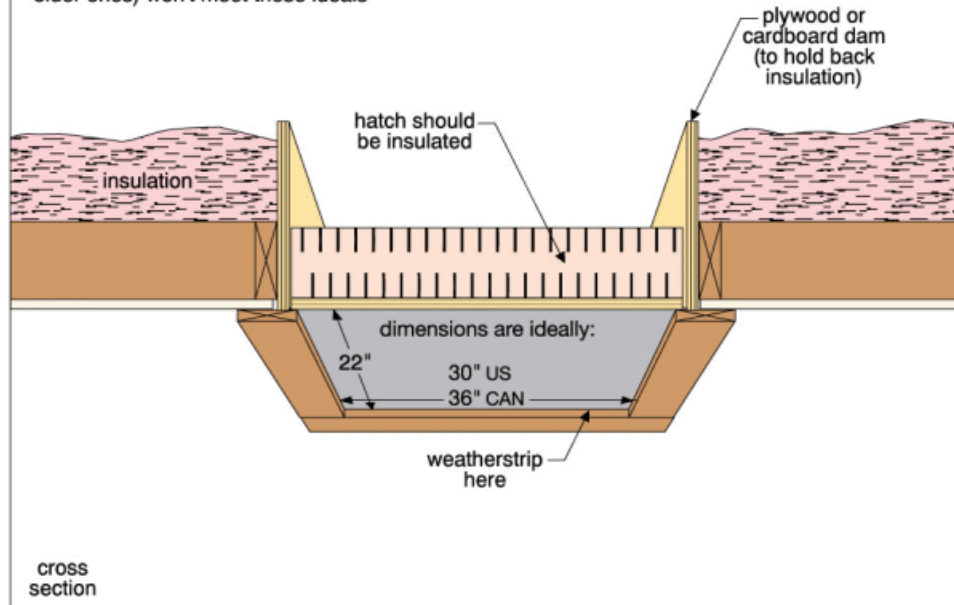
69. Condition: • [Not insulated](#)

91. Not insulated

Recommend adding insulation to the attic hatch door that leads over the garage storage area. Add R board or other product to increase thermal efficiency. Do not overload attic with heavy items.

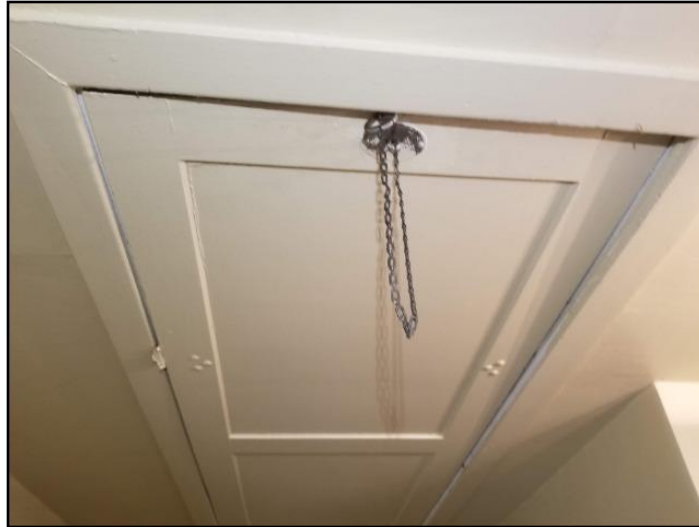
70. Condition: • [Not insulated and not weatherstripped](#)

Implication(s): Chance of condensation damage to finishes and/or structure | Increased heating and cooling costs | Reduced comfort

92. *Not insulated and not weatherstripped*

Task: Improve

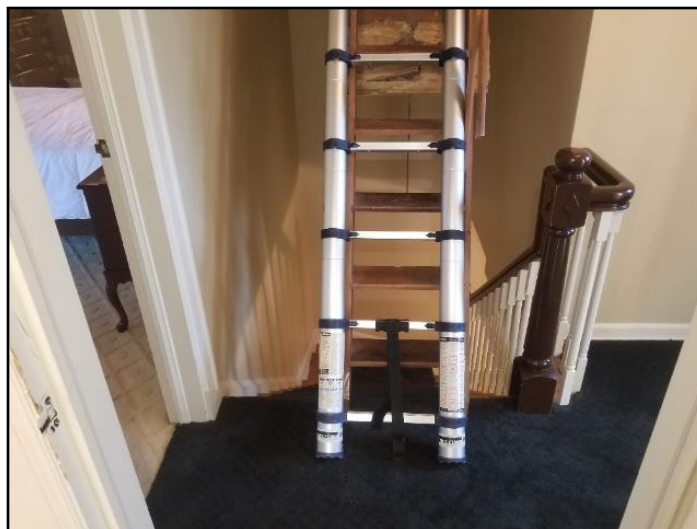
72. Condition: • [Unsafe to climb](#)

93. *Unsafe to climb*

Attic pull down ladder should be replaced or removed. A scuttle hatch or different stairs can be created for installed. Contract reputable contractor for options.

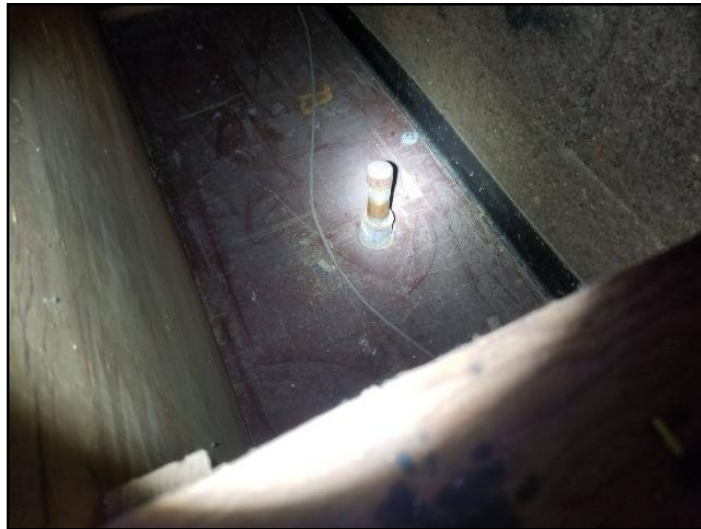
96.

74. Condition: • Determine function of copper pipe in work room. May be related to boiler system. Consult licensed plumber or boiler company for further evaluation.

Task: Further evaluation

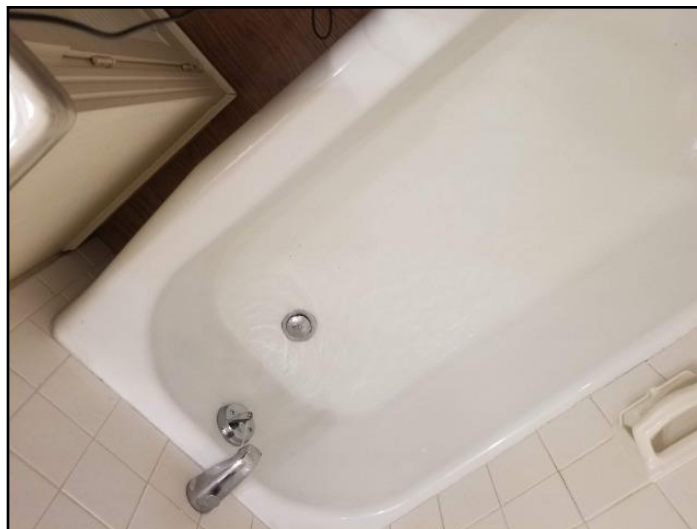
97. Slow drain

Task: Service Clean

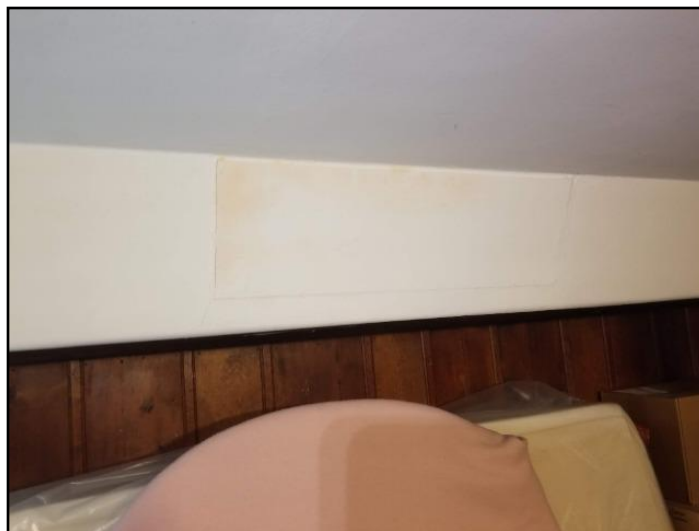
113.

84. Condition: • Discoloration noted in basement living room. Monitor for changes. When able open up panel to determine what potential source of staining.

Task: Further evaluation Monitor

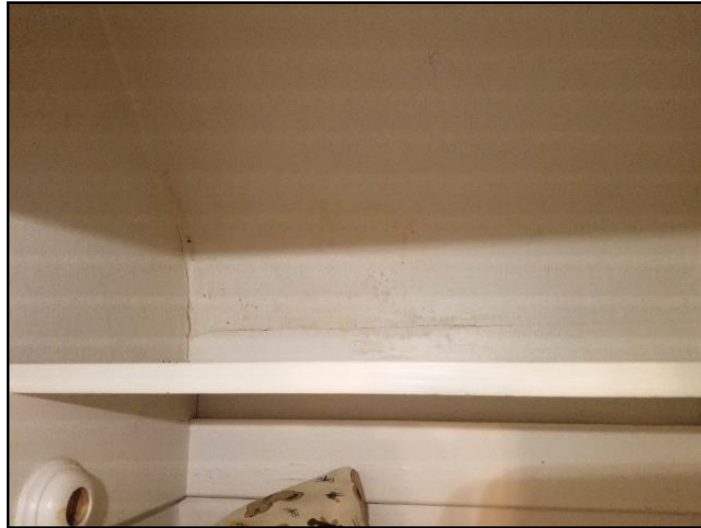
114.

86. Condition: • Closet had small area of organic growth. Clean and treat area as needed.

Task: Clean

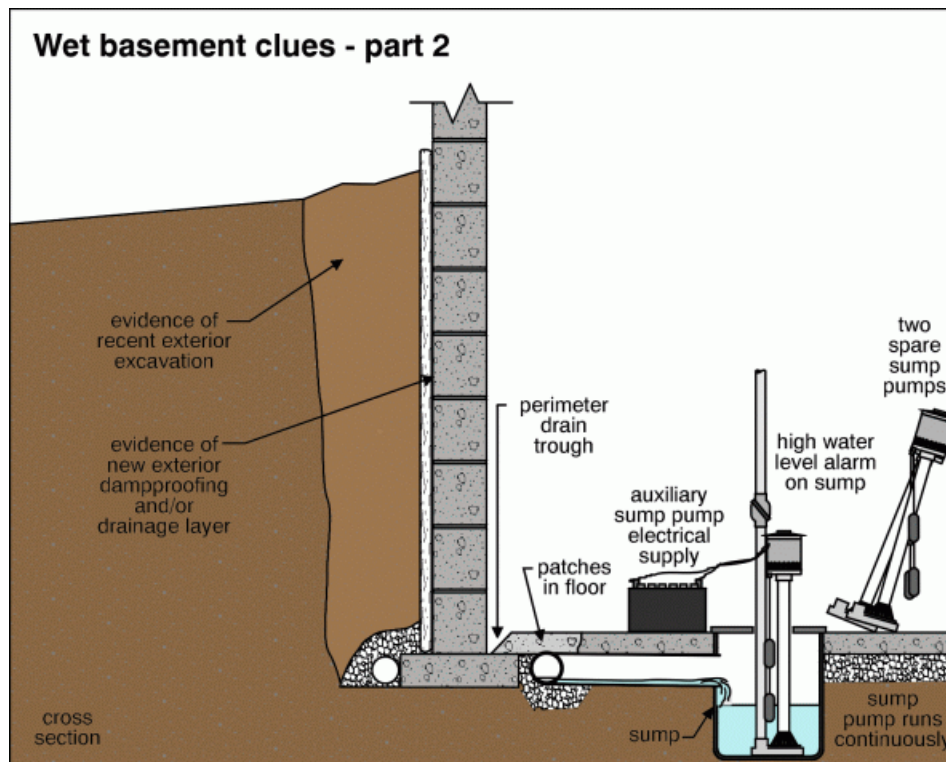
97. Condition: • [Stains](#)

Correct exterior grading and gutters to decrease water reaching foundation walls.
