# YOUR INSPECTION REPORT

47 Kenneth Avenue  
Toronto, ON M6P 1J1

INSPECTION DATE:  
Friday, September 8, 2017

RE: Report No. 2163  
47 Kenneth Avenue  
Toronto, ON  
M6P 1J1

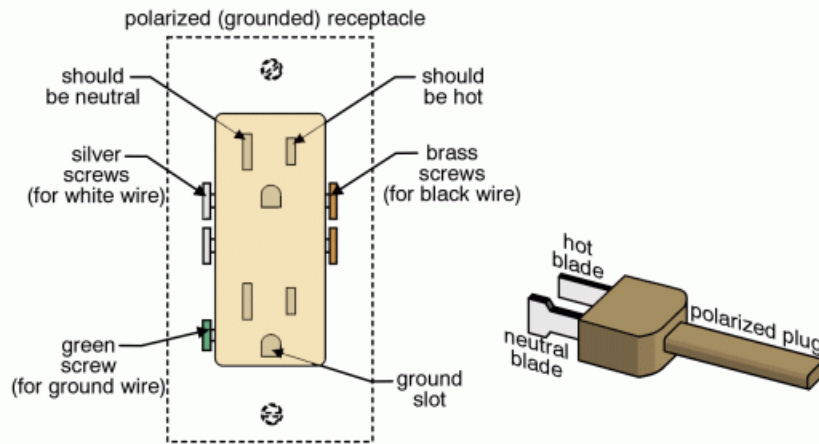
### Reversed polarity

when the polarity is reversed, the wide receptacle slot is (incorrectly) hot and the narrow slot is neutral - this is not uncommon when people forget that the black wire should be attached to the receptacle's brass screws
