YOUR INSPECTION REPORT

493 Glenlake Avenue
Toronto, ON M6P 1G9

INSPECTION DATE:
Thursday, September 7, 2023

RE: Report No. 7266, v.2
493 Glenlake Avenue
Toronto, ON
M6P 1G9

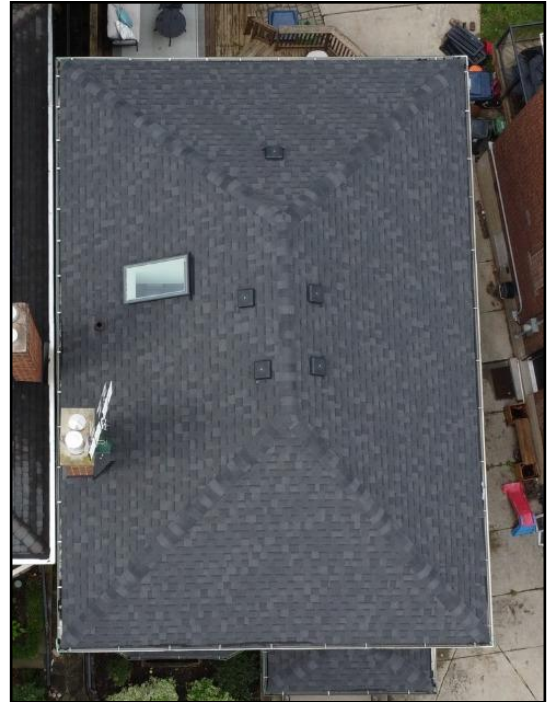
2. Asphalt shingles

Approximate age: • New

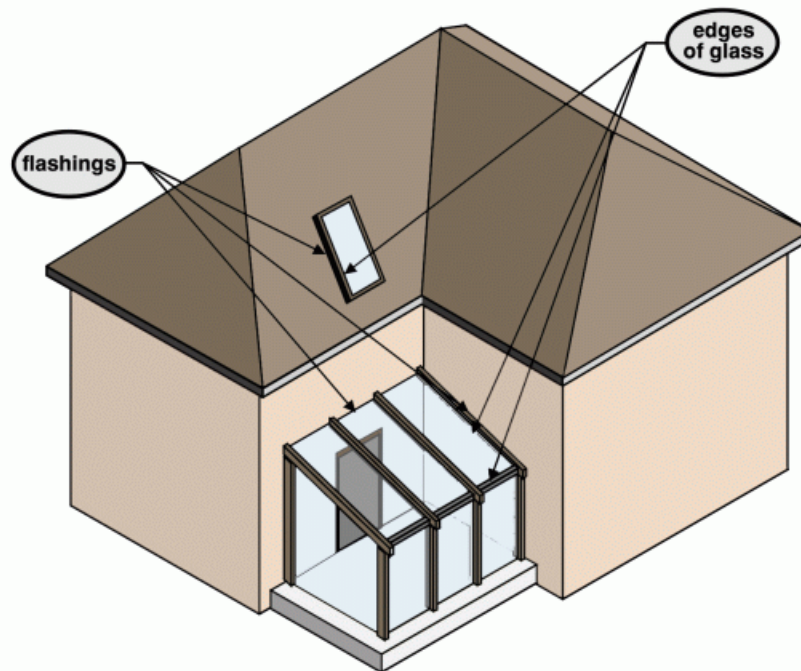
Skylight and solarium leaks

skylights and solariums are very prone to leakage
leakage typically occurs through the flashings or at
the edges of the glass
