INSPECTION REPORT

For the Property at:
208 SAMPLE STREET
NASHVILLE, TN 37214

Prepared for: SAMPLE REPORT
Inspection Date: Wednesday, December 13, 2023
Prepared by: Chris Cutrell, 2207

RE: Report No. 1536, v.4
208 Sample Street
Nashville, TN
37214

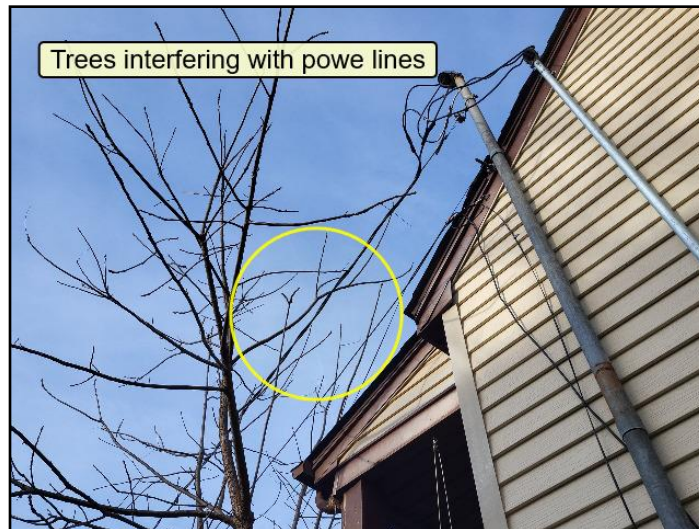
Condition: • Branches / vines interfering with wires

Implication(s): Damage to wire | Electric shock | Interruption of electrical service

Branches / vines interfering with wires
