YOUR INSPECTION REPORT

1234 Main Avenue
Sioux Falls, SD 57104

Friday, July 28, 2017

RE: Report No. 1001, v.6
1234 Main Avenue
Sioux Falls, SD
57104

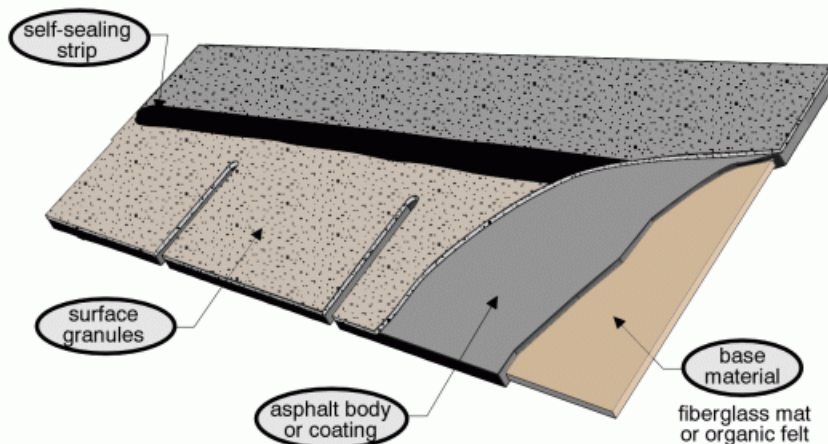
Asphalt shingle composition

Condition: • [Granule loss](#)

Implication(s): Chance of water damage to contents, finishes and/or structure

Task: Replace

Time: Immediate

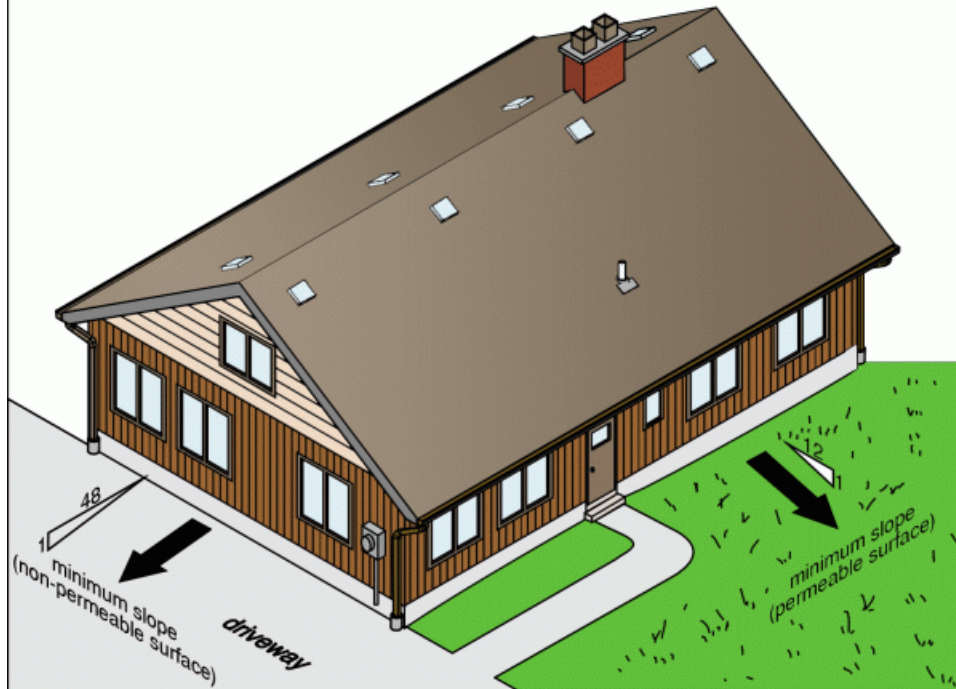
Recommended grading slopes

Condition: • [Improper slope or drainage](#)

Implication(s): Chance of water damage to contents, finishes and/or structure

Improper slope

Time: Immediate

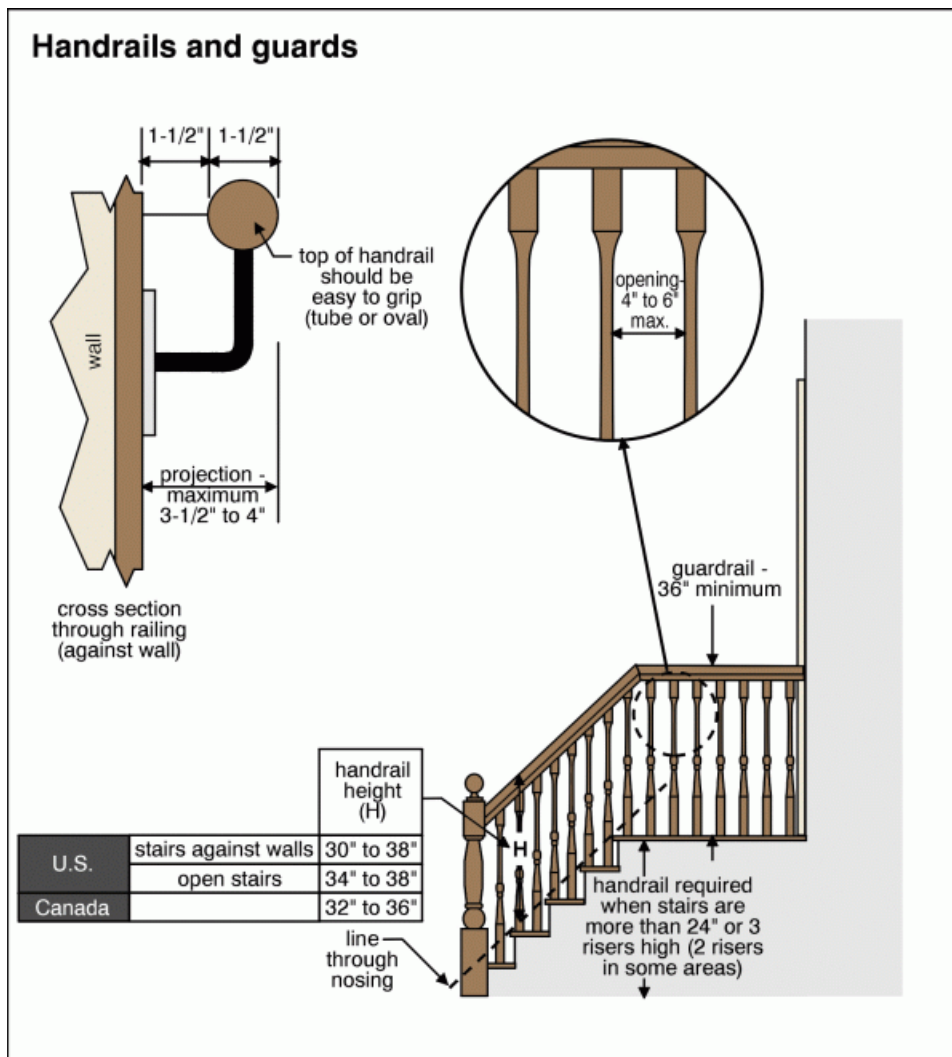
Condition: • [Missing](#)

Implication(s): Fall hazard

Missing handrail

Task: Repair Safety issue

Time: Immediate

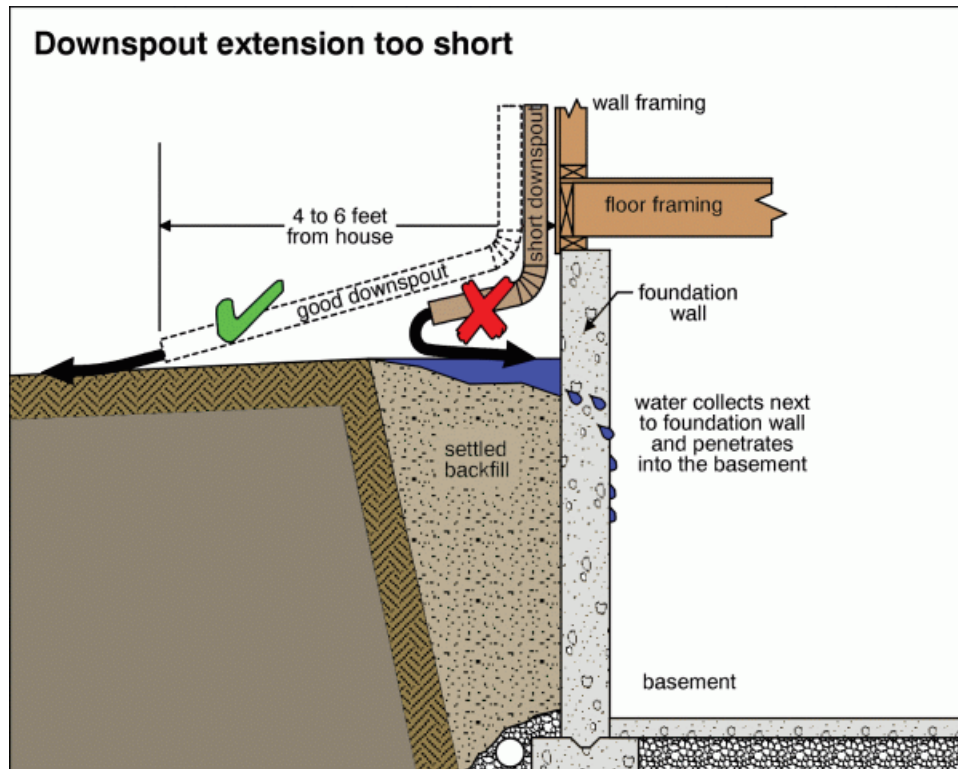
2. Condition: • [Discharge too close to building](#)

Implication(s): Chance of water damage to contents, finishes and/or structure

Task: Improve

Time: Immediate

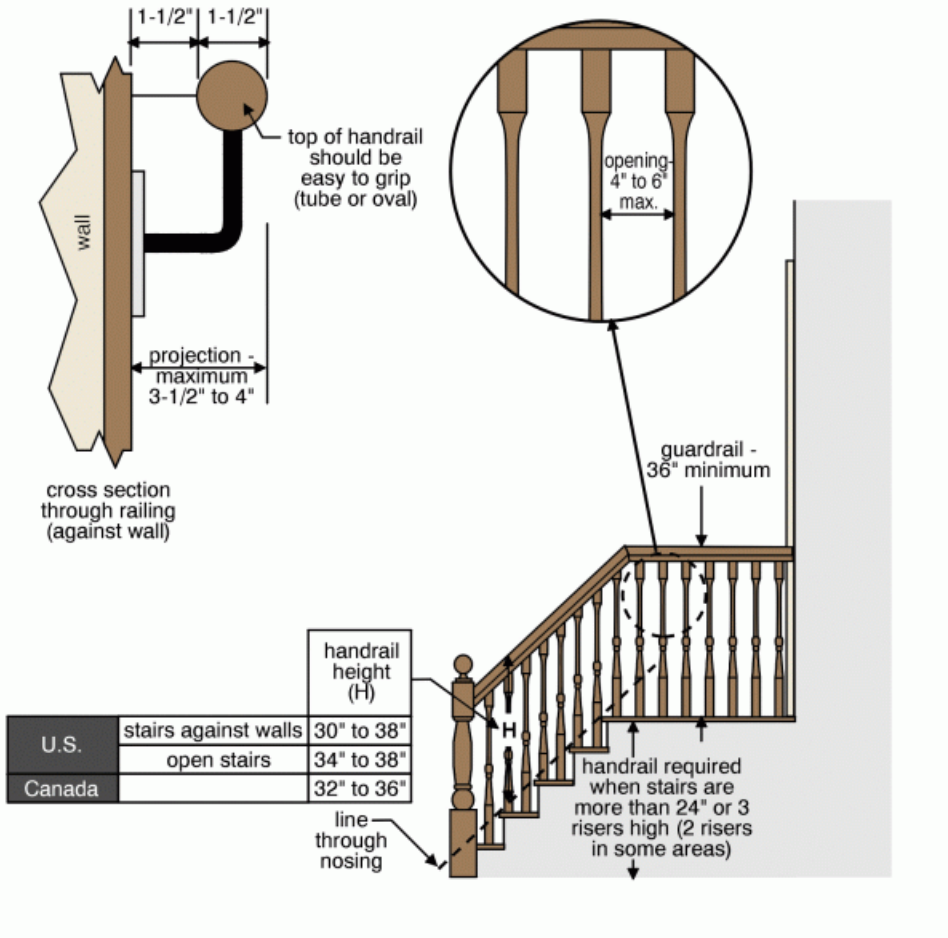
Handrails and guards

12. Condition: • [Missing](#)

Implication(s): Fall hazard

Missing handrail

Task: Repair Safety issue

Time: Immediate

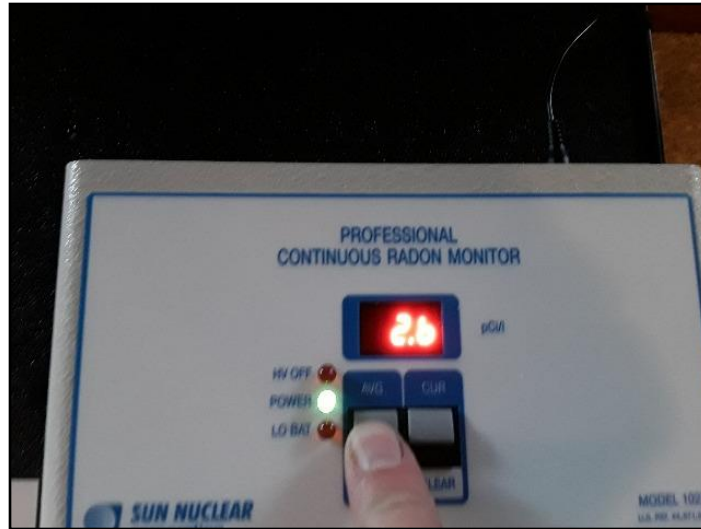
Radon result

Result: • The U.S. EPA has set an action level of 4 pCi/L. At or above this level of radon the EPA recommends you take corrective measures to reduce your exposure to radon gas.
