# YOUR INSPECTION REPORT

1018 Bloom Road  
Danville, PA 17821

Friday, September 11, 2020

RE: Report No. 1003, v.2  
1018 Bloom Road  
Danville, PA  
17821

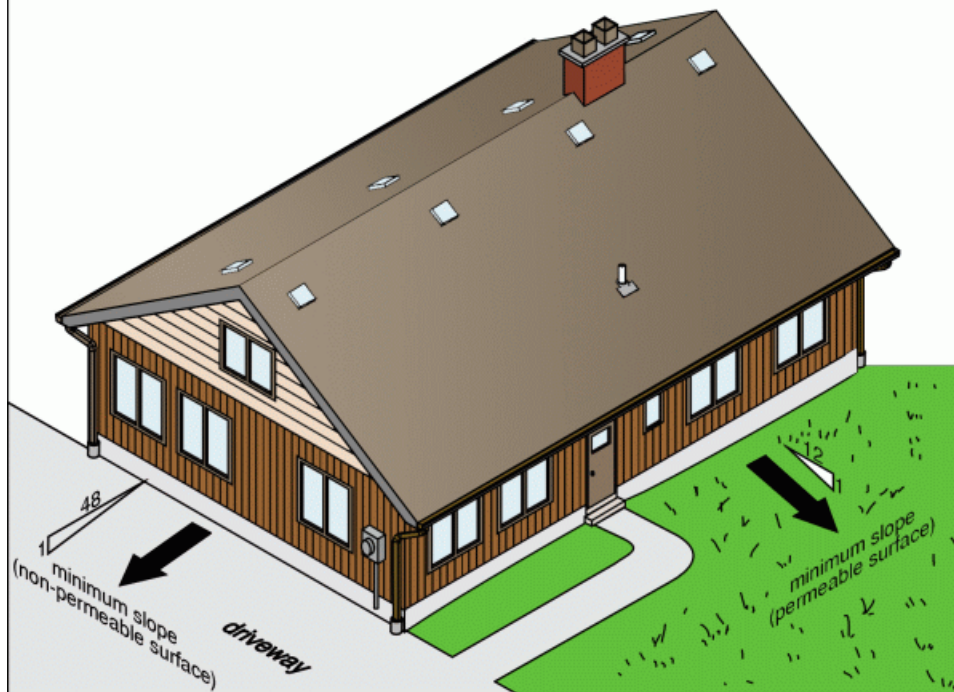
## Recommended grading slopes

**Implication(s):** Chance of water damage to structure, finishes and contents

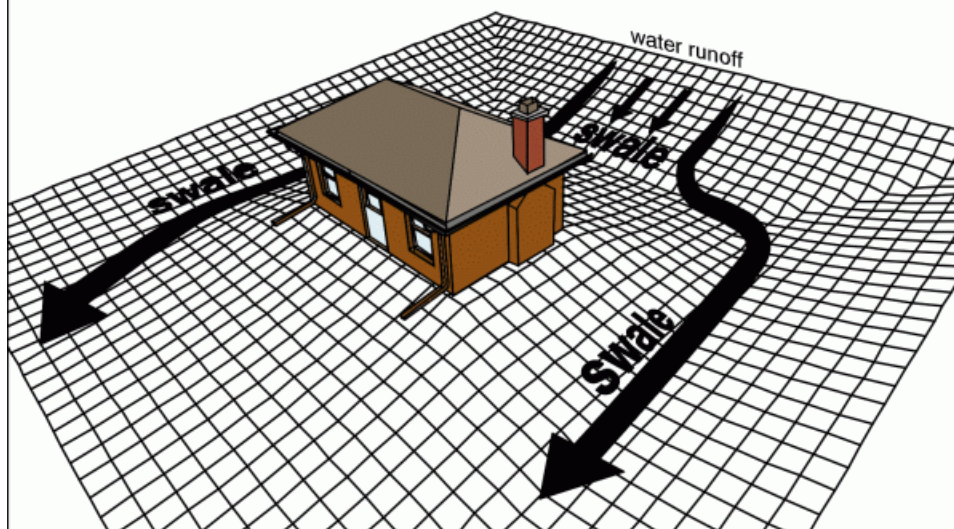
## Swales

when the overall lot drainage is toward the house, swales can be used to direct surface water away from the foundation

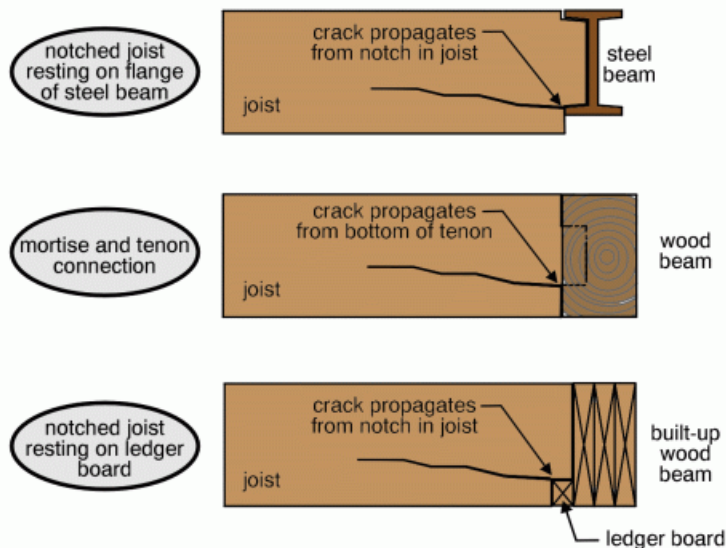
### Examples of weak joist/beam connections

**Condition:** • [Split or damaged](#)**Implication(s):** Weakened structure | Chance of structural movement**Location:** Basement**Task:** Further evaluation

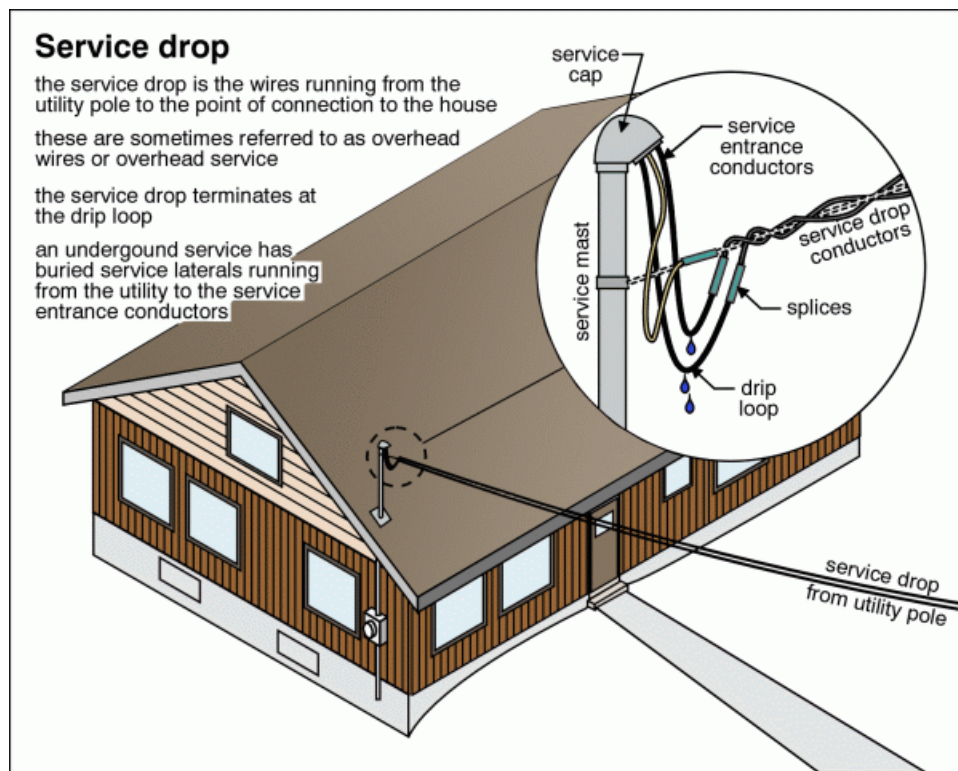
## Service entrance cable should not be covered by siding

**Implication(s):** Electric shock | Interruption of electrical service

**Task:** Repair
