# YOUR INSPECTION REPORT

123 Hudson St. NE  
St. Michael , MN

Tuesday, June 28, 2016

RE: Report No. 1001, v.3  
123 Hudson St. NE  
St. Michael , MN

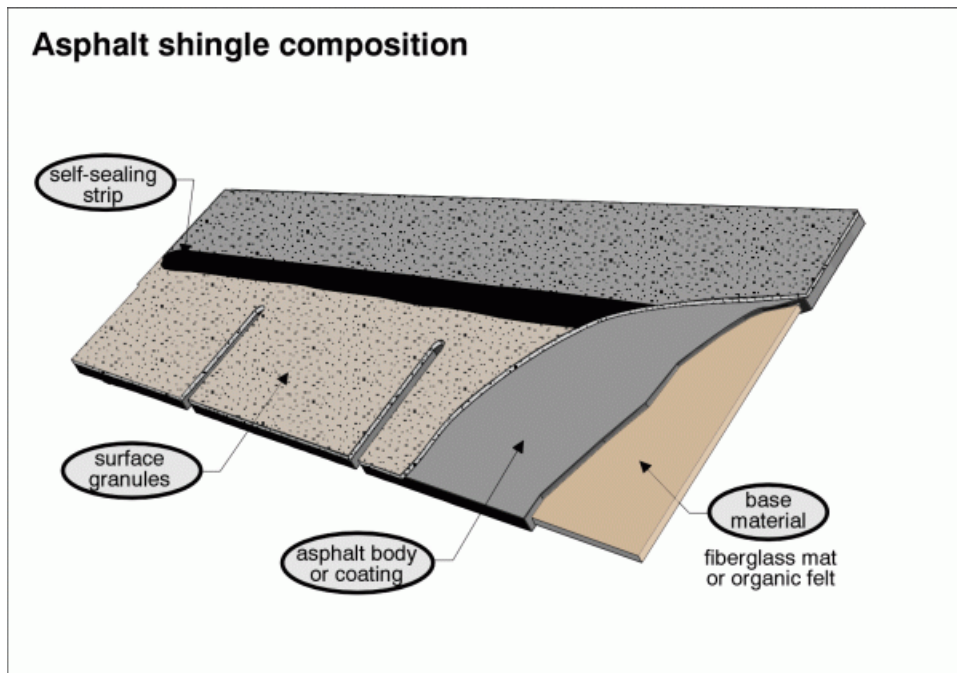
### Asphalt shingle composition

**Condition:** • [Granule loss](#)

**Implication(s):** Chance of water damage to contents, finishes and/or structure

**Task:** Replace

**Time:** Less than 1 year

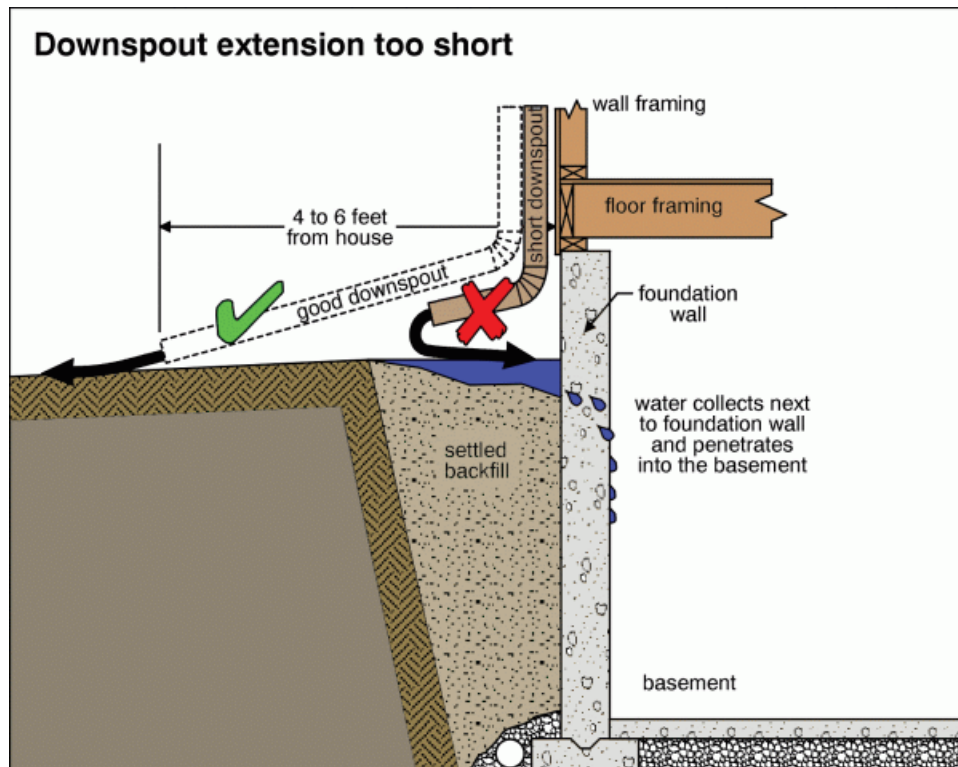
**Condition:** • [Downspouts end too close to building](#)

Down spouts does not extend past building, currently water flows towards the house foundation

**Implication(s):** Chance of water damage to contents, finishes and/or structure

**Task:** Improve

**Time:** Immediate

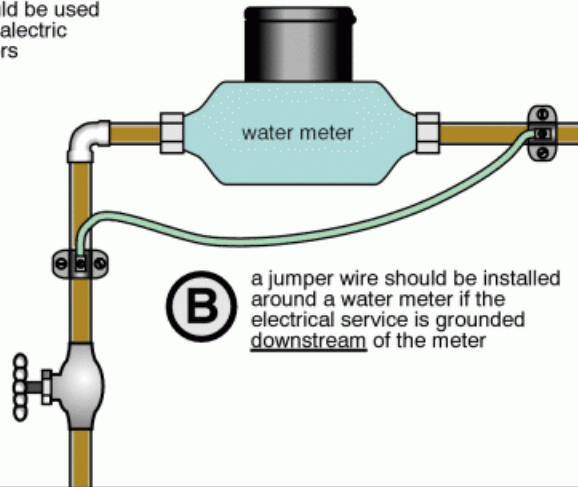
**Condition:** • [No jumper for meters and valves](#)

Jumper cable missing on meter

**(B)** a jumper wire should be installed around a water meter if the electrical service is grounded downstream of the meter

**(A)** a jumper wire should be used to bridge around dielectric plumbing connectors

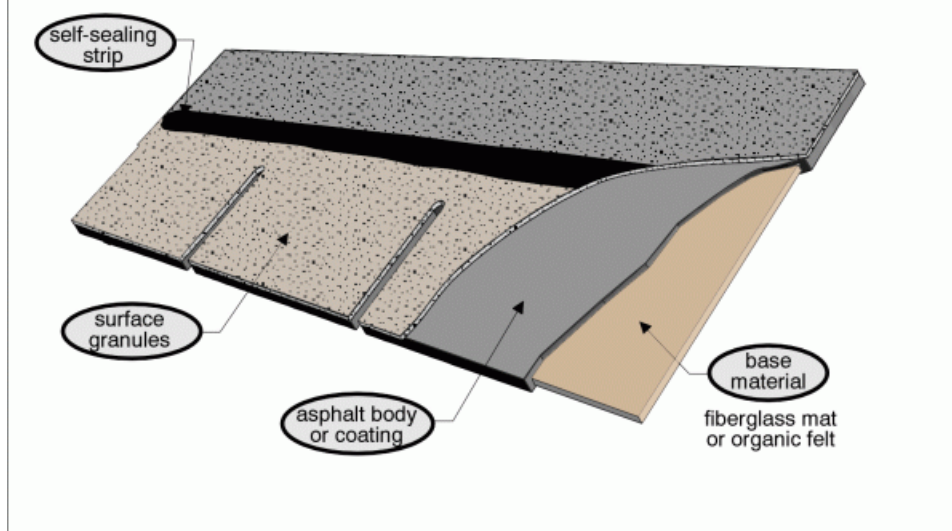
### Asphalt shingle composition

**1. Condition:** • [Granule loss](#)

**Implication(s):** Chance of water damage to contents, finishes and/or structure

**Task:** Replace

**Time:** Less than 1 year

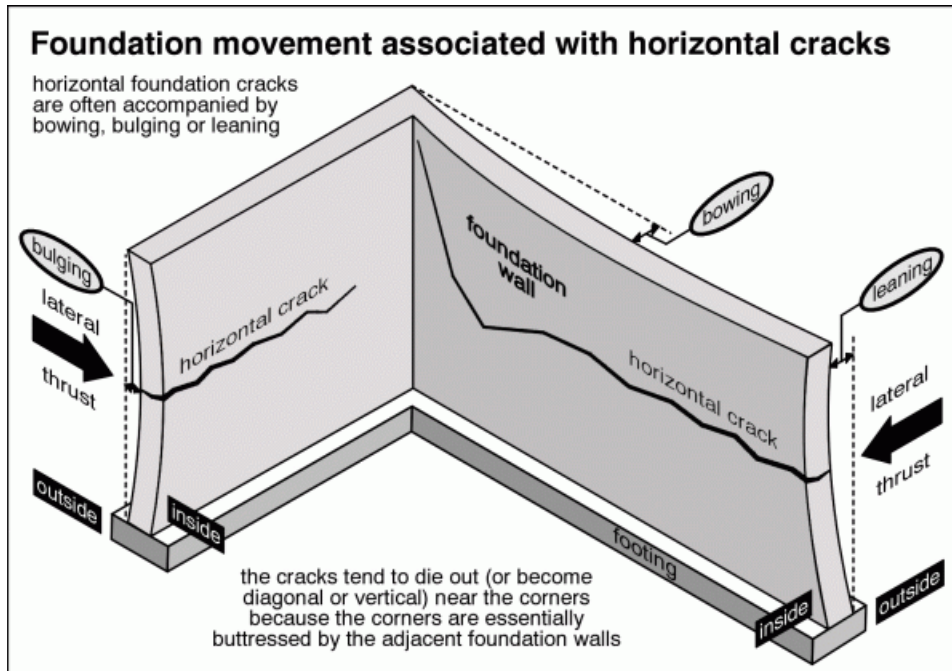
**Condition:** • [Cracked horizontally](#)

Large horizontal crack in foundation on the south side

**Task:** Repair

**Time:** Immediate

**Cost:** \$1,500 - and up

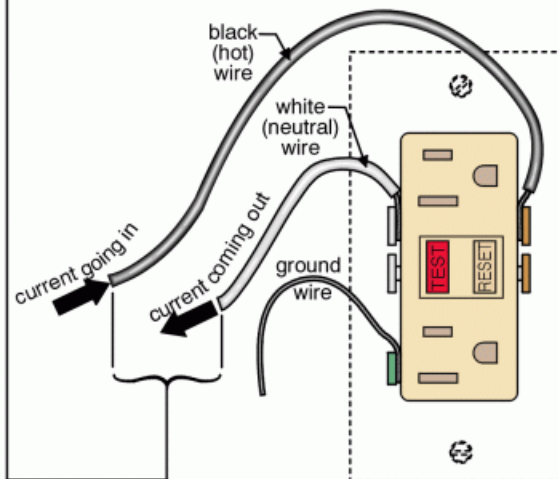
21. No GFCI (Ground Fault Circuit Interrupter)

**Condition:** • [No GFCI \(Ground Fault Circuit Interrupter\)](#)

**Task:** Replace
