INSPECTION REPORT

For the Property at:
123 ROAD STREET
ALBERTA, AB

Prepared for: JOE SMITH
Inspection Date: Monday, June 17, 2019
Prepared by: Trevor Sczesny

RE: Report No. 1721, v.2
123 Road Street
Alberta, AB

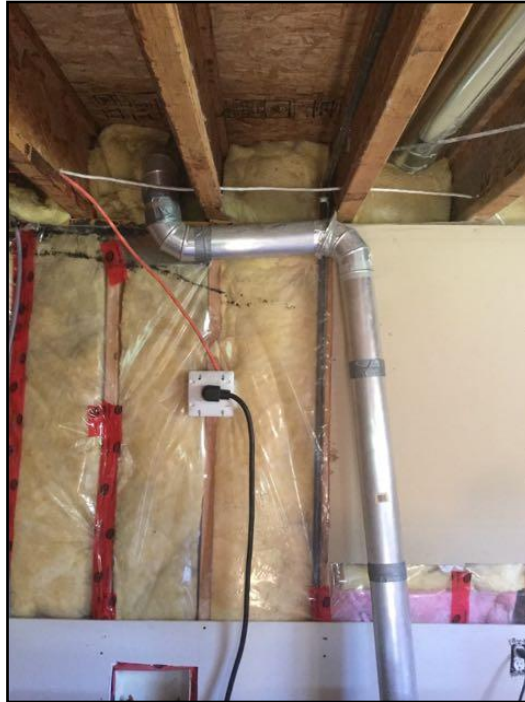
51. Condition: • Improvements can be made to the dryer vent for improved air flow and efficiency.

50. *Improvements can be made to the dryer vent...*
