YOUR Inspection Report

123 West Main St
Louisville, KY 40204

Gary Witt

RE: Report No. 1249
123 West Main St
Louisville, KY
40204

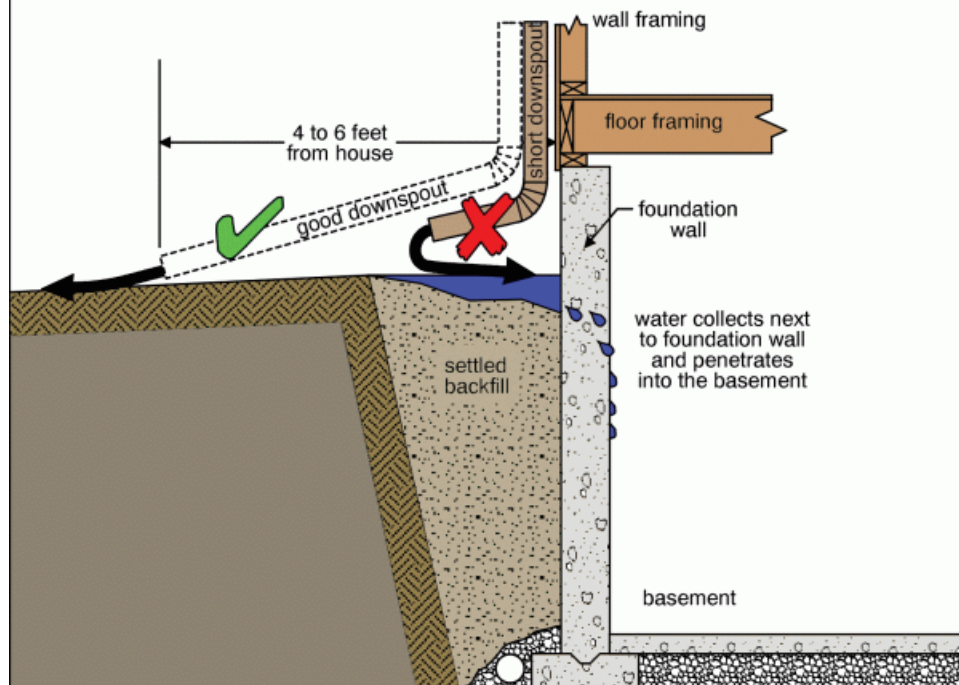
2. Condition: • Discharge too close to building

Downspout extension too short

Recommend downspout discharge be direct via drain pipe to a point past the end of the retaining walls. Swales may also be created to direct drainage away from foundation and towards creek on side of house.

Task: Further evaluated by a qualified contractor recommended

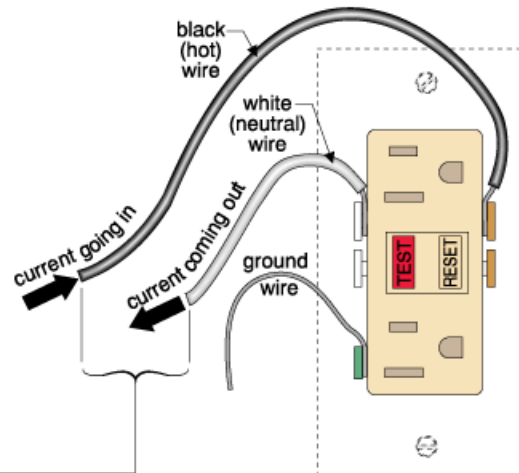
if the GFCI is in the panel, the entire circuit will be shut down

GFCI Outlet recommended

Task: Furnish and install GFCI type outlets in the location recommended

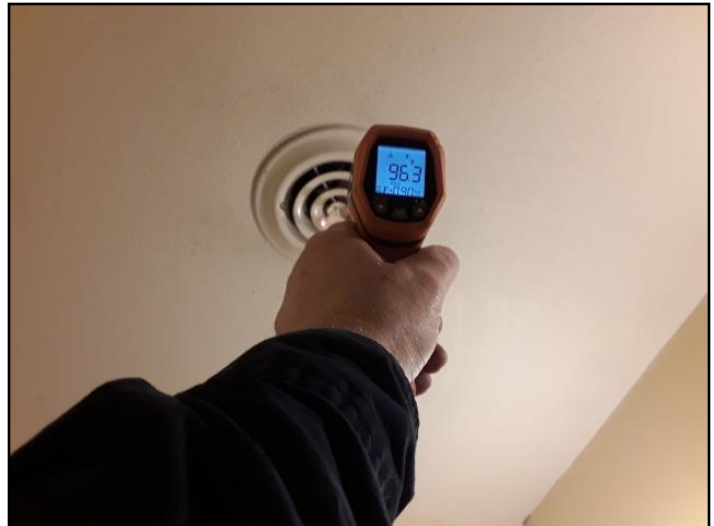
Heater supply temp 96 deg

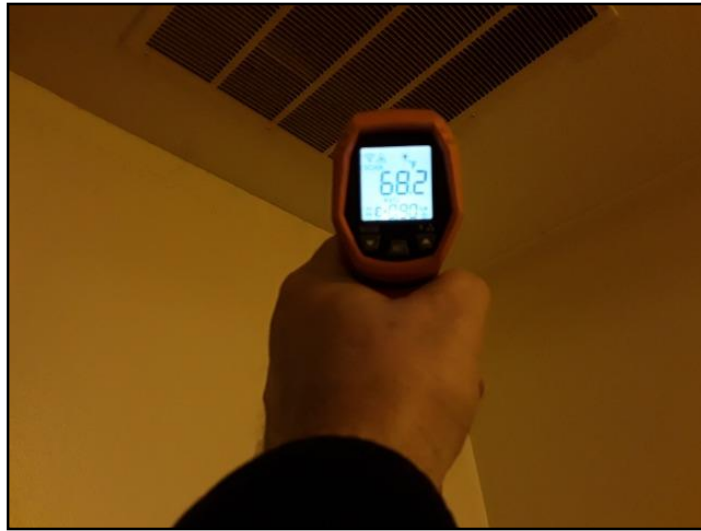
Heater return temp 68 deg

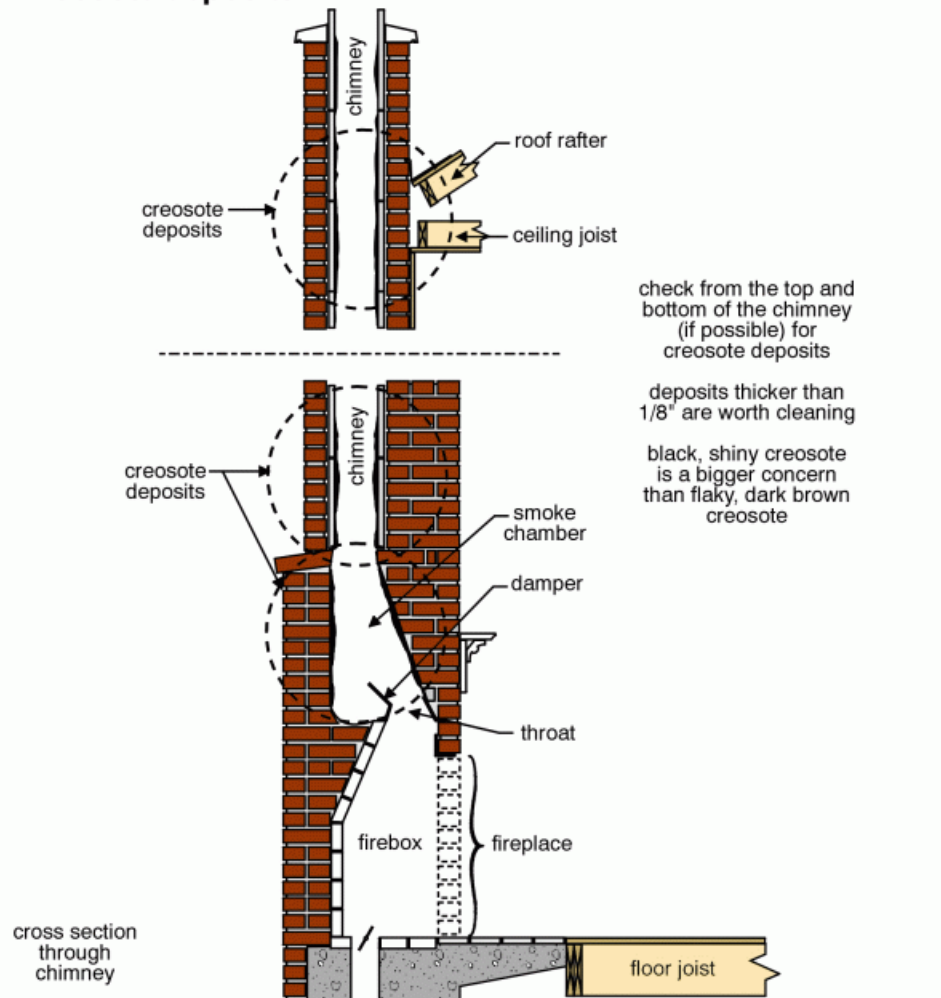
Heavy creosote build-up noted on the chimney flue connected to the basement wood stove (front flue in chimney)

Creosote build-up (front flue)

Task: Further evaluation by a qualified chimney sweep recommended

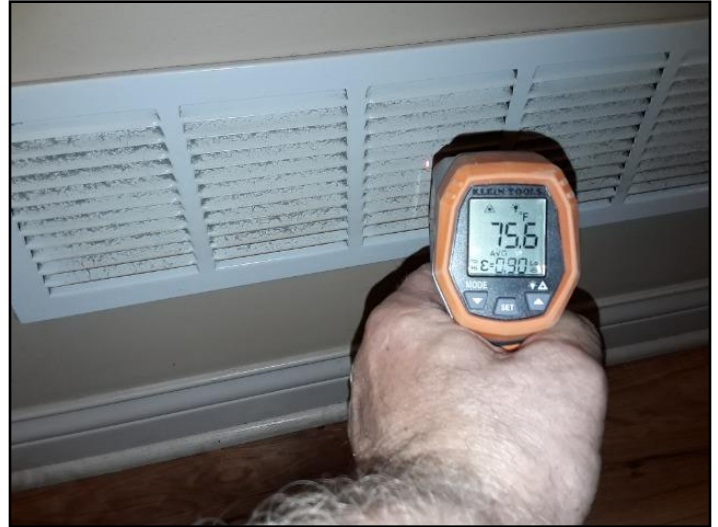
Cooling return temp 76 deg

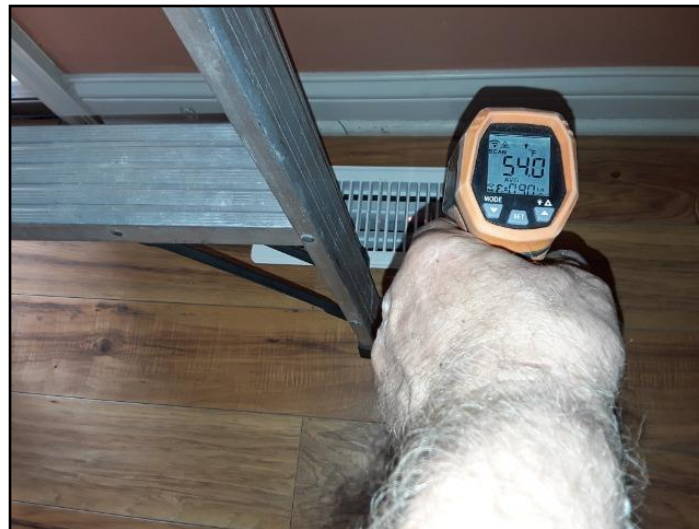
Cooling supply temp 54 deg

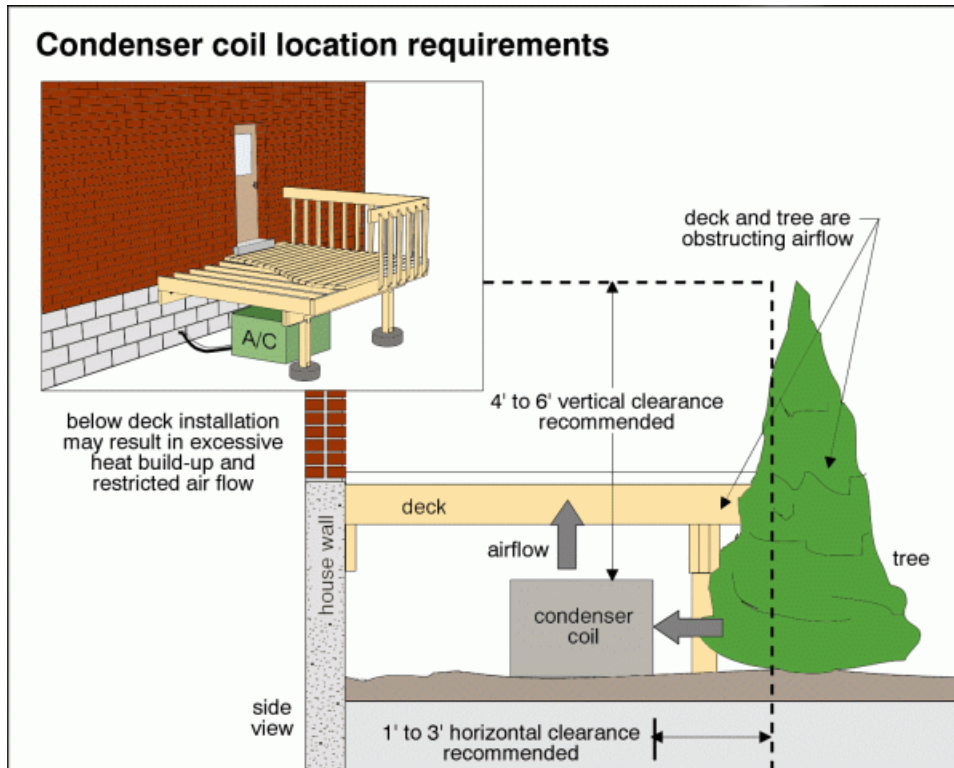
11. Condition: • Air flow around A/C was restricted

Air flow around A/C was restricted

Task: Trim back shrubs & remove wood lath to a point 2 feet around A/C unit
