YOUR INSPECTION REPORT

47 Laws Street
Toronto, ON M6P 2Y8

INSPECTION DATE:
Tuesday, April 23, 2019

RE: Report No. 2438
47 Laws Street
Toronto, ON
M6P 2Y8

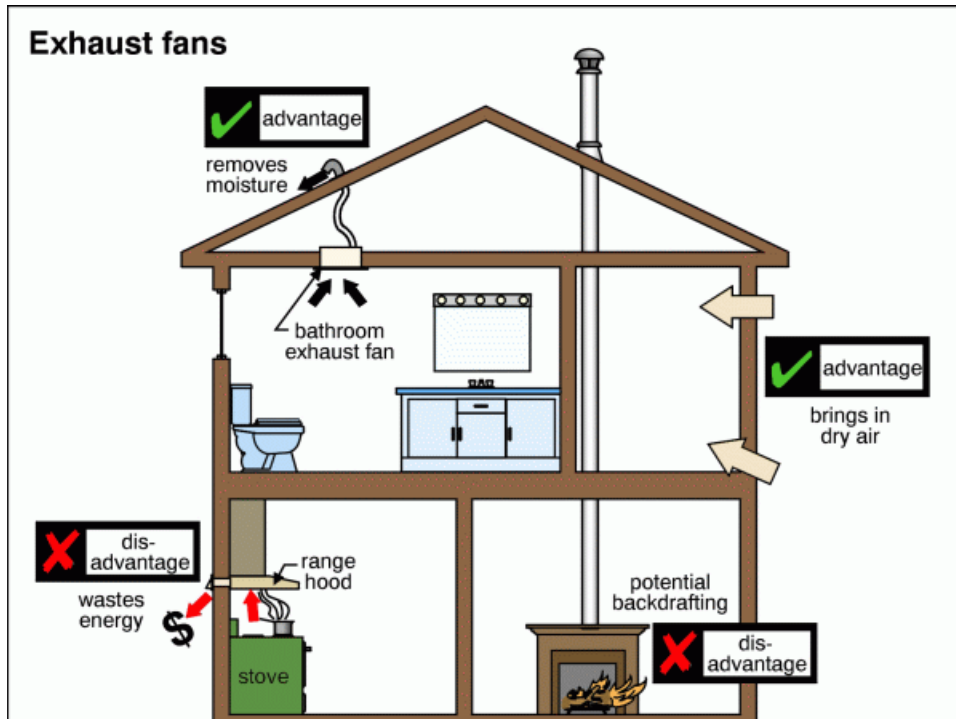
Condition: • [Noisy](#)

Implication(s): Reduced system life expectancy | Equipment failure

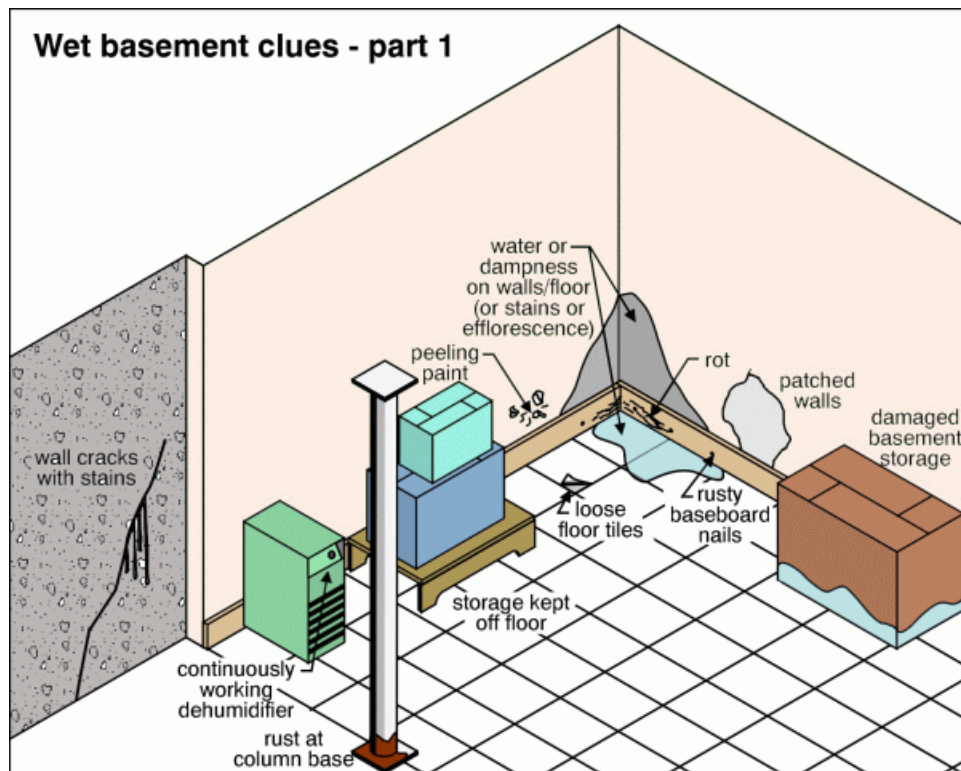
Basement leakage clues - rot, stains or water marks

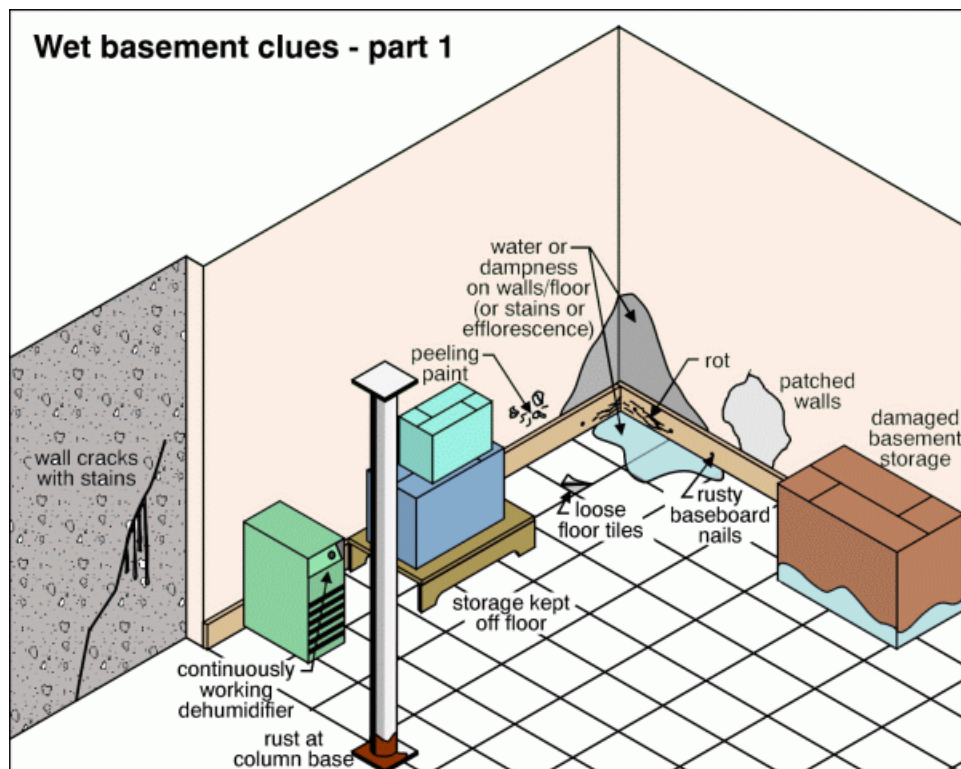
Condition: • [Water marks](#)

It is common to find water marks in a basement of this age. Numerous possible causes - Condensation, leakage, plumbing leakage, installation issue, etc. There was no standing water observed during the inspection. some stains tested with moisture meter and were wet.

Implication(s): Chance of water damage to contents, finishes and/or structure

Task: Troubleshoot and repair
