# Your Inspection Report

57 Kenneth Ave  
Toronto, ON M6P 1J1

**PREPARED BY:**  
Jim Gibson, P.Eng.

RE: Report No. 73954, v.2  
57 Kenneth Ave  
Toronto, ON  
M6P 1J1

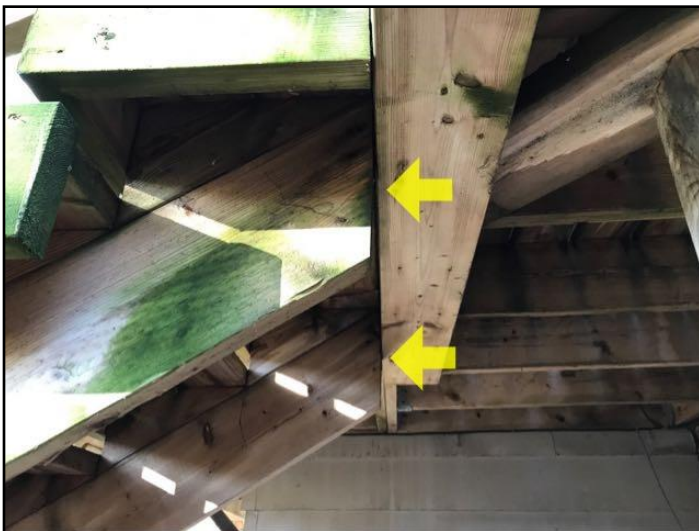
*Connections weak, not level*

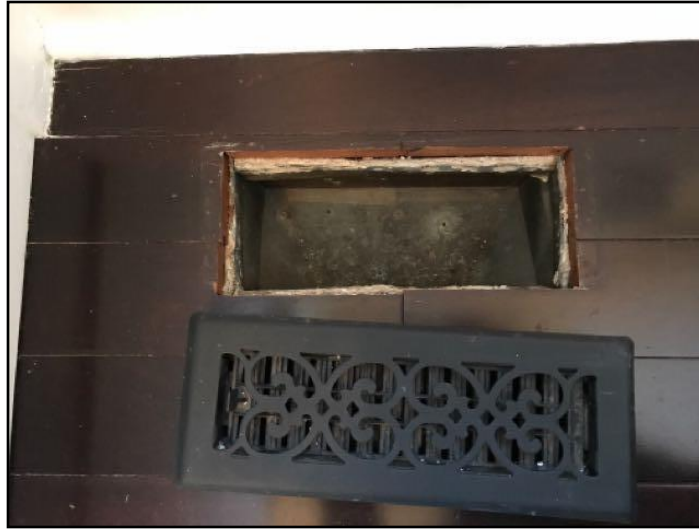
*Duct insulation - may contain asbestos*
