YOUR INSPECTION REPORT

FOR THE PROPERTY AT:
48 Parkdale Rd
Toronto, ON

INSPECTION DATE:
Wednesday, May 3, 2017

RE: Report No. 2112
48 Parkdale Rd
Toronto, ON

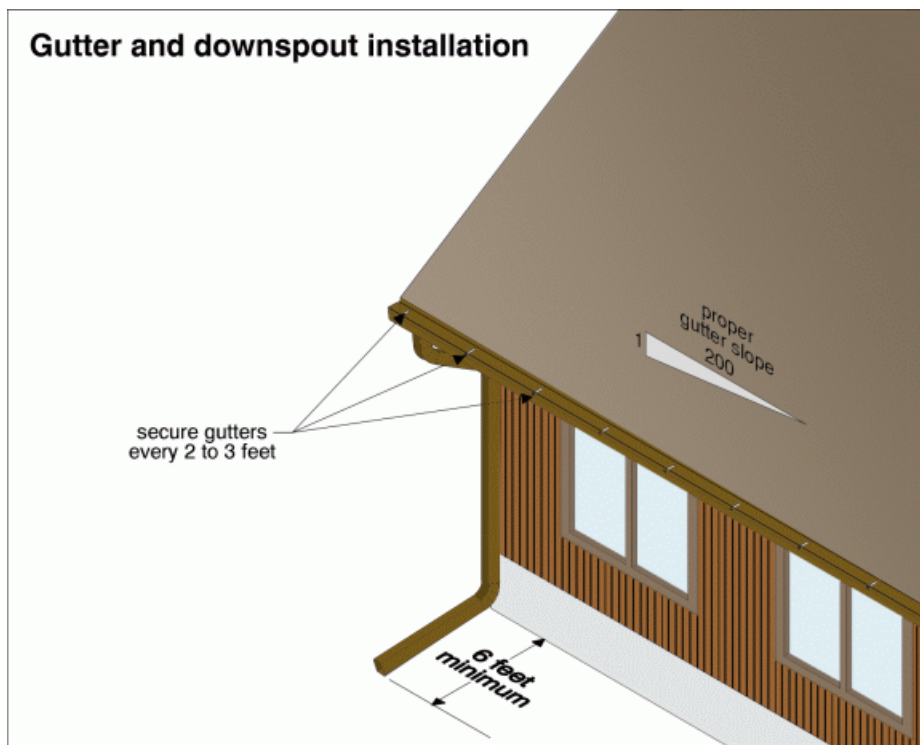
1. Missing Gutters (eavestrough)

Condition: • [Missing](#)

Implication(s): Chance of water damage to contents, finishes and/or structure

Time: Less than 1 year

Cost: Minor

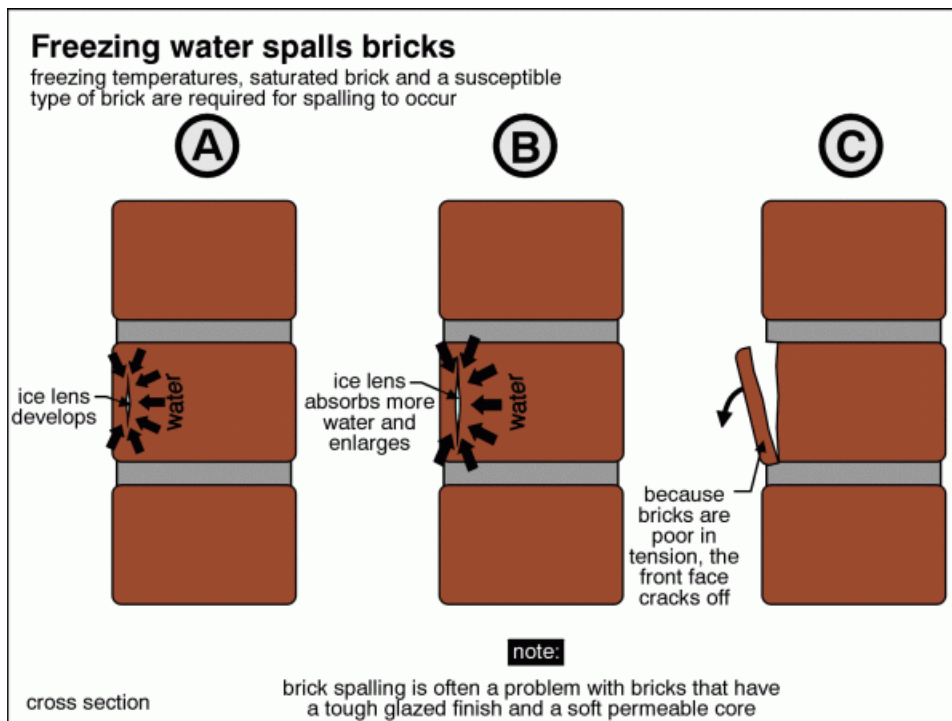
3. Example of spalling

Condition: • [Spalling](#)

Spalling/ masonry deterioration noted at various areas. Repair / Replace / Tuck point masonry. This is regular maintenance for a home of this age.

Task: Repair

Time: Less than 1 year

Cost: Regular maintenance item

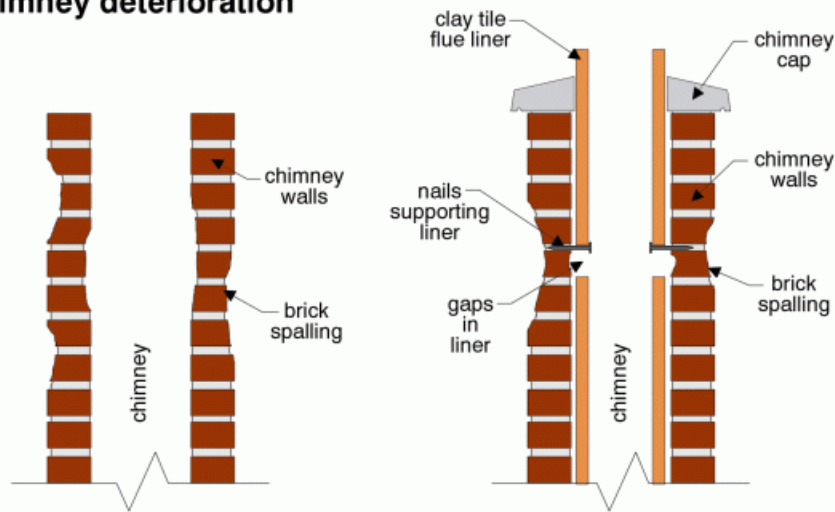
Chimney deterioration

unlined chimneys are particularly prone to damage caused by condensation of flue gases - the damage tends to be worse near the top of the chimney

even lined chimneys can suffer from condensation related brick damage
