INSPECTION REPORT

For the Property at:
123 ABC STREET
MEDICINE HAT, AB

Prepared for: JOHN SMITH
Inspection Date: Monday, January 4, 2021
Prepared by: Westley Franks

RE: Report No. 1097
123 ABC Street
Medicine Hat, AB

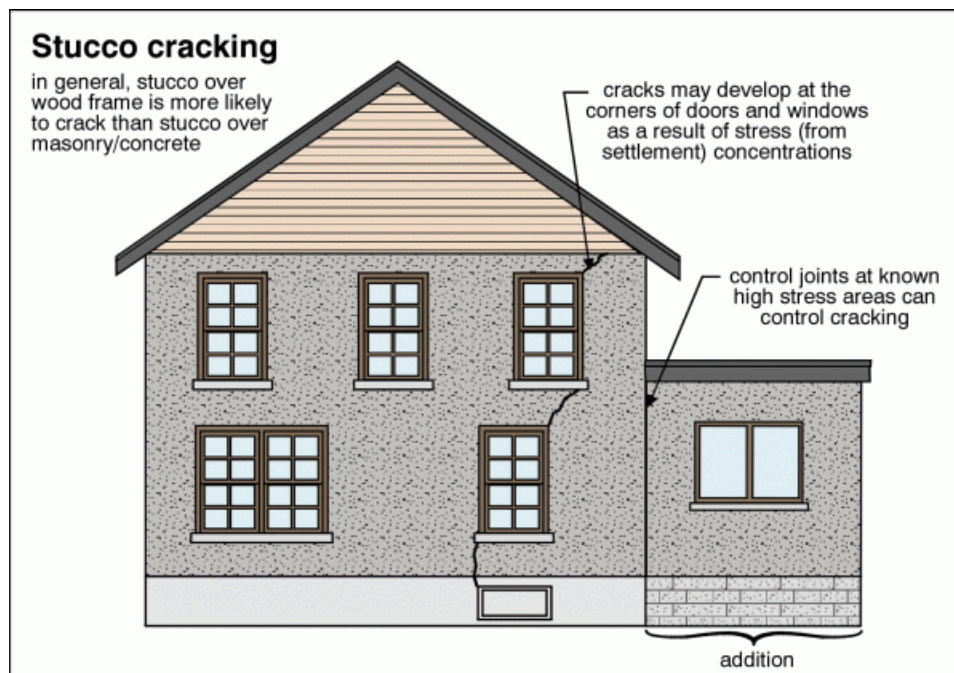
3. Condition: • Minor stucco drying cracks

10. Minor stucco drying cracks

Task: Monitor the condition

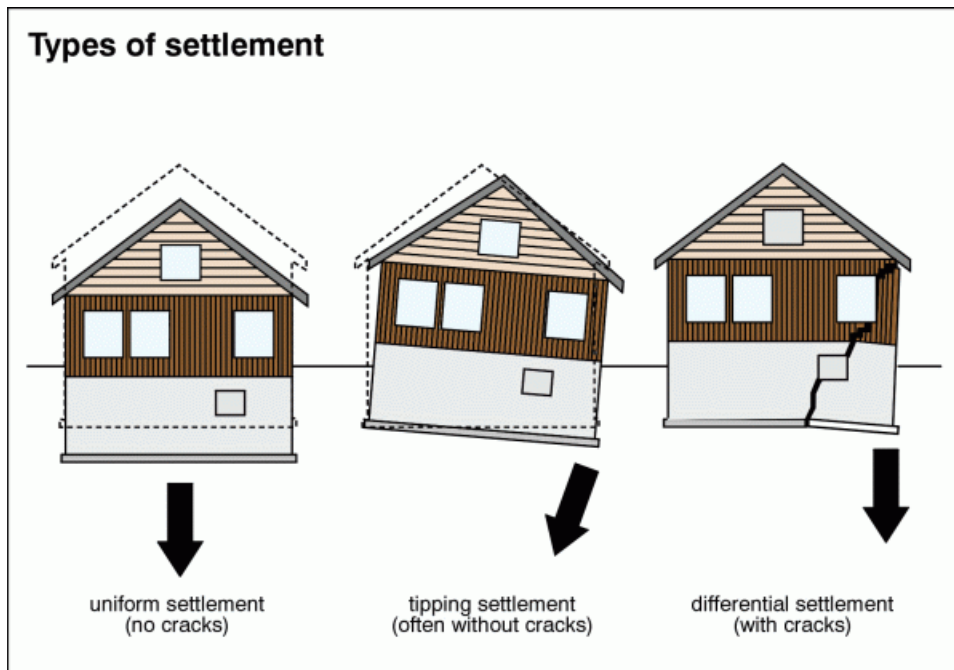
There is an old vertical foundation crack under the front stairs that has been repaired with polyurethan foam injection.

Crack repair - epoxy and polyurethane injection

polyurethane is flexible and is not a structural repair, however, it can prevent leakage

Task: Monitor the condition, if the condition changes, Get an expert opinion from a qualified contractor,

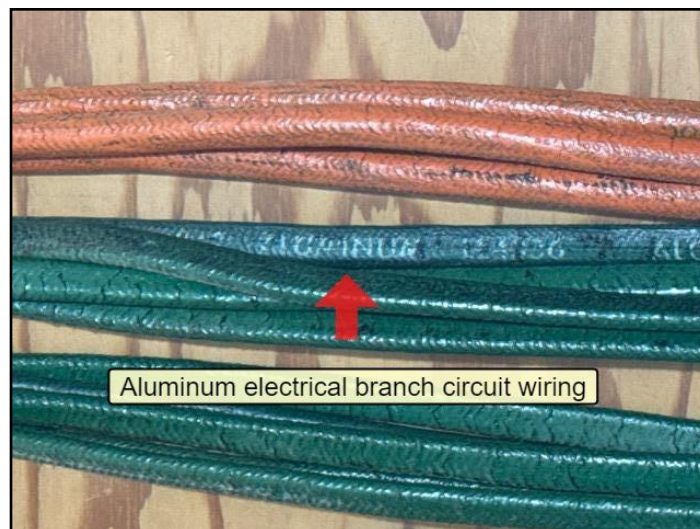
Condition: • [Aluminum electrical branch circuit wiring is present in the home, this wiring has a history of a overheating if it](#) was not installed and maintained properly. Over time aluminum wiring connections can become loose or rusted causing problems in the electrical circuits of the home. All aluminum wire connections in the electrical panel should be tightened, and all the receptacles, switches and lights should be "Pig Tailed" to copper wire using the proper aluminum wire connectors and de-oxidization compound. It is also recommended that the aluminum wiring branch circuits be protected with Arc-Fault protection.

Implication(s): Fire hazard | Over heating wiring | Damage to conductor insulation | Damage to equipment

24. Aluminum electrical branch circuit wiring

Task: Repair and maintain by a qualified contractor,

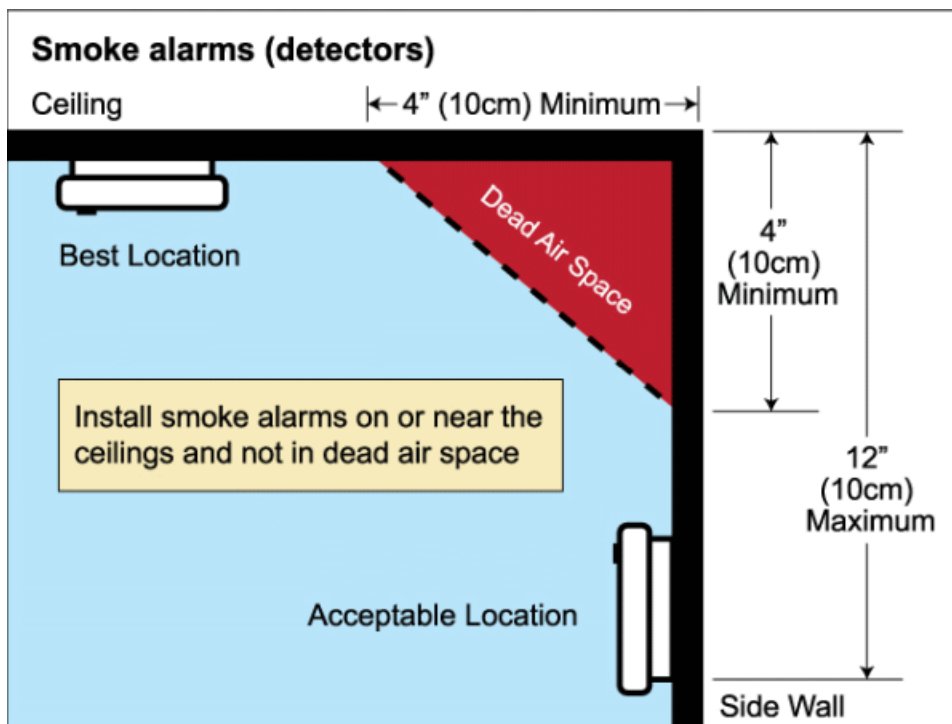
Condition: • There are No Smoke alarms present in the home. It is recommended that new 120 volt / battery back up CO/Smoke and Smoke alarms be installed and interconnected. This condition is typical for homes of this age.

Implication(s): Fire hazard | Life safety hazard

27. No Smoke alarms present

Task: Provide new by a qualified contractor

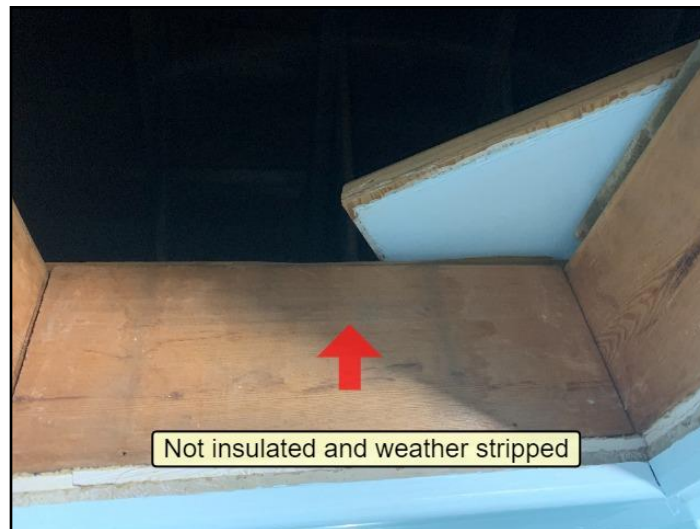
46. Not insulated and weather stripped

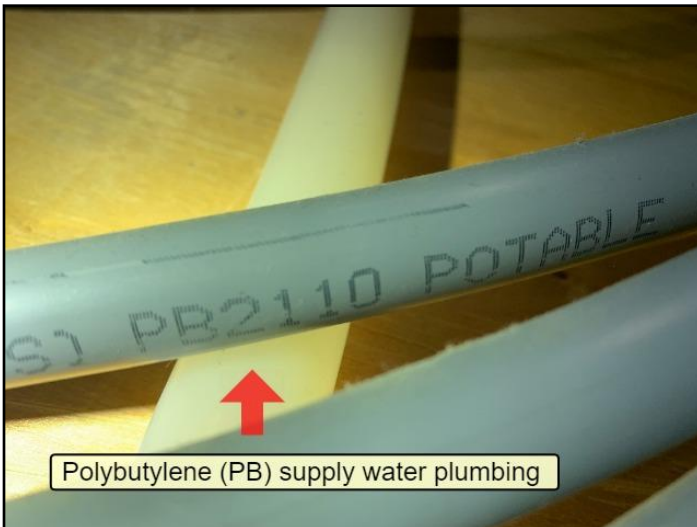
Condition: • Polybutylene (PB) supply water plumbing pipe has been found in the home. This piping has a history of a significantly high rate of failure. There have been instances in the past when this kind of pipe has ruptured or the connectors have failed. This pipe is no longer used in residential plumbing applications for this reason.

Implication(s): Chance of water damage to structure, finishes and contents | Leakage

54. Polybutylene (PB) supply water plumbing

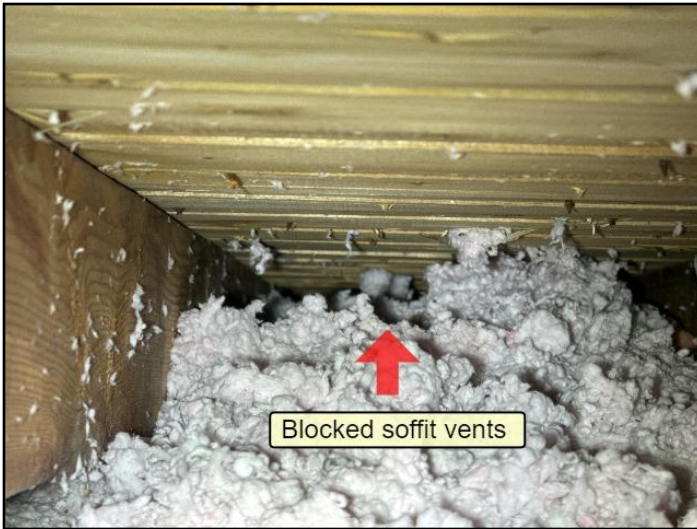
Blocked soffit vents

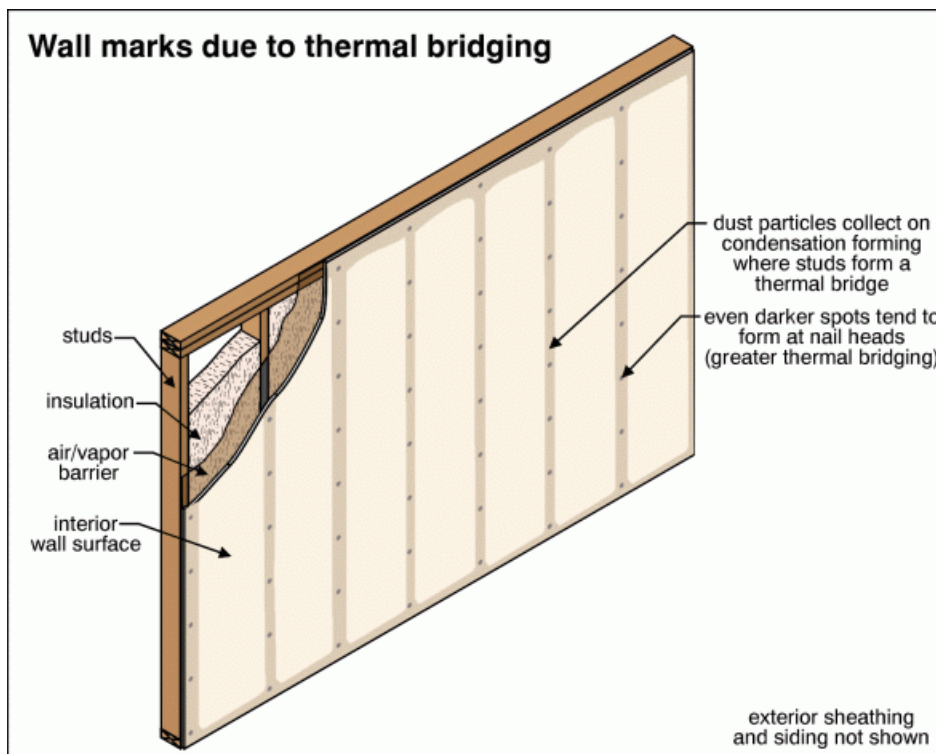
61. Thermal bridging

23. Condition: • [The Ghosting Effect is caused by warm moist air from the home leaking through the drywall in areas of poor insulation at the studs and rafters.](#) This thermal bridging causes condensation as the warm moist meets the cold outside air. As it condenses it leaves behind air contaminants, smoke and dust that causes the staining.

Implication(s): Material deterioration

Task: Monitor the condition

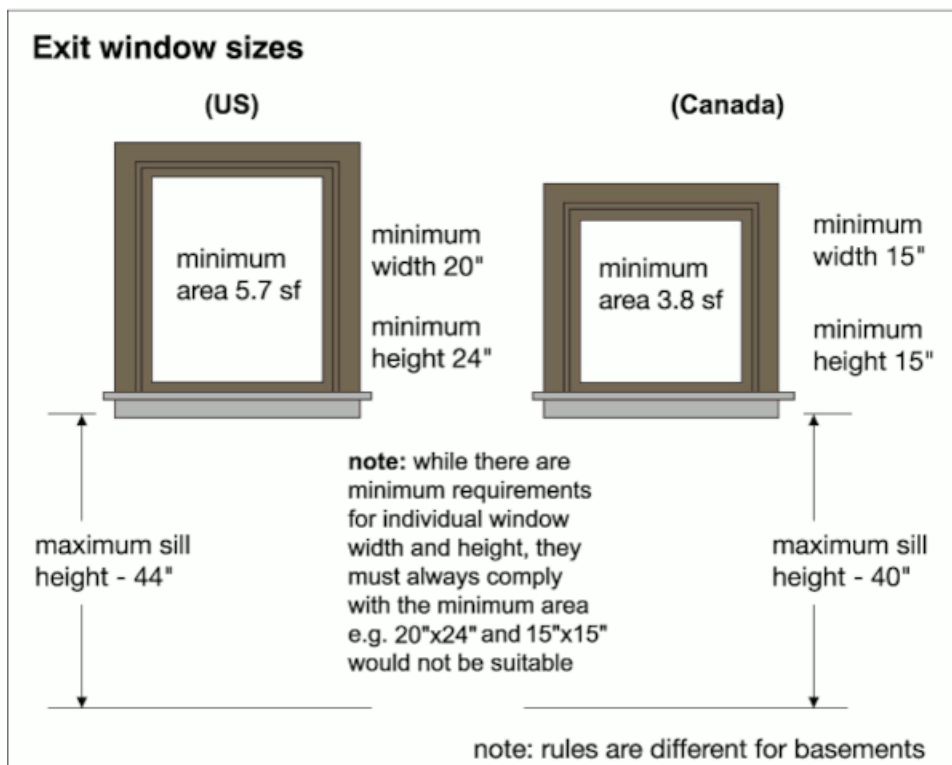
67. Restricted emergency exit

25. Condition: • Restricted emergency exit

This condition is typical for homes of this age

Task: Provide new by a qualified contractor
