# YOUR INSPECTION REPORT

135 Giltspur Drive  
Toronto, ON M3L 1M4

INSPECTION DATE:  
Tuesday, October 14, 2025

RE: Report No. 8666, v.2  
135 Giltspur Drive  
Toronto, ON  
M3L 1M4

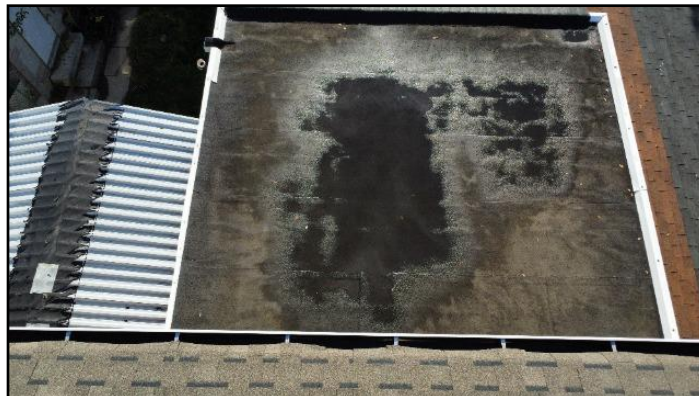
7. Ponding

**Condition:** • [Ponding](#)

any roof that still has water on it after 48 hours is defined as a ponding roof

a dry roof may show signs of ponding - dirty circles on the roof or algae/vegetation growth

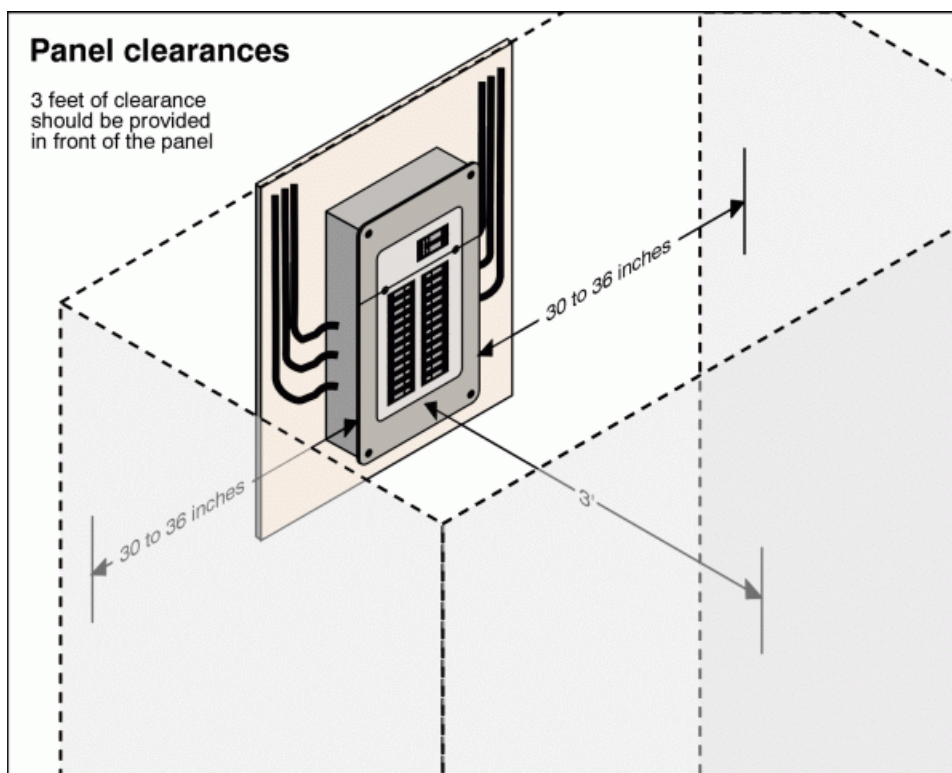
**38.** *Poor access***Condition:** • [Poor location](#)

**Implication(s):** Fire hazard**Location:** Basement Panel**Task:** Correct**Time:** As Soon As Possible**Cost:** Minor

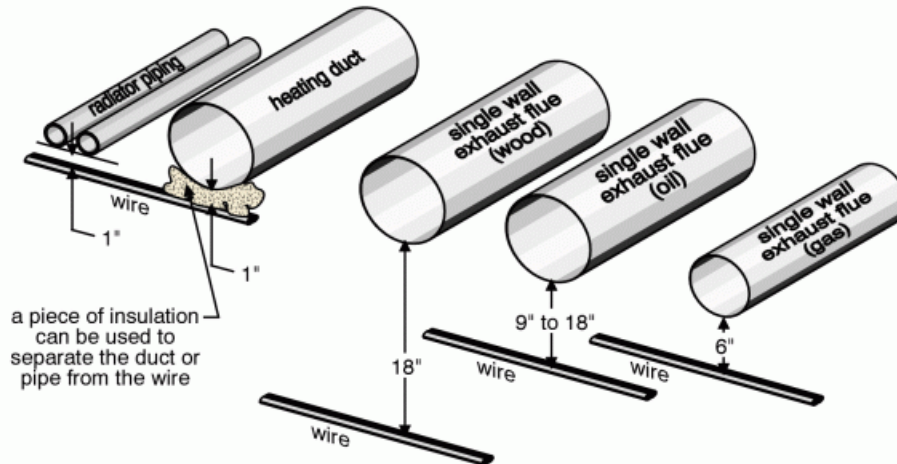
**41.** example**DISTRIBUTION SYSTEM \ Wiring (wires) - damaged or exposed****Condition:** • [Exposed on walls or ceilings](#)**Implication(s):** Electric shock**Location:** Basement**Task:** Correct**Time:** As Soon As Possible

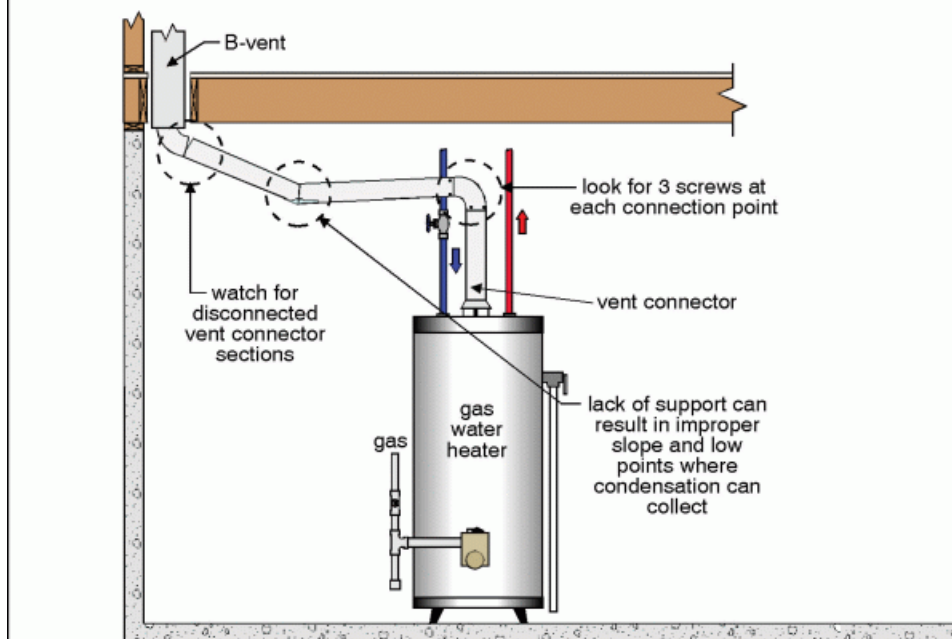
**Condition:** • [Poor connections](#)

**Implication(s):** Equipment not operating properly | Hazardous combustion products entering home

52. vent not secured to water heater

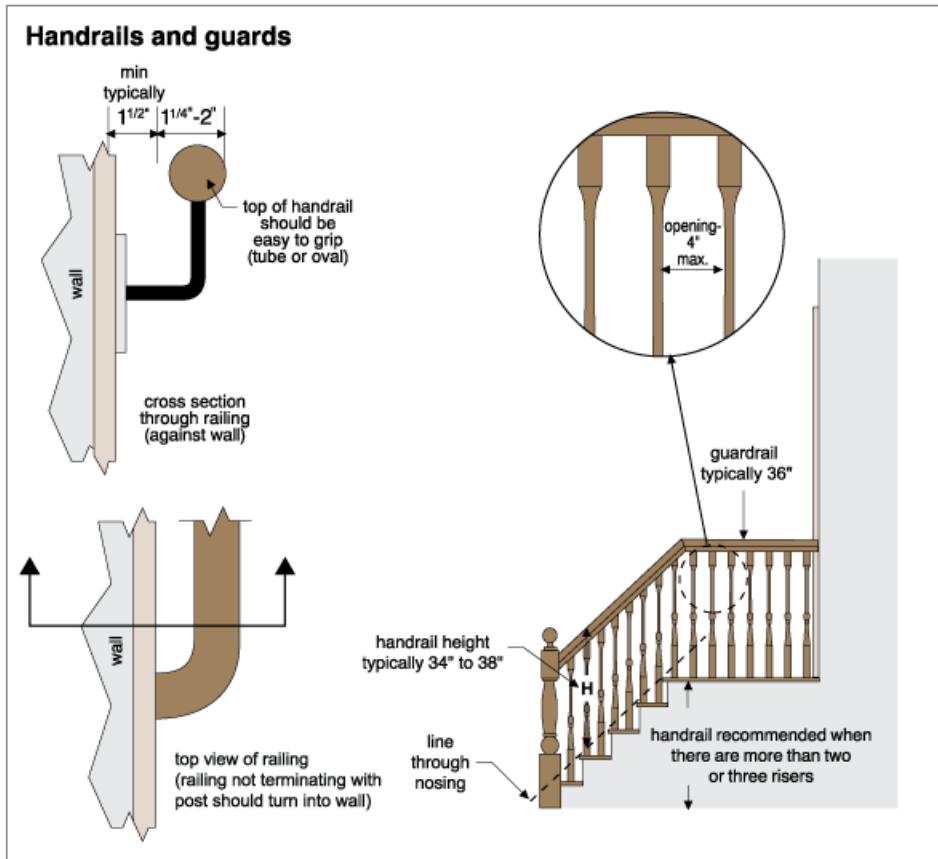
59. Too far apart

**Task:** Correct

**Time:** Less than 1 year

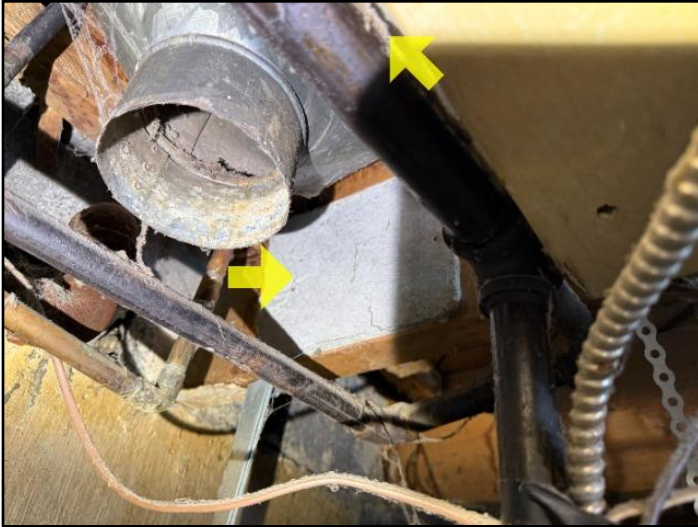
61. Possible asbestos containing materials

**Time:** Before disturbing material

**Cost:** \$150 - \$250 per register if asbestos is present
