YOUR INSPECTION REPORT

168 Sixth Street
Toronto, ON M8V 3A5

INSPECTION DATE:
Monday, August 27, 2018

RE: Report No. 2317, v.2
168 Sixth Street
Toronto, ON
M8V 3A5

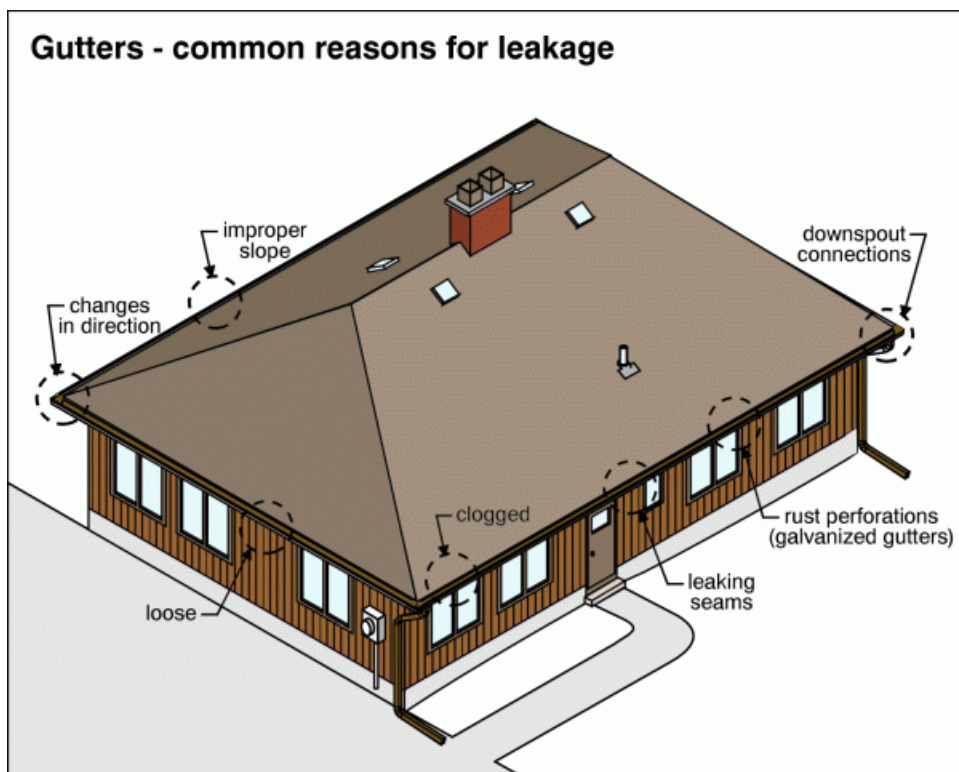
Condition: • [Clogged](#)

Implication(s): Chance of water damage to contents, finishes and/or structure

Task: Clean

Time: Regular maintenance

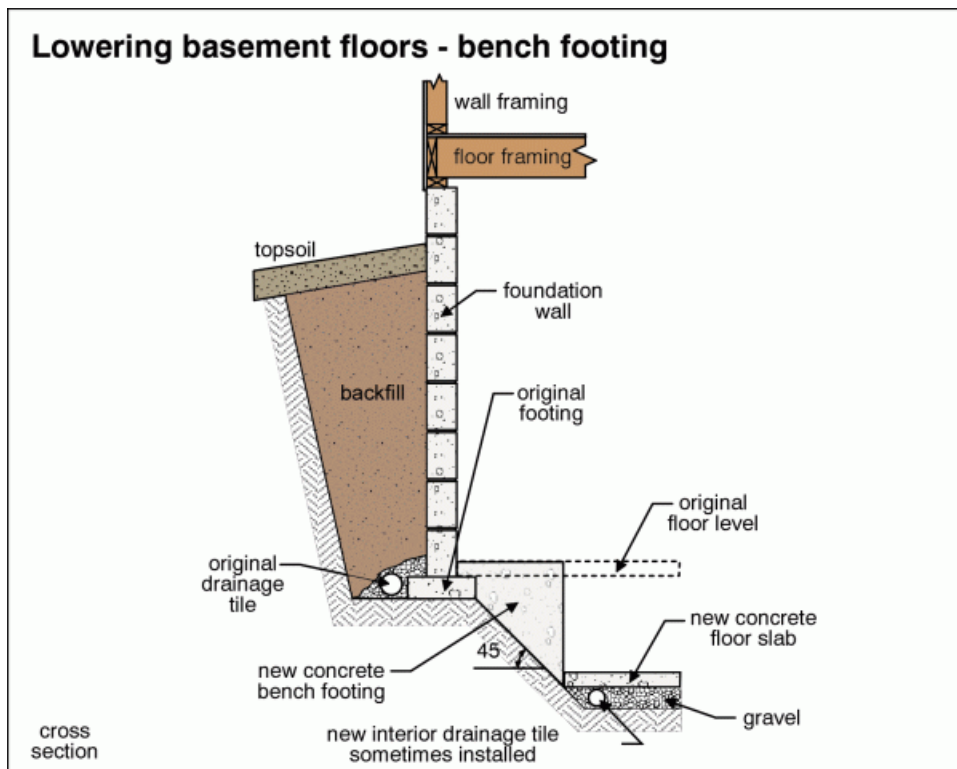
Foundation material: • [Stone](#)

Task: Click link to read more information / For Your Information
