YOUR INSPECTION REPORT

34 Coe Hill Drive
Toronto, ON M6S 3C8

INSPECTION DATE:
Tuesday, August 27, 2019

RE: Report No. 2524, v.2
34 Coe Hill Drive
Toronto, ON
M6S 3C8

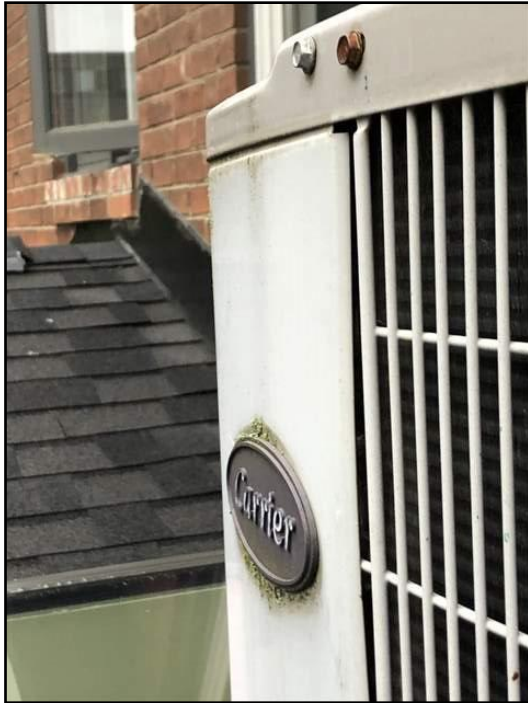
11. Air cooled

Split system. Condenser on rear addition with air handler in attic. Ducts in ceiling on second floor only
