# Your Inspection Report

84 Lavinia Ave  
Toronto, ON

**INSPECTION DATE:**  
Tuesday, September 27, 2016

RE: Report No. 55437  
84 Lavinia Ave  
Toronto, ON

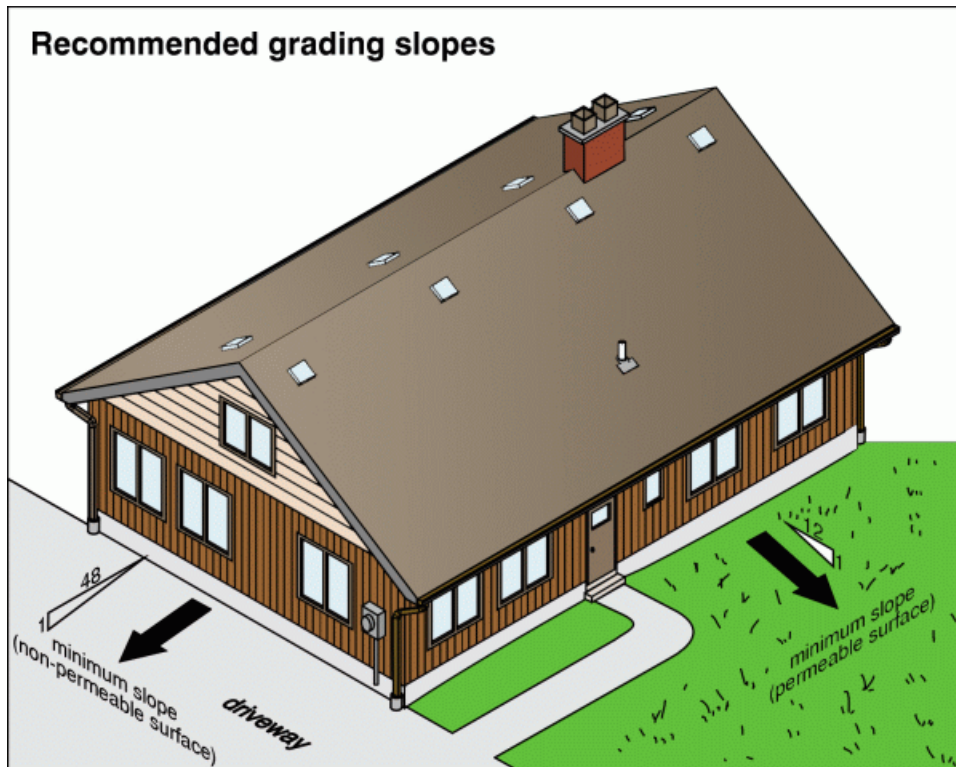
**Condition:** • The grading generally runs from the back to the front of the property.

**Implication(s):** When trying to minimize basement leakage, it is always best to be proactive and slope the grading away from the house.

**Task:** Monitor/Improve

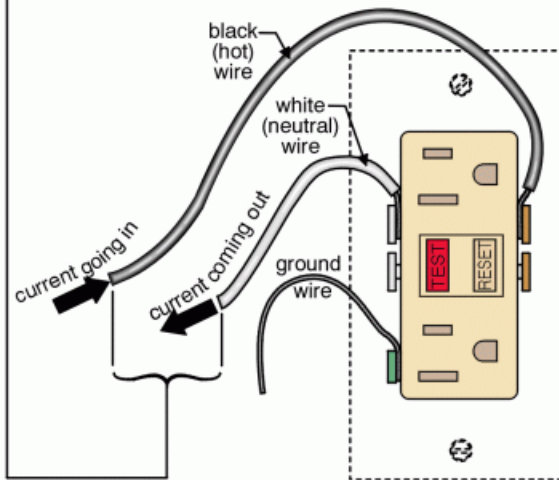
if the GFI is in the panel, the entire circuit will be shut down

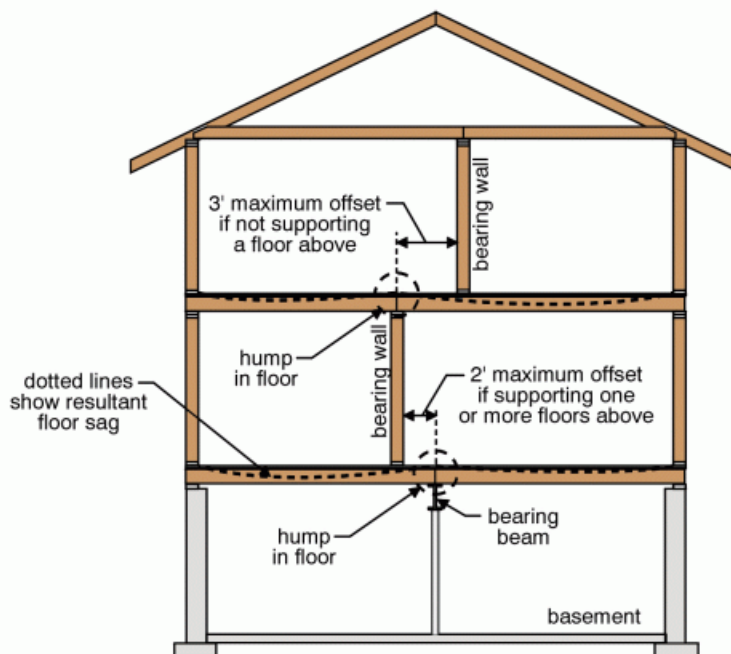
### **Offset bearing walls**

It is not usually cost effective to attempt any correction unless the floor treatment is being updated.
