# Your Inspection Report

346 Indian Road Crescent  
Toronto, ON M6P 2H1

**INSPECTION DATE:**  
Monday, August 24, 2026

RE: Report No. 9748  
346 Indian Road Crescent  
Toronto, ON  
M6P 2H1

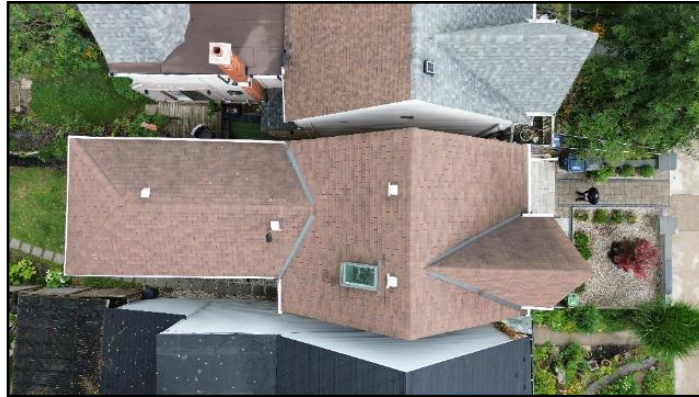
1. Asphalt shingles

**Approximate age:** • Age not determined. Roof appears serviceable with no visible signs of advanced wear. Replacement not considered imminent based on current observed condition.
