Your Inspection Report

268 Montrose Avenue
Toronto, ON M6G 3G8

Michael Turney, Certification #33304

RE: Report No. 1019, v.4
268 Montrose Avenue
Toronto, ON
M6G 3G8

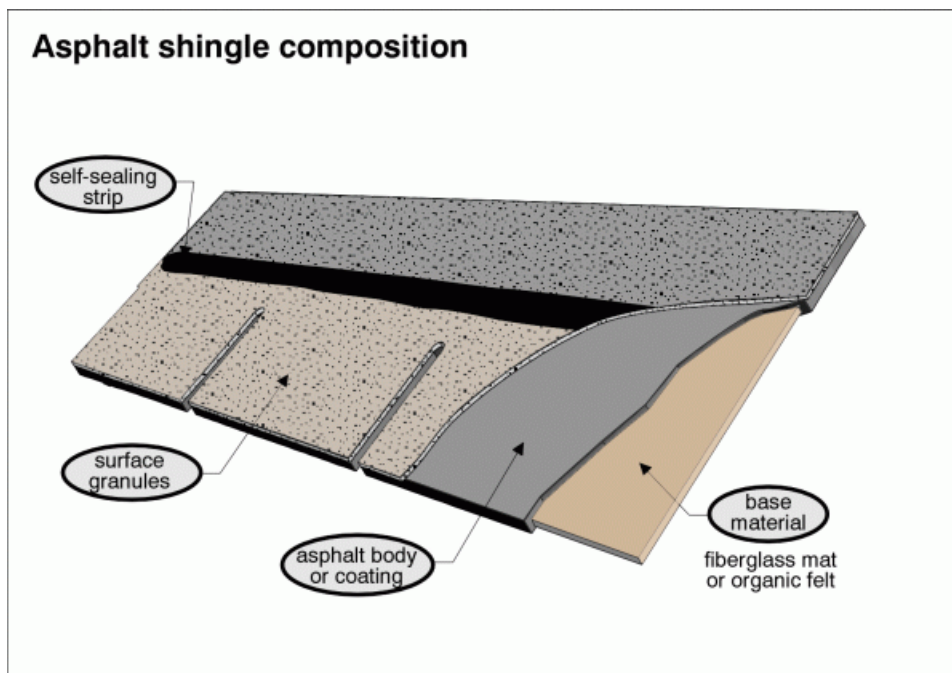
1. Condition: • Aging

Curling, deteriorating shingles

Task: Replace - and consider replacing roll roofing at the same time.
