YOUR Inspection Report

75 York View Dr
Toronto, ON M8Z 2G3

Sunday, August 18, 2019

Report No. 5700, v.2

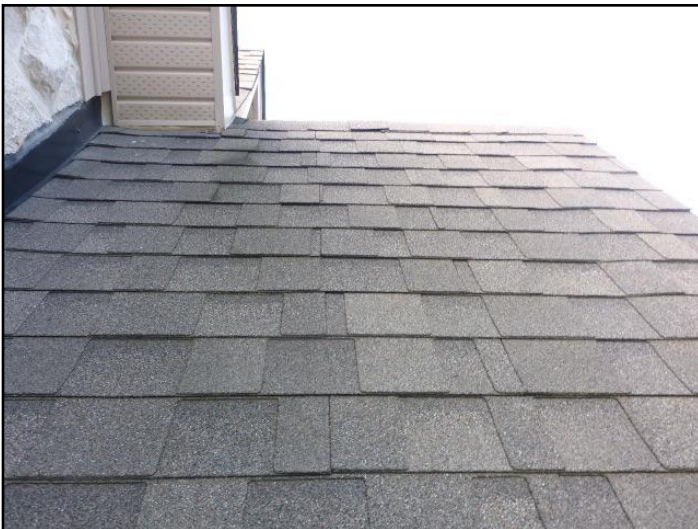
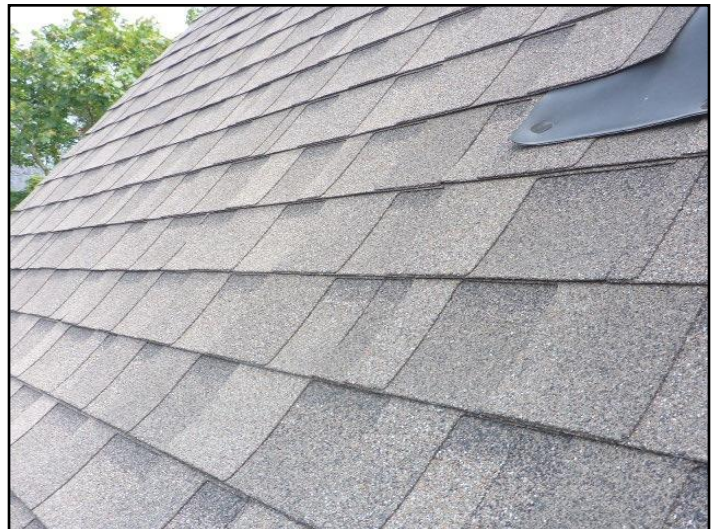
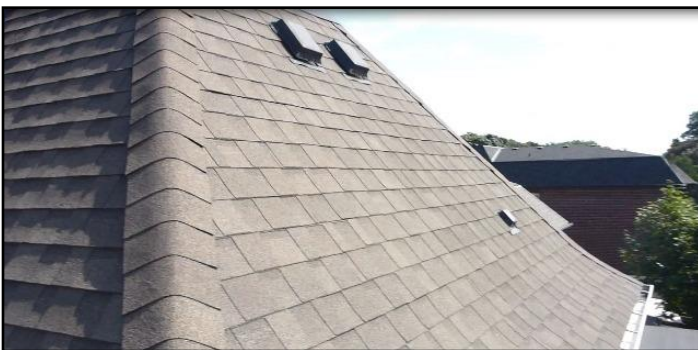
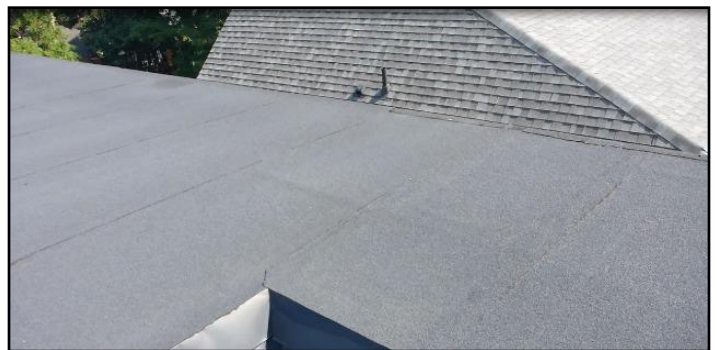
• View of roof from above (fyi):

Condition: • Some minor ponding noted near skylight. This is a common condition and no immediate action is required. Monitoring skylights as part of regular home maintenance is recommended.

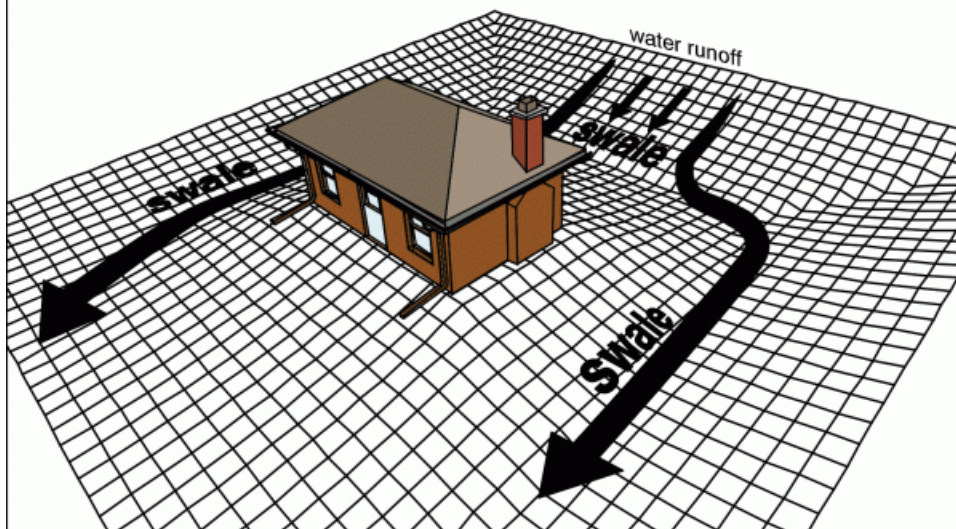
Swales

when the overall lot drainage is toward the house, swales can be used to direct surface water away from the foundation

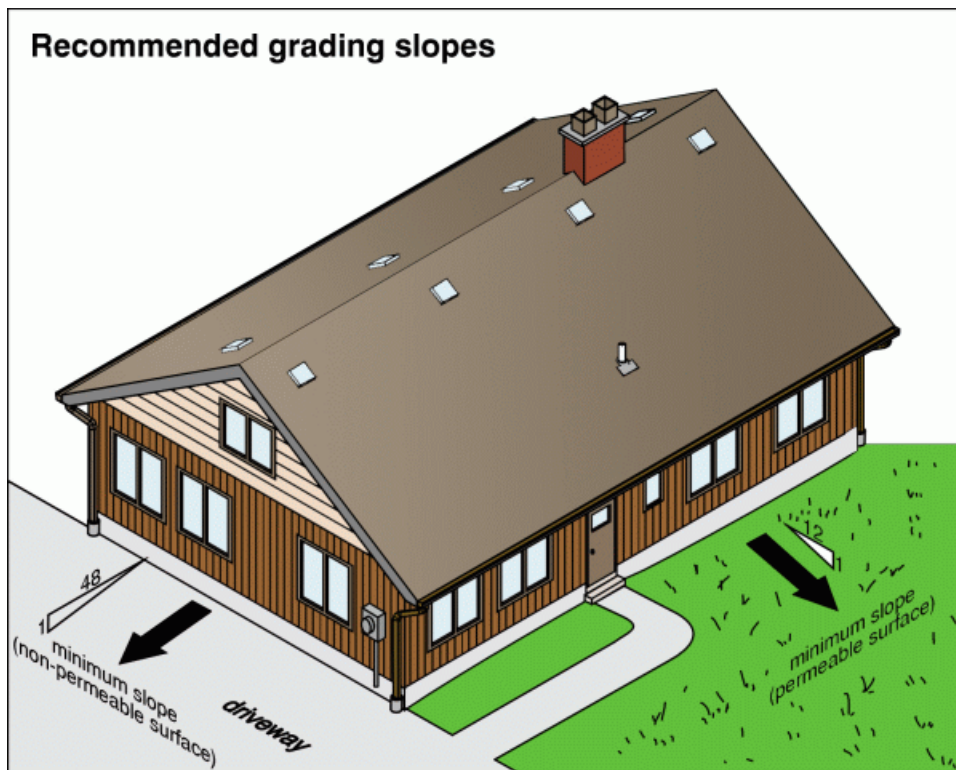
Condition: • [Low areas](#)

To reduce the likelihood of water penetration to the basement, always maintain a positive slope away from the foundation wall.

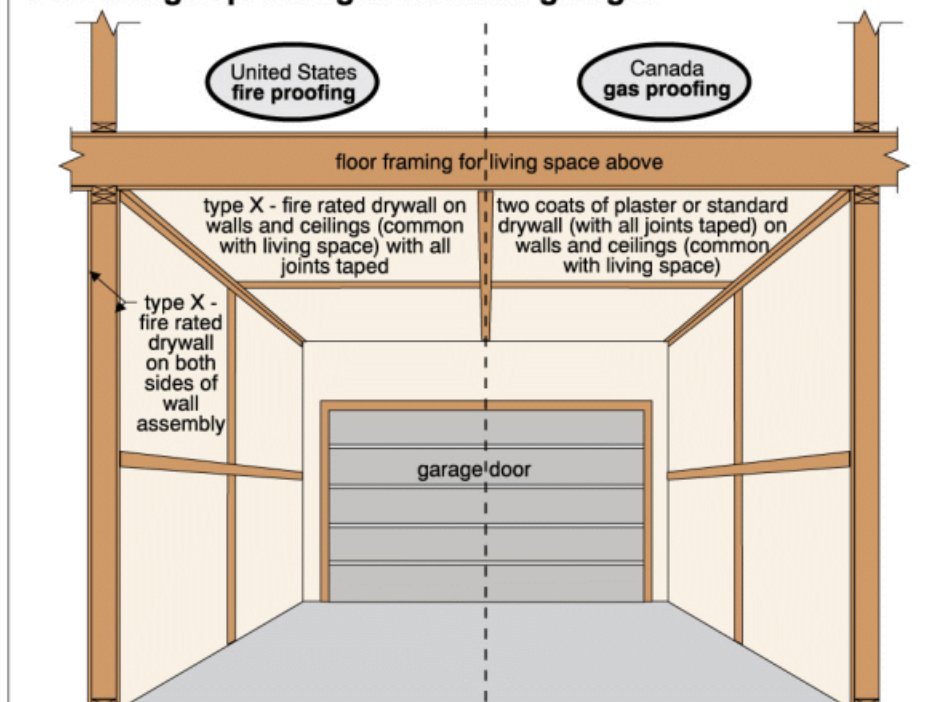
Fire and gas proofing in attached garages

Condition: • Storage in the garage prevented a thorough inspection for gas proofing issues. Be sure to seal any hole/gaps that are discovered once the space is clear to prevent the migration of gases into the living space.

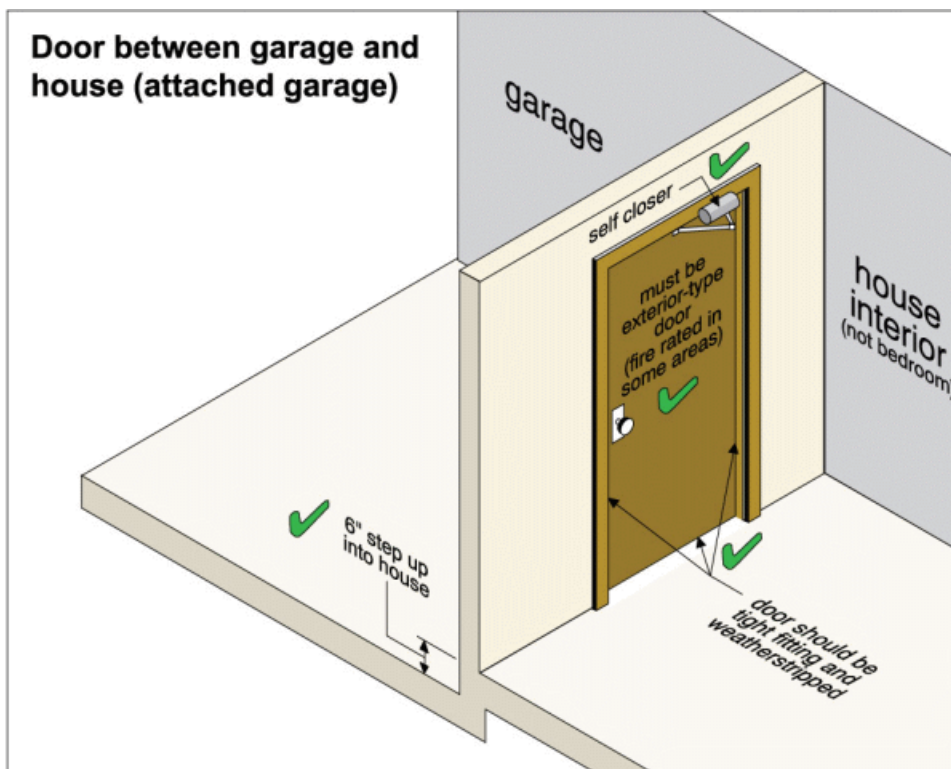
Door between garage and house (attached garage)

Condition: • [Man-door closer missing \(8.3\)](#)

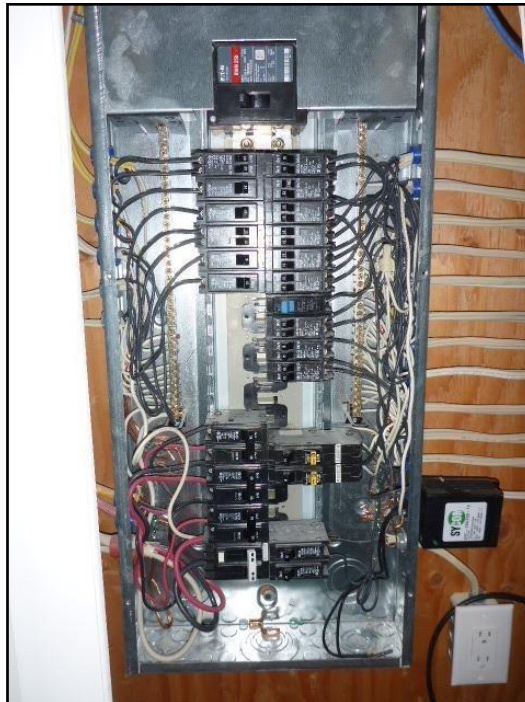
Electrical protected by breakers

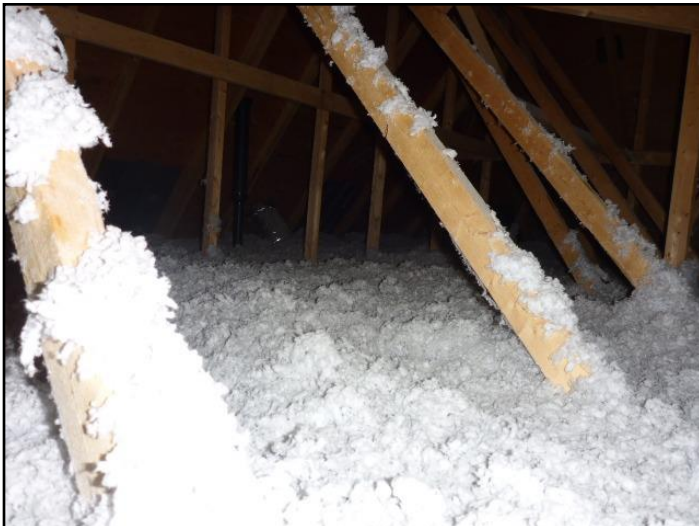
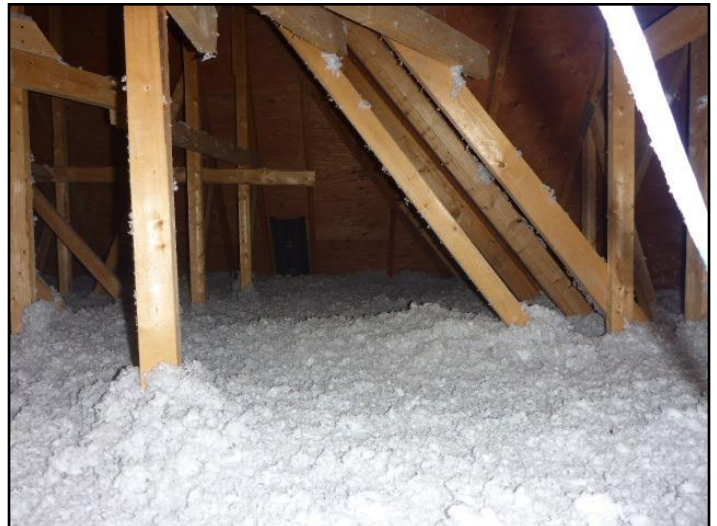
- View of attic (fyi):

Condition: • [Insulation - voids noted](#)
