# INSPECTION REPORT

For the Property at:  
**1234 MAIN ST**  
GERMANTOWN, WI 53022

Prepared for: PAUL VANENGEN  
Inspection Date: Thursday, May 14, 2020  
Prepared by: Paul VanEngen

RE: Report No. 1003, v.2  
1234 Main St  
Germantown, WI  
53022

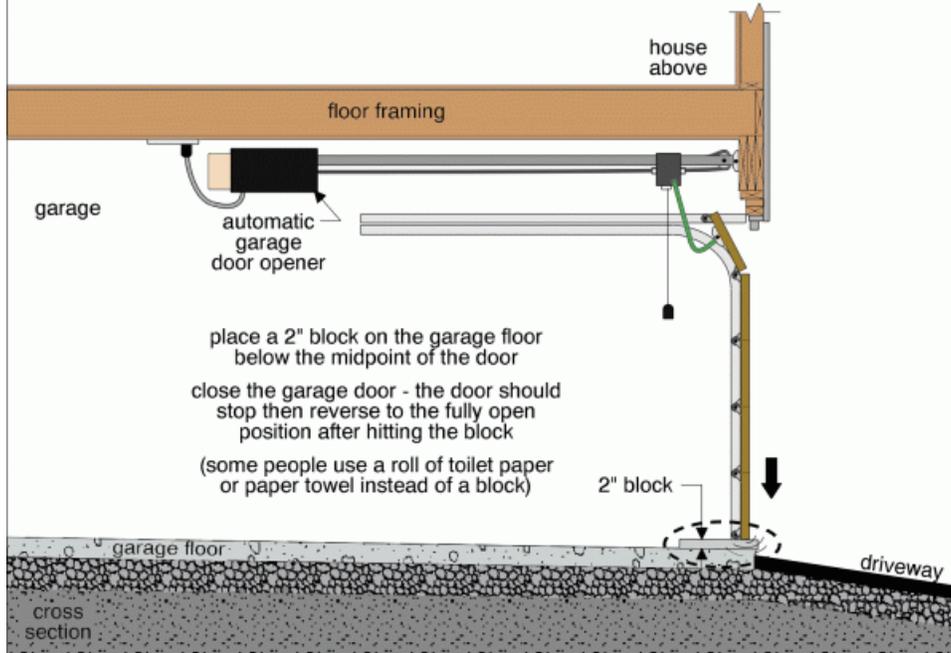
**Condition:** • [Fails to auto reverse](#)

Door fails to auto reverse. Major safety hazard.

**Testing automatic reverse**

**Task:** Contact a licensed professional for repair/replacement.

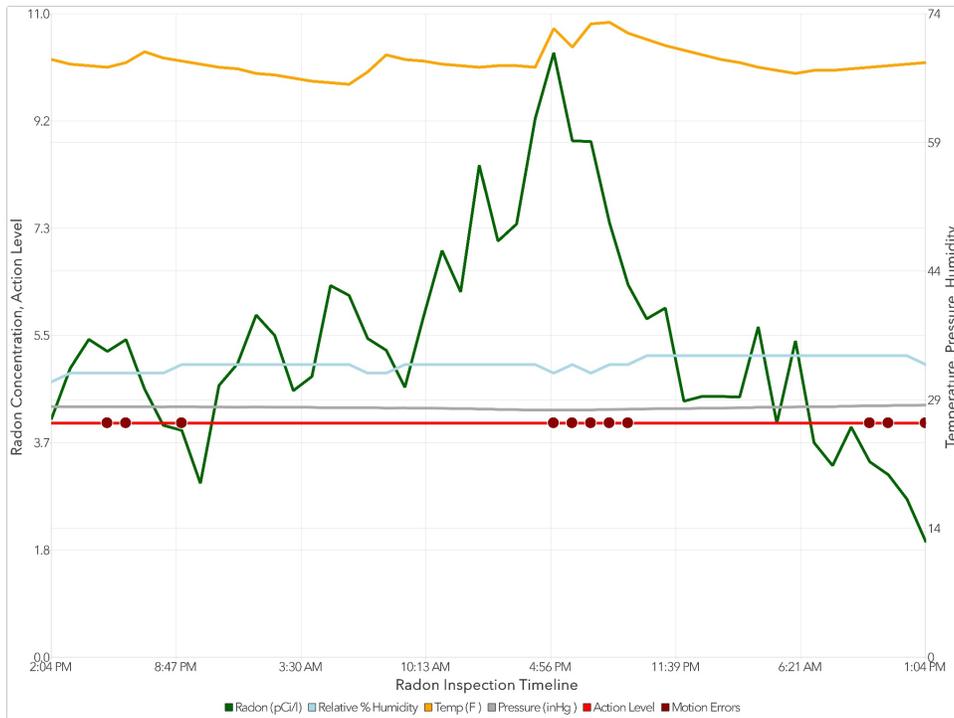
## Radon Inspection Chart

**Test Result: No Mitigation Recommended**
