Your Inspection Report

35 Aitken Circle
Markham, ON L3R 7L2

INSPECTION DATE:
Friday, April 22, 2016

RE: Report No. 1360, v.5
35 Aitken Circle
Markham, ON
L3R 7L2

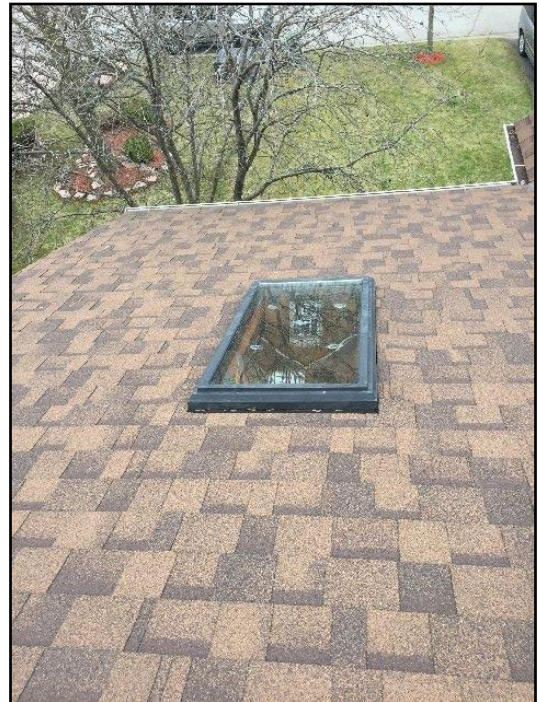
2. Composition shingles

Roof appears to be in good condition. IKO Cambridge, Limited Lifetime (AR) Shingles. Roof was Stripped and new roof vents, sheathing and plumbing vents also installed at that time. Shingles are a 25-30 year shingle. Installed Aprox within last 5 years.

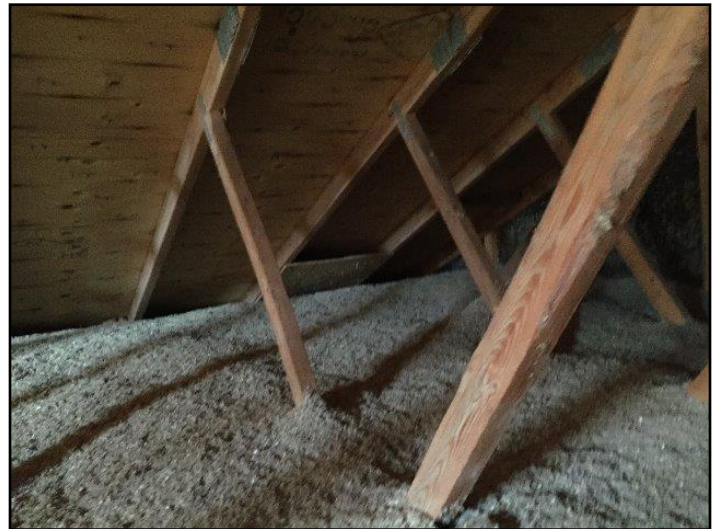
9. Trusses

In Good Condition
