# Your Inspection Report

1204 Walker Line Road  
Algonquin Highlands, ON P1H 0K1

RE: Report No. 3126, v.2  
1204 Walker Line Road  
Algonquin Highlands, ON  
P1H 0K1

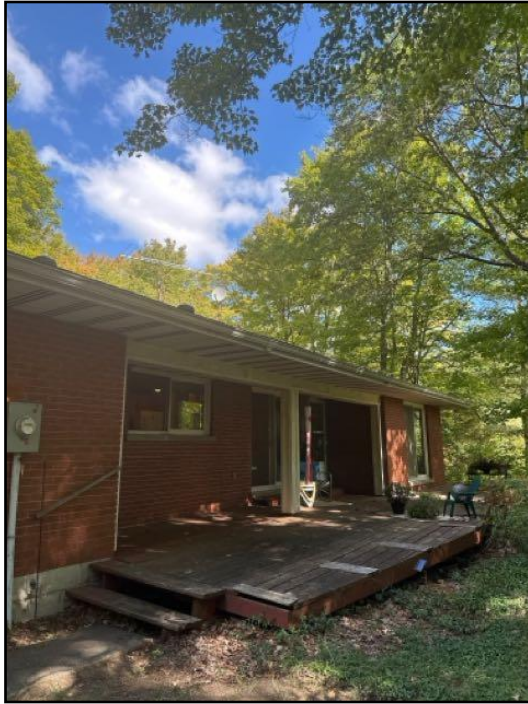
13. Vulnerable to ice damming

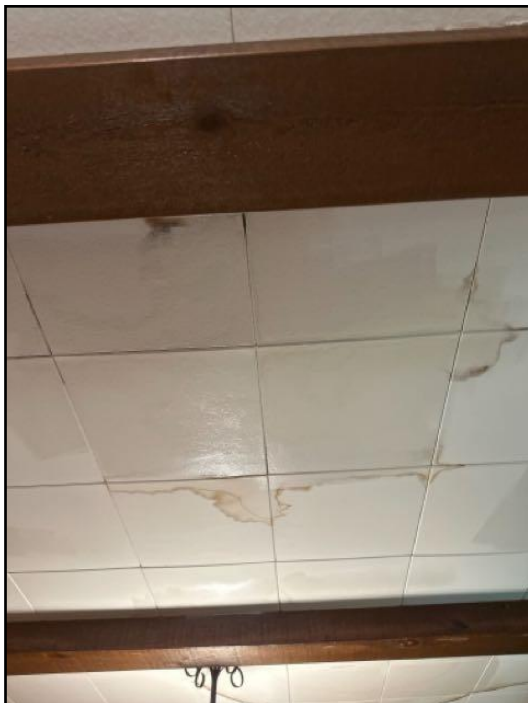
15. Vulnerable to ice damming

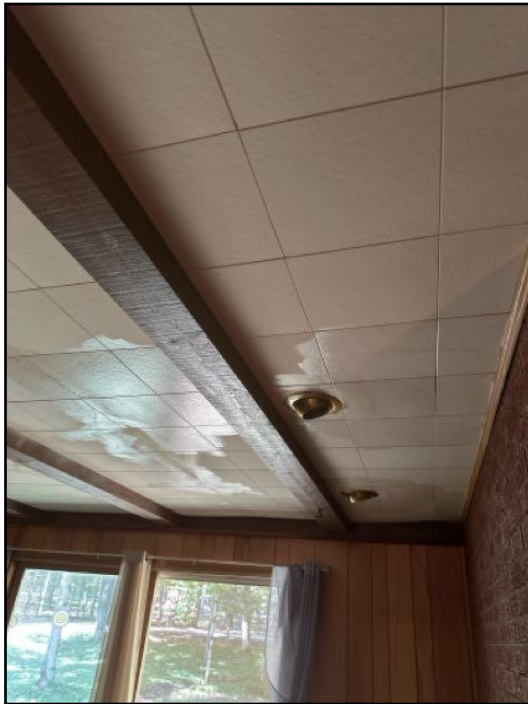
17. Vulnerable to ice damming

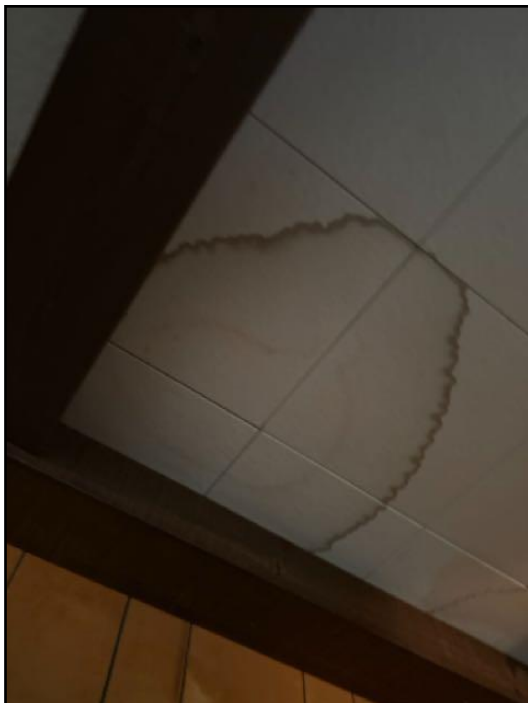
19. Vulnerable to ice damming

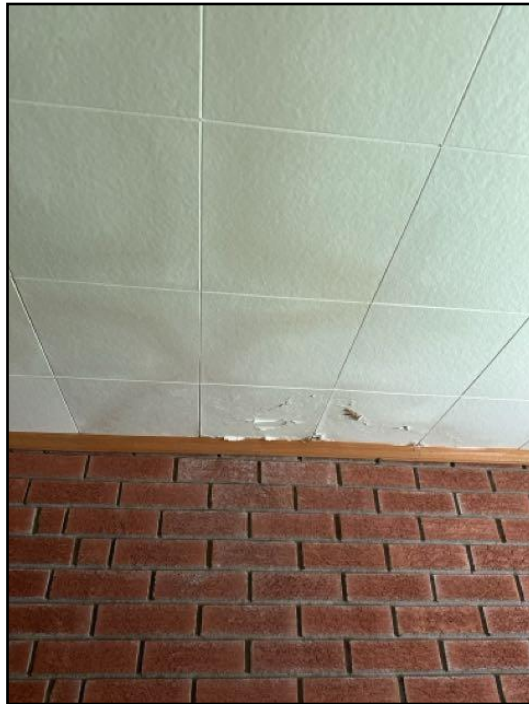
21. Vulnerable to ice damming

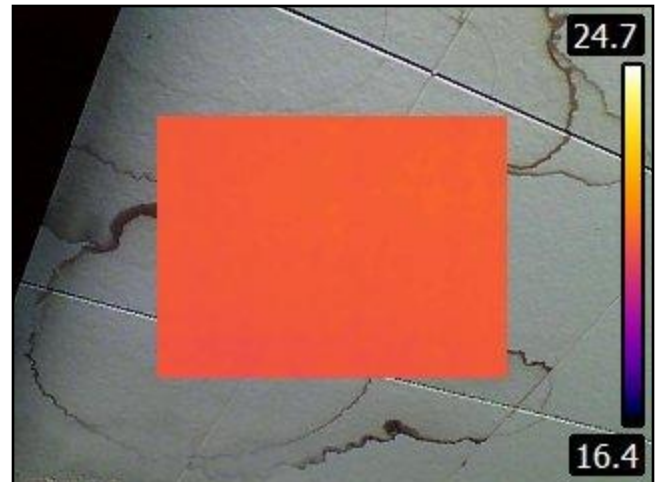
22. Vulnerable to ice damming

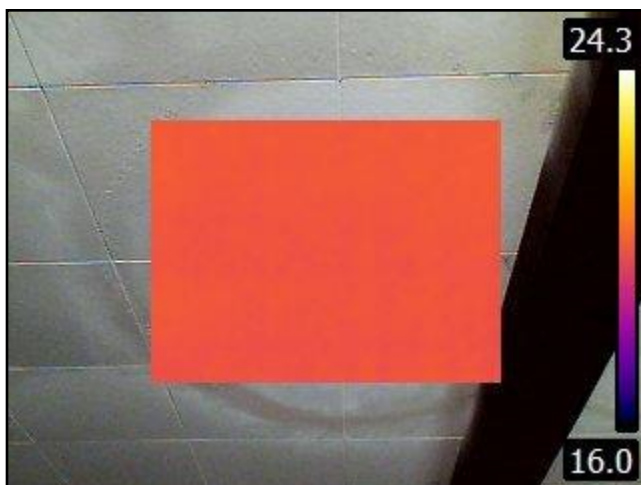
23. Vulnerable to ice damming

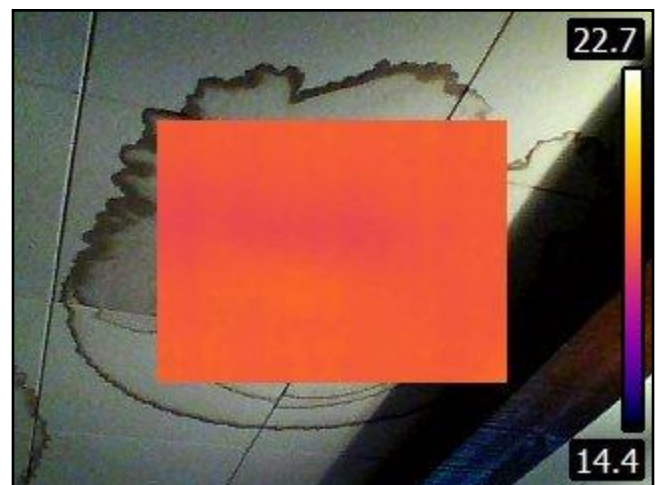
24. Vulnerable to ice damming

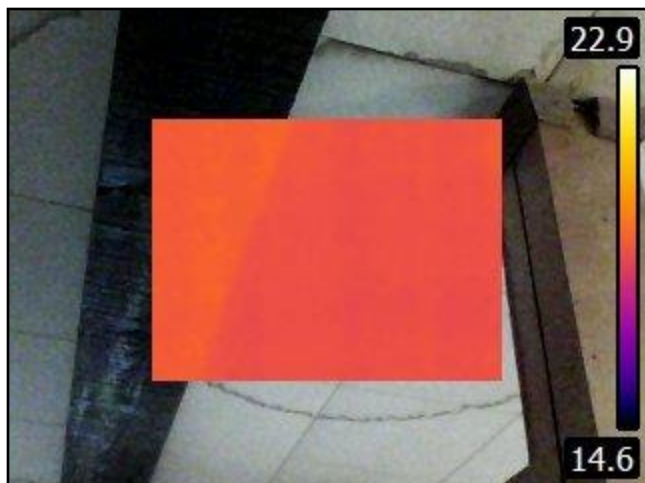
25. Vulnerable to ice damming

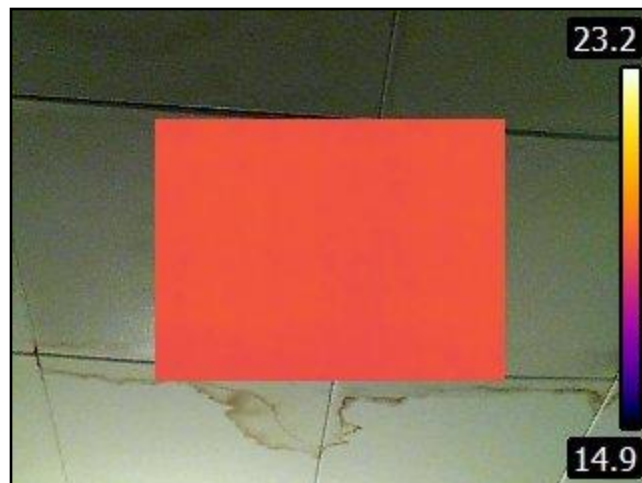
26. Vulnerable to ice damming

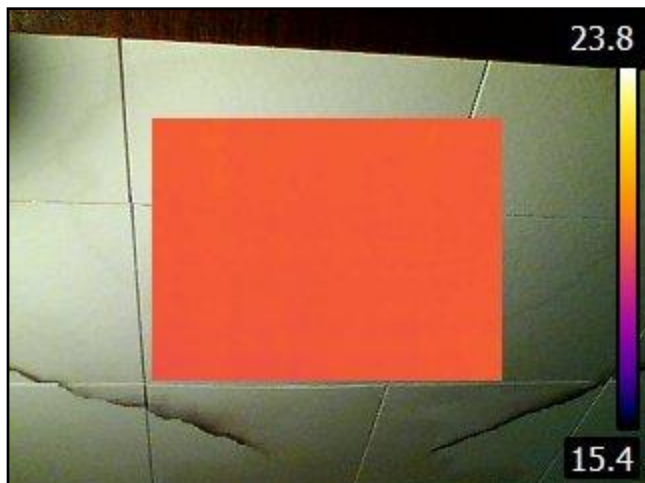
27. Vulnerable to ice damming

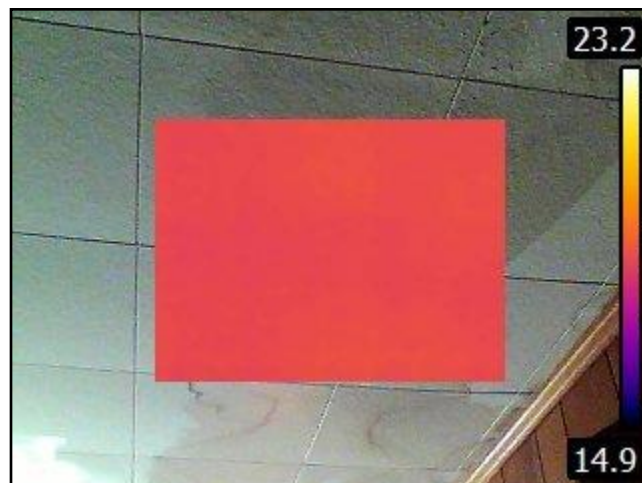
30. Vulnerable to ice damming

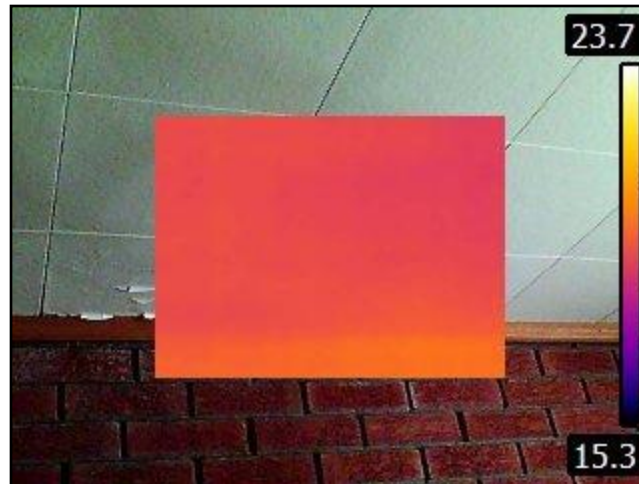
31. Vulnerable to ice damming

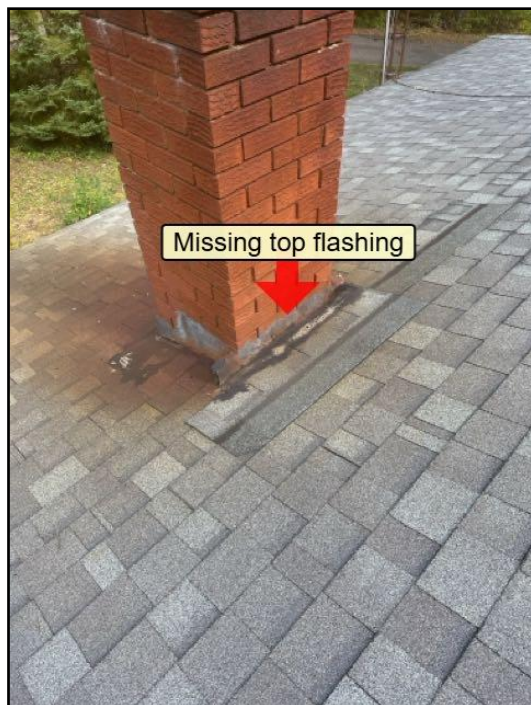
32. Vulnerable to ice damming

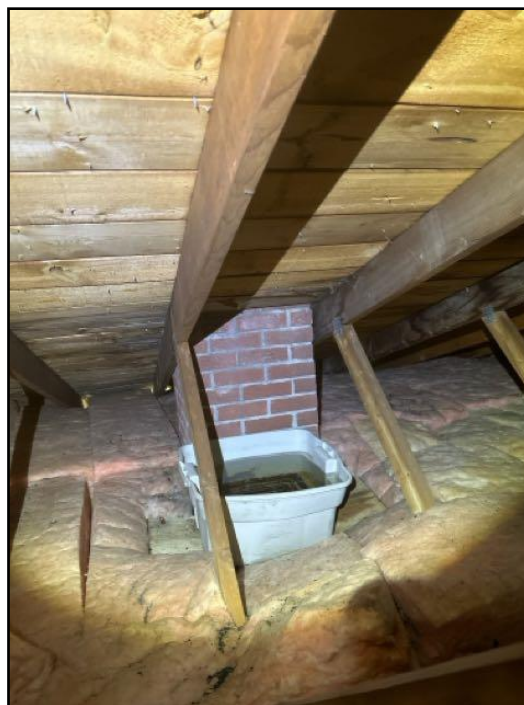
33. Vulnerable to ice damming

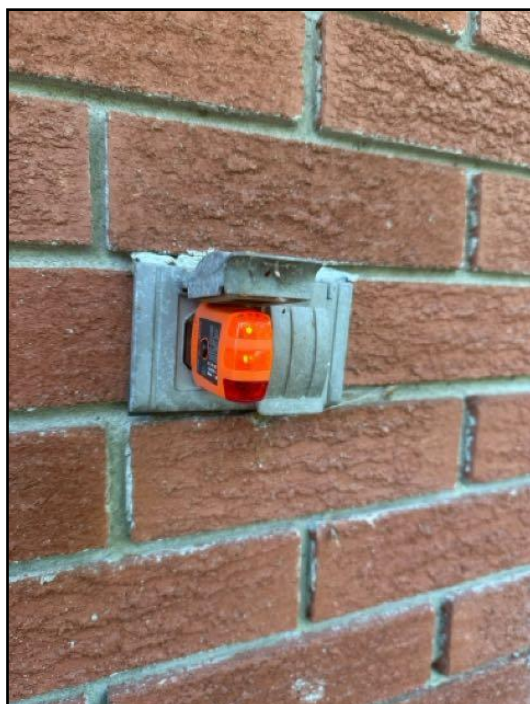
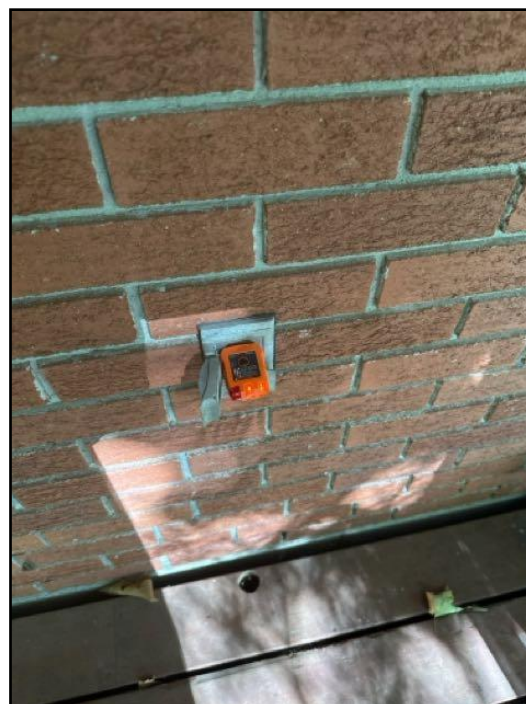
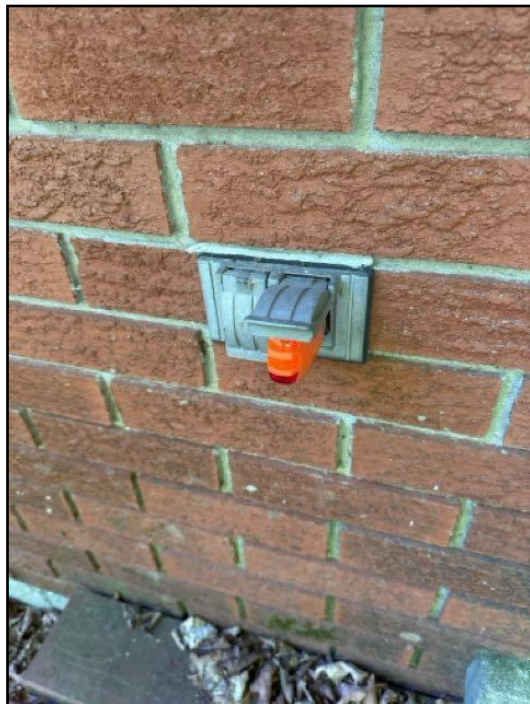
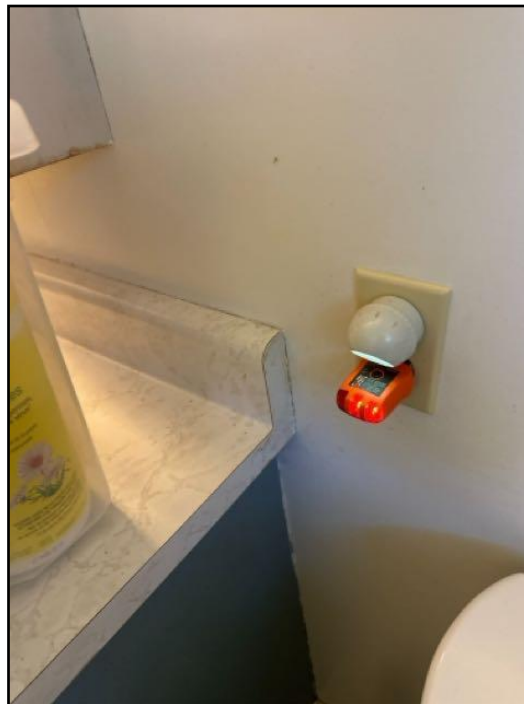
**14. Condition:** • GFCI/GFI needed (Ground Fault Circuit Interrupter)

GFI receptacles protect you from shock whenever water, moisture, or the weather is near a receptacle, recommend replacing receptacles with GFCI receptacles in the future. Kitchen outlet to the right of sink has a light switch, consider adding a GFI breaker to this circuit instead.

**Task:** Replace

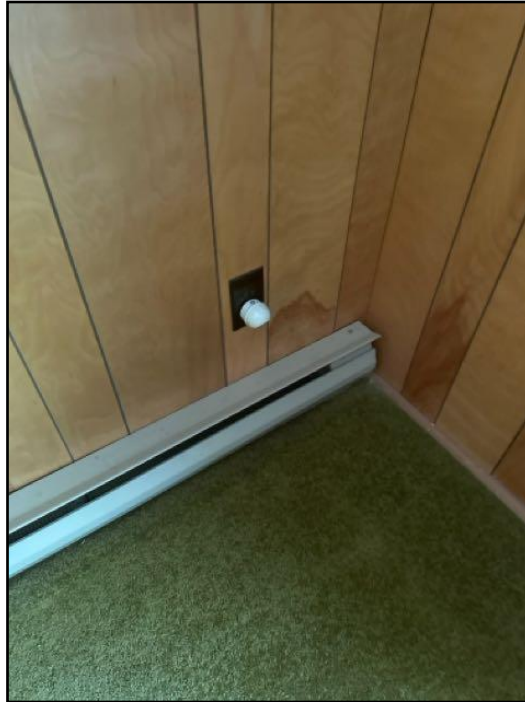
**116.** *Electrical receptacle above heater*

## 17. Condition: • Electrical receptacle above heater

Receptacles above the baseboards are fire hazards when in use. Recommend re-locating the receptacles/heaters when remodeling and avoid using receptacles when baseboards are in use. Recommend inserting plastic plugs as a reminder. Main floor Living room.

**Implication(s):** Fire hazard

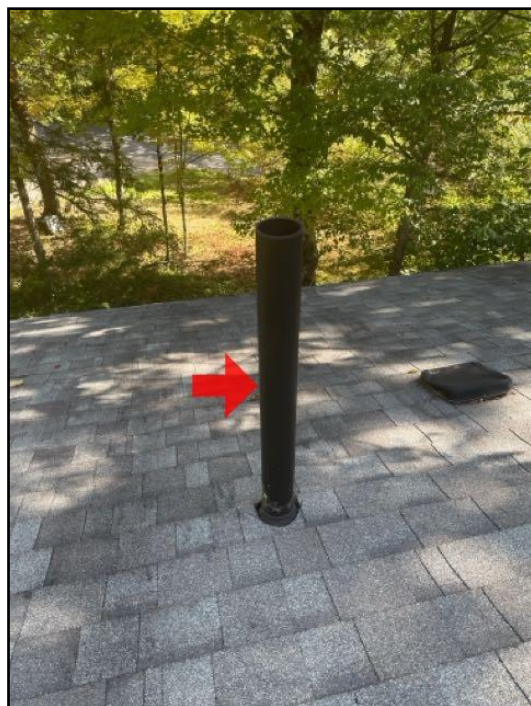
145. Vent termination problems

**24. Condition:** • Vent termination problems

Both waste vent pipe are too long and should terminate only 12" from exterior wall. When kitchen sink is used during the winter months we risk moist air freezing at the very tip and eventually clogging the pipe. When the pipe is clogged gargling sounds will be heard at the sink and possibly sewer gasses. Recommend drilling 4 holes in the pipe 12" above roof line. (1/8" holes)
