Your Inspection Report

123 Any Street
Any Town, TN 54321

INSPECTION DATE:
Friday, March 29, 2019

RE: Report No. 4601, v.5
123 Any Street
Any Town, TN
54321

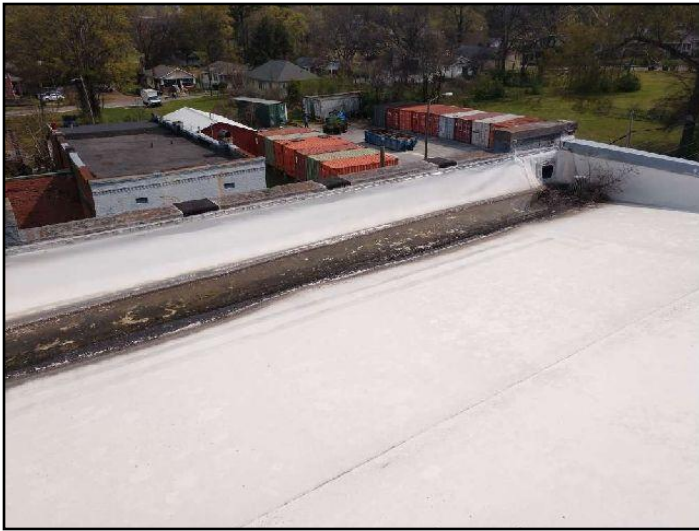
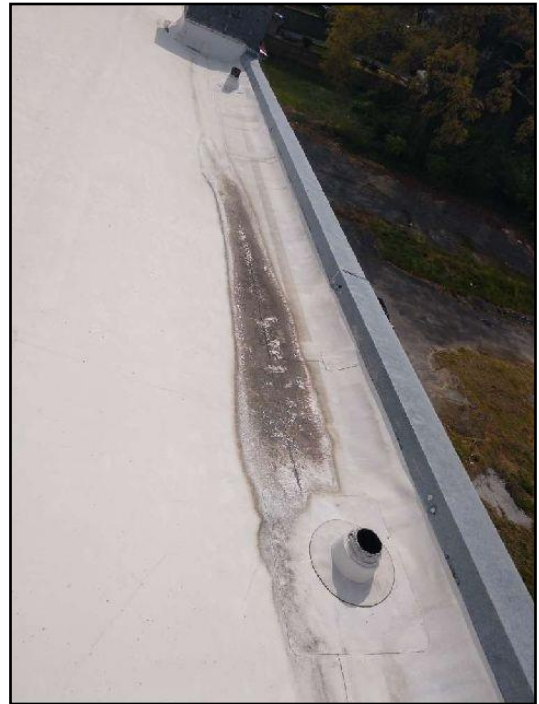
Condition: • [Ponding](#)

At the bottom of the pitch of the roof there were areas near all of the interior roof drains that had signs of ponding. This roof does not appear to be old and is well-installed with the exception of these areas. I recommend having the roofing company that installed this roof if they can be located modify these areas or the roof drains so water completely sheds.

Implication(s): Chance of water damage to structure, finishes and contents

1. Ponding

2. Ponding

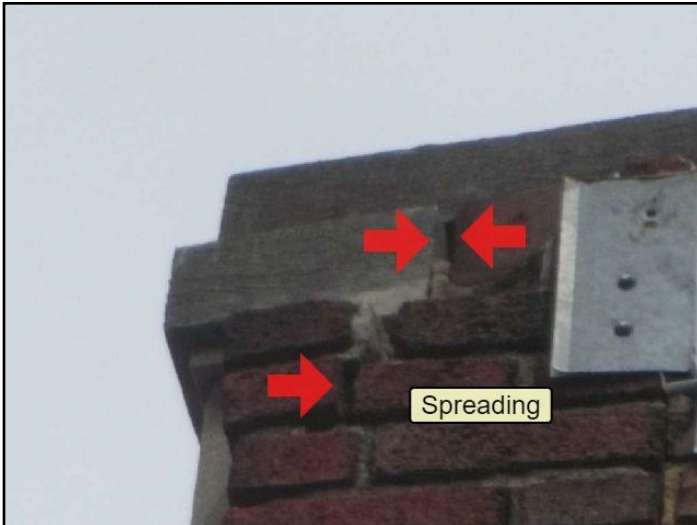
Condition: • [Masonry deterioration](#)

The front right top corner of the masonry needs repair to prevent further damage and possible injury if materials fell.

Implication(s): Weakened structure | Chance of structural movement

Location: Right Side Exterior

4. Masonry deterioration

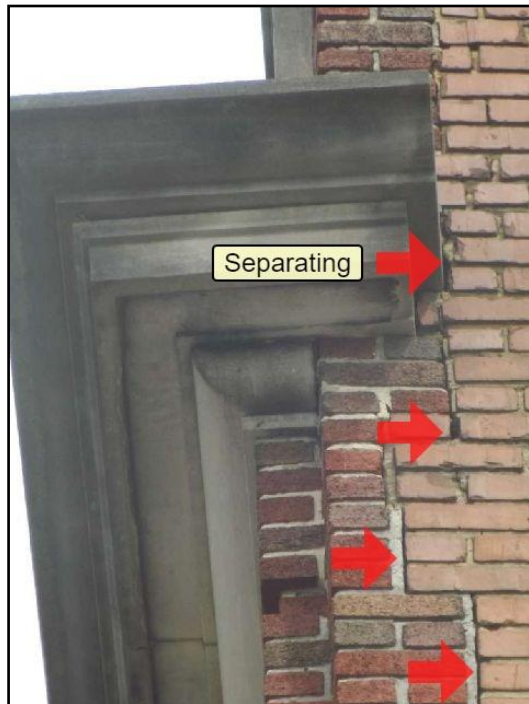
Condition: • [Masonry deterioration](#)

The concrete soffit above the third-floor windows below the front of the building seems to be sagging. The mortar supporting it and the bricks below it seemed to be deteriorating. If this were to fall that could be very damaging or cause injury or death. I highly recommend that a masonry specialist come in and perform maintenance on this part of the structure to prevent damage or injury.

6. Masonry deterioration

A masonry company that this inspector knows is experienced in repair of older masonry is Gentry Painter Masonry (G&P Masonry) They are located at 2901 S. Orchard Knob Ave., Chattanooga 37407 and their number is 423-624-9953. (This inspector is a certified masonry inspector and has dealt direct with (overseen) this company in the past)

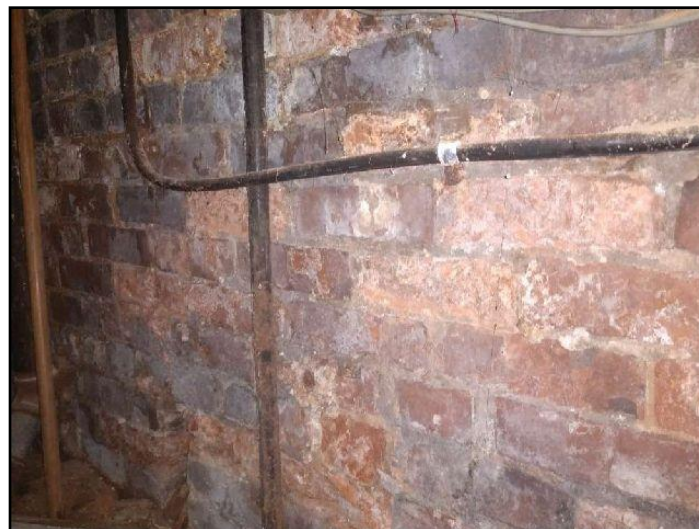
Condition: • [Spalling](#)

Spalling is a common characteristic for masonry. It is non structural and cosmetic. Sealing the material could cause more damage than it can help so I do not suggest it be sealed

8. Spalling

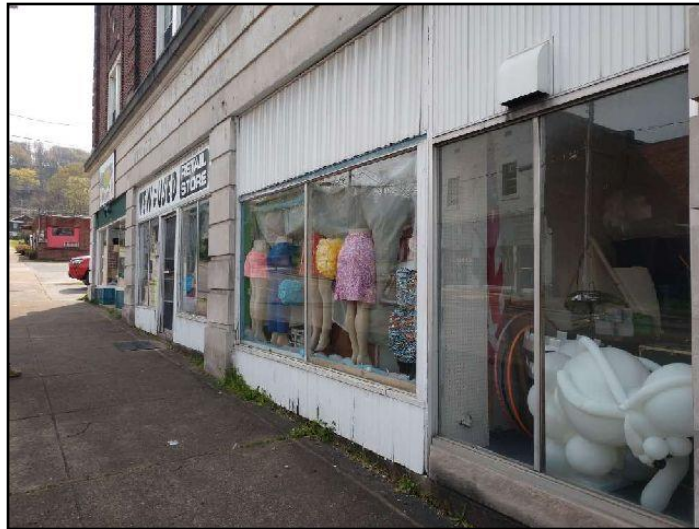
9. Safety glass not installed

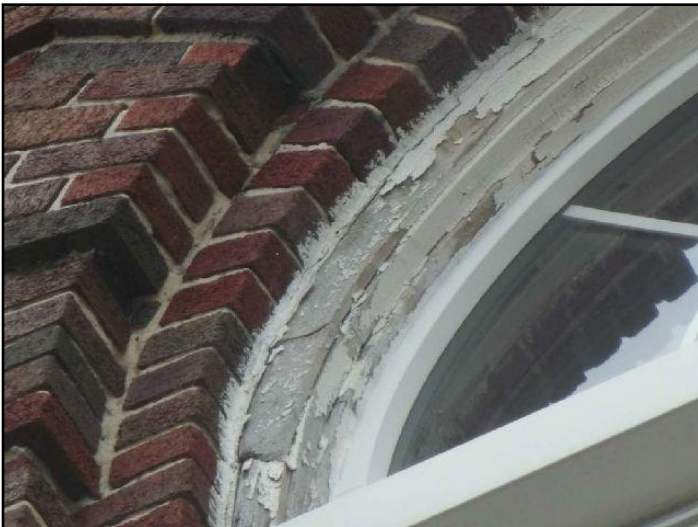
Implication(s): Chance of water damage to structure, finishes and contents | Material deterioration

Location: Front Third Floor

10. Paint or stain needed

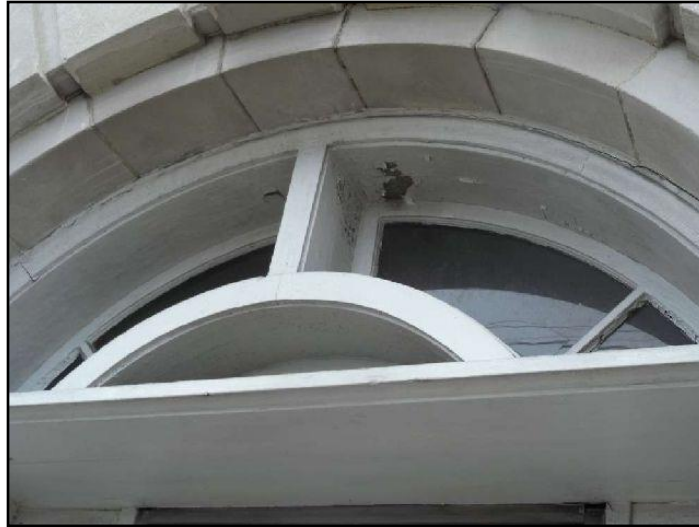
12. *Paint or stain needed*

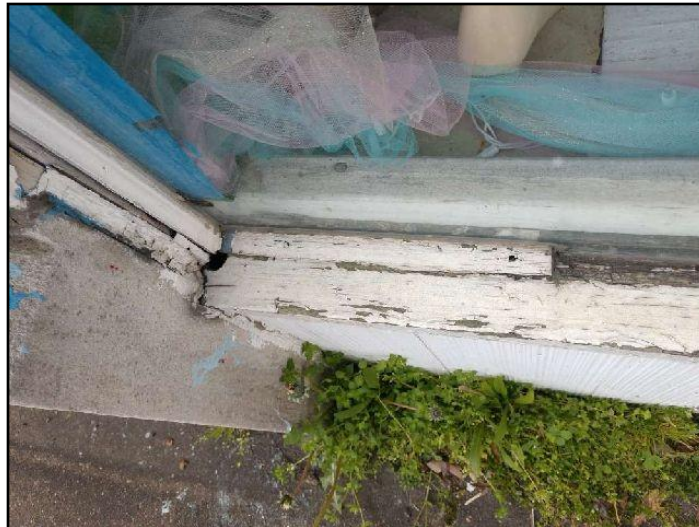
Condition: • [Paint or stain needed](#)

Implication(s): Chance of water damage to structure, finishes and contents | Material deterioration

Location: Trim around fixed glass retail shop windows

13. *Paint or stain needed*

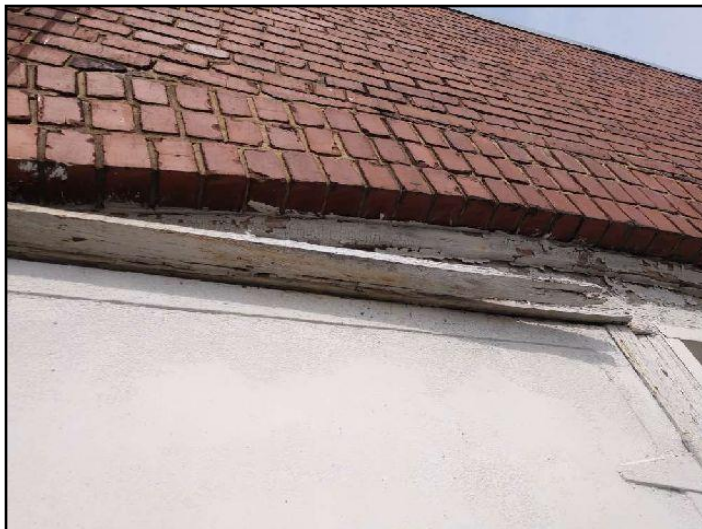
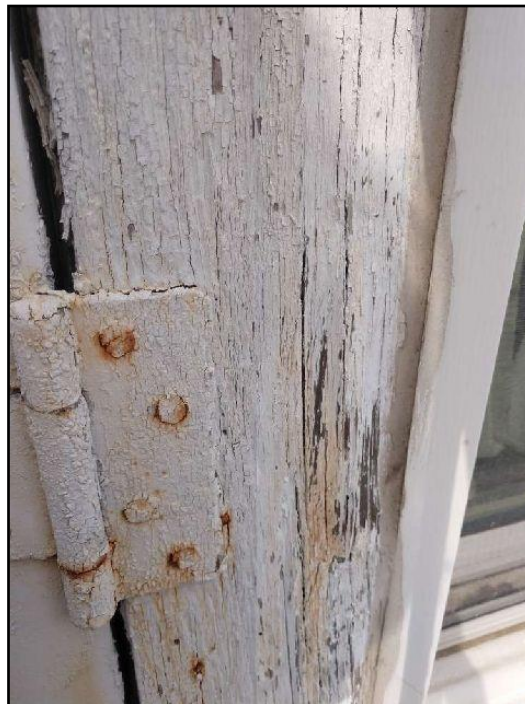
14. Rot

15. Rot

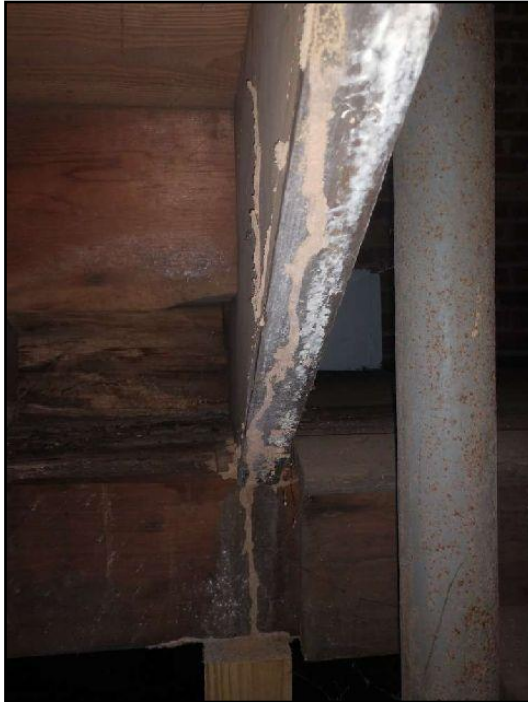
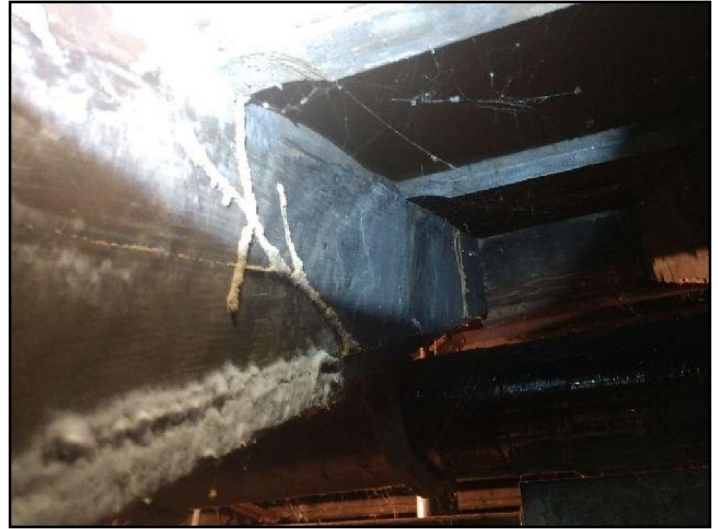
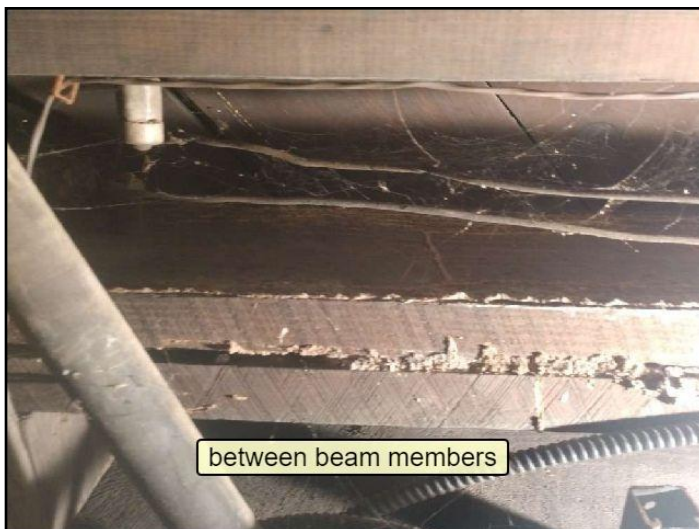
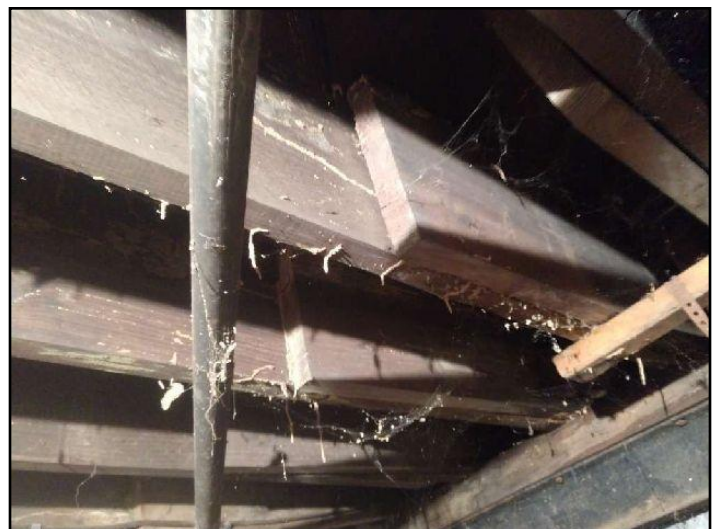
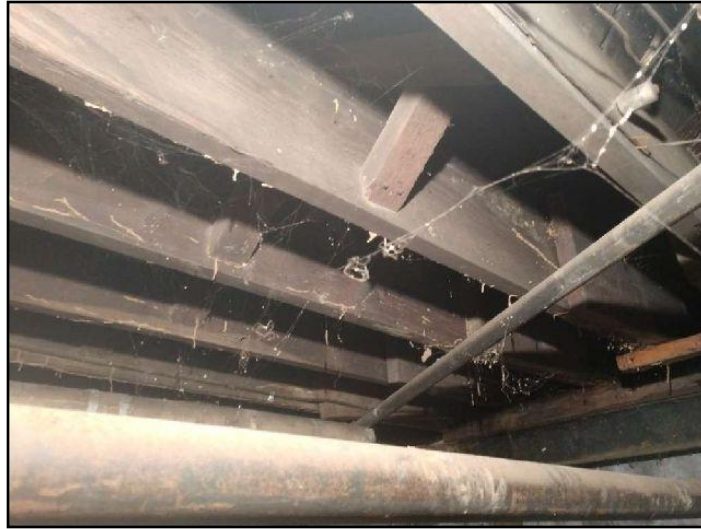
16. Signs of infestation in wood. (Past or...

17. Signs of infestation in wood. (Past or...

18. Signs of infestation in wood. (Past or...

19. Signs of infestation in wood. (Past or...

20. Signs of infestation in wood. (Past or...

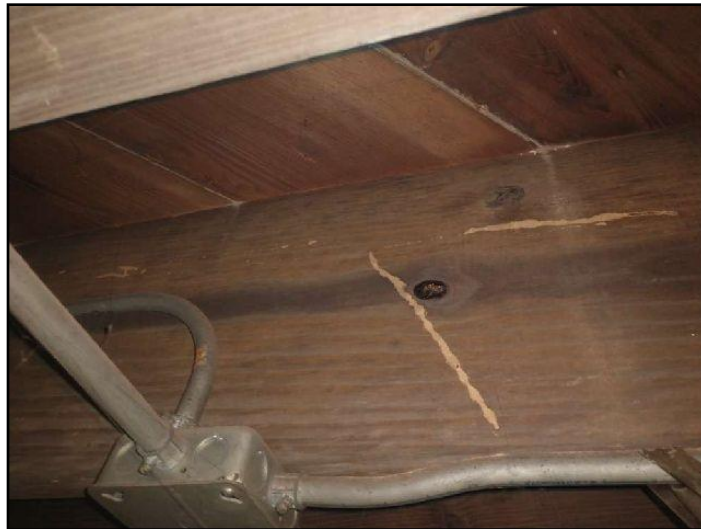
Condition: • Signs of infestation in wood. (Past or present)

Location: Center front Basement

21. Signs of infestation in wood. (Past or...

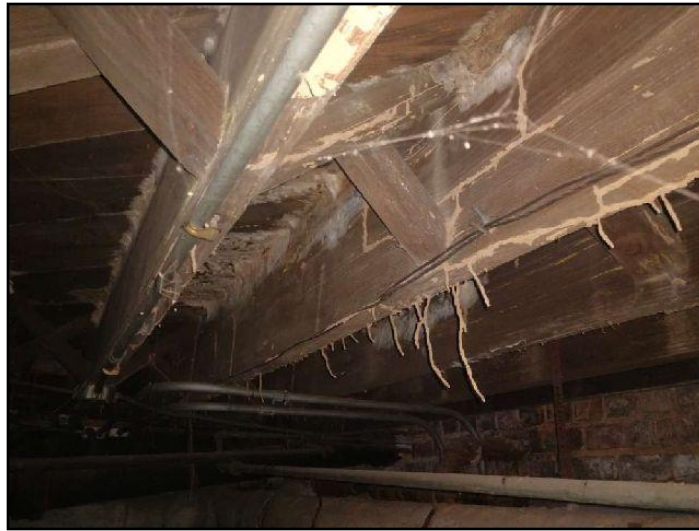
Condition: • Signs of infestation in wood. (Past or present)

22. Signs of infestation in wood. (Past or...

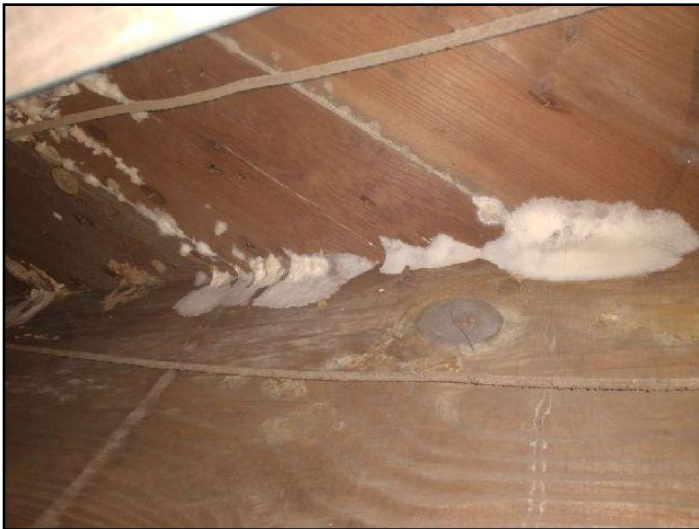
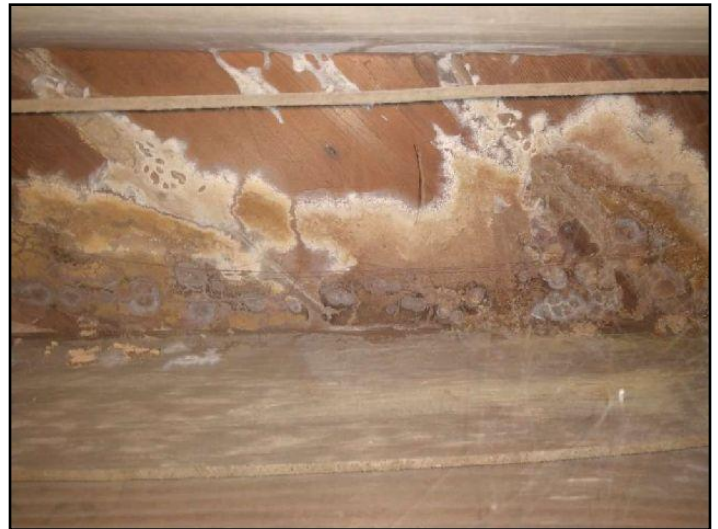
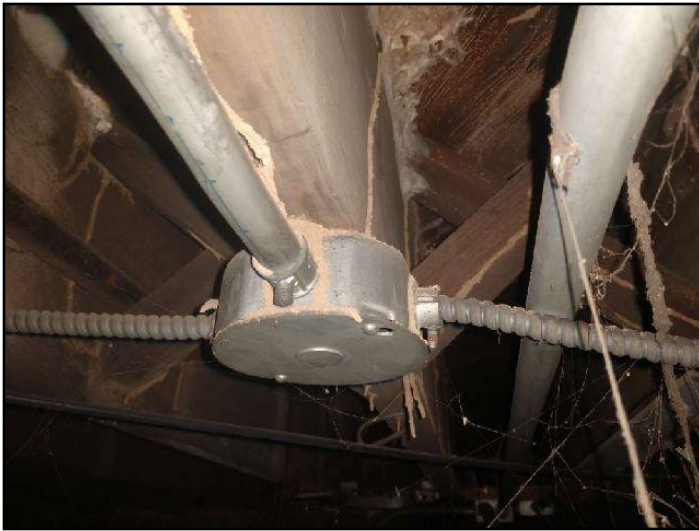
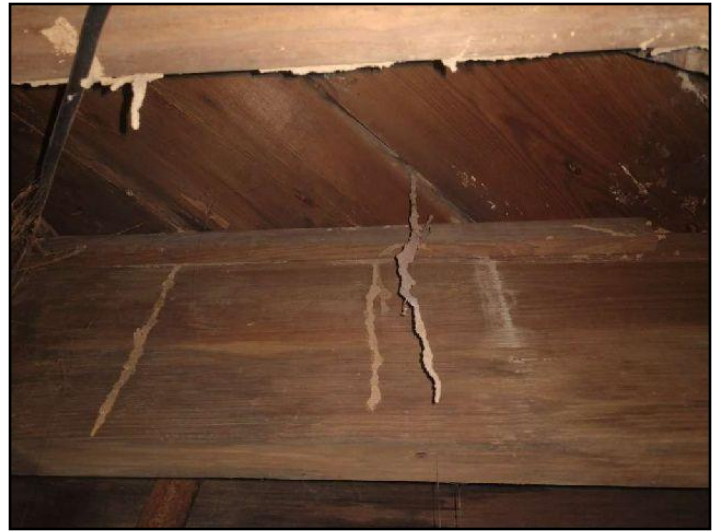
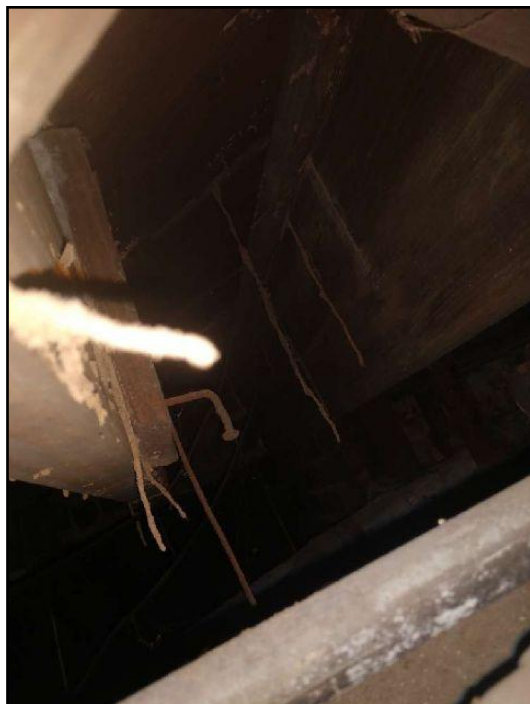
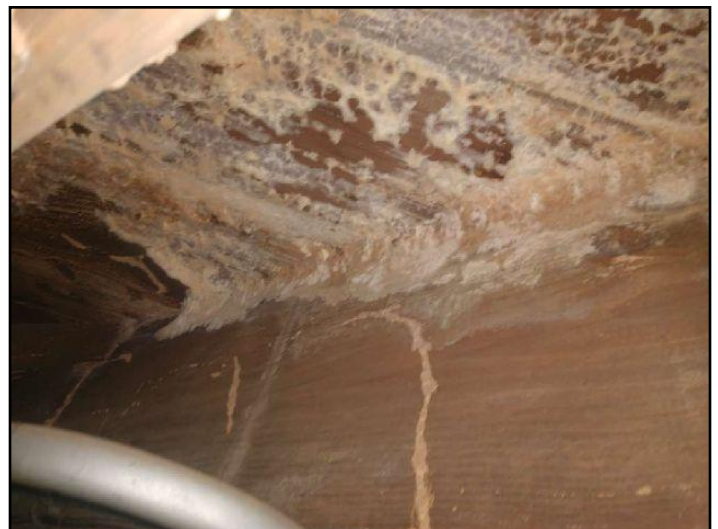
Condition: • Suspected Fungal growth on framing. Organic growth on wood framing is one of the most destructive conditions that can exist in a home built on a crawlspace. Elevated moisture, inadequate air flow, debris, insulation, duct leaks, dryers discharging under the floor, etc. can all quickly and catastrophically effect the structural integrity of the home. If any of these conditions exist, I recommend having a exterminator or indoor air quality expert further evaluate to see extent of conditions. I also recommend an invasive inspection of all framing where the insulation is removed and/or looked under throughout to evaluate the extent of the growth and damage. I DO NOT recommend insulation in a crawlspace that is tight and/or has a high water table or moisture level.

Location: Center Basement

23. Suspected Fungal growth on framing. Organic...

24. Suspected Fungal growth on framing. Organic...

25. Suspected Fungal growth on framing. Organic...

26. Suspected Fungal growth on framing. Organic...

27. Suspected Fungal growth on framing. Organic...

28. Suspected Fungal growth on framing. Organic...

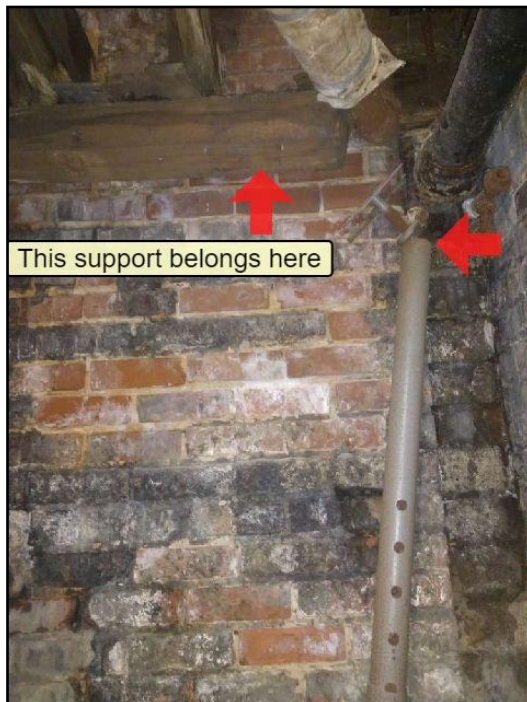
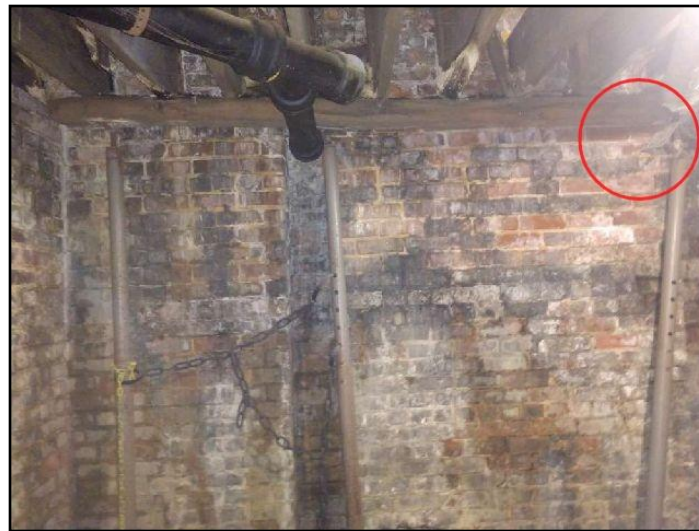
Condition: • [Missing](#)

Implication(s): Chance of structural movement

Location: Basement

30. Missing

32. Missing

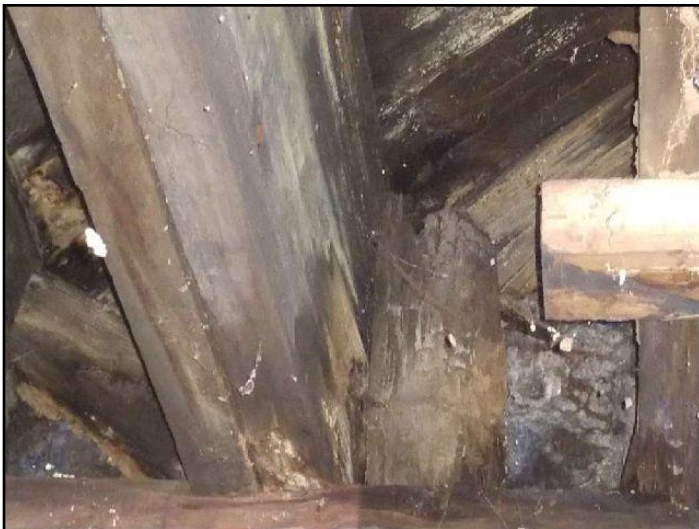
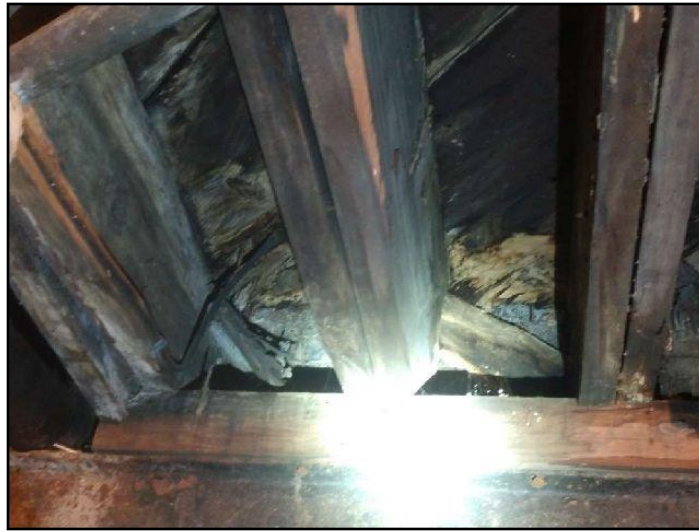
Condition: • [Rot or insect damage](#)

Implication(s): Weakened structure

33. Rot or insect damage

35. Rot or insect damage

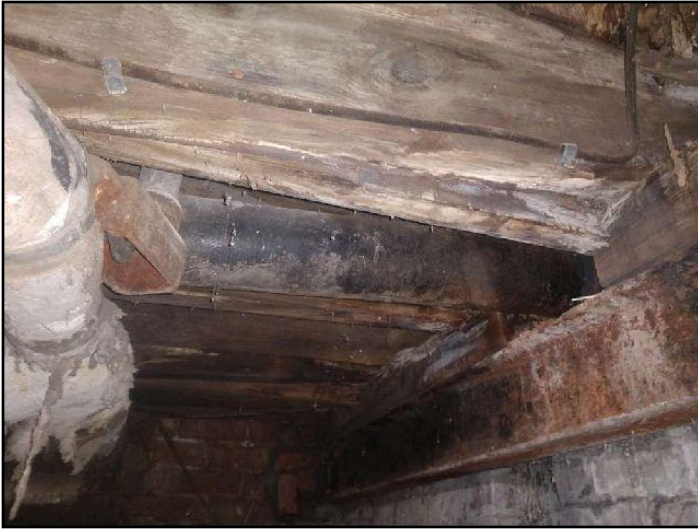
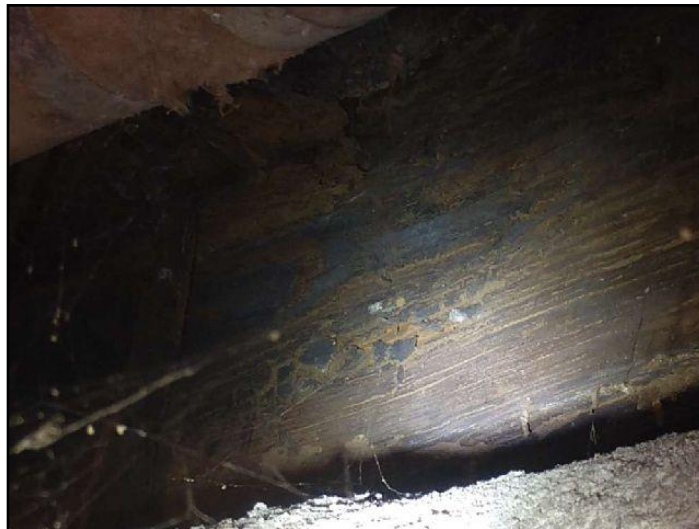
Implication(s): Weakened structure

Location: Basement

36. Rot, insect or fire damage

38. Rot, insect or fire damage

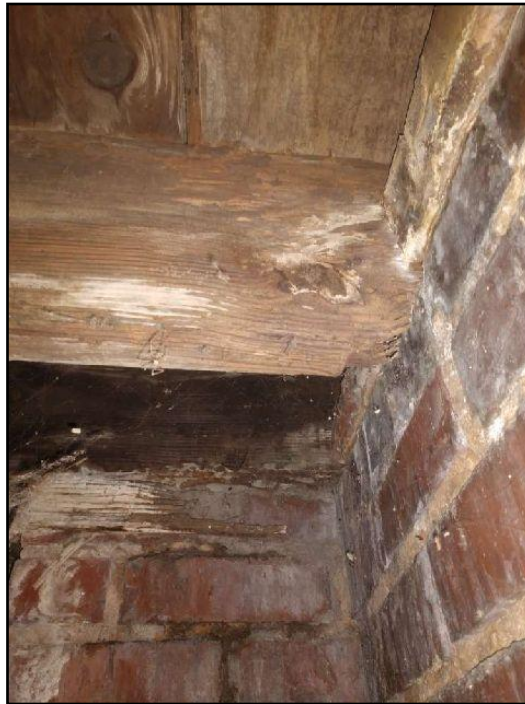
Condition: • [Rot, insect or fire damage](#)

39. Rot, insect or fire damage

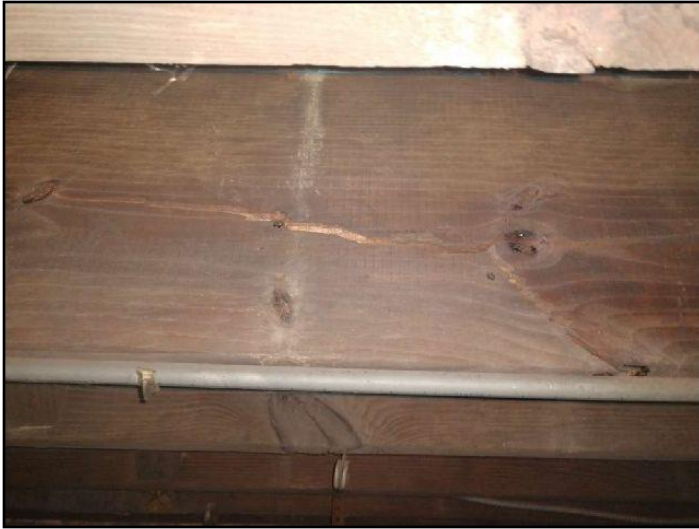
41. Split or damaged

Condition: • [Split or damaged](#)

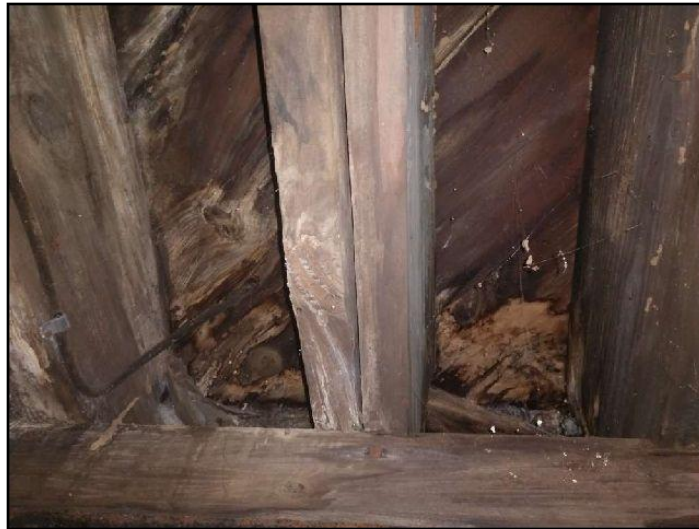
44. Rot

Condition: • Rot

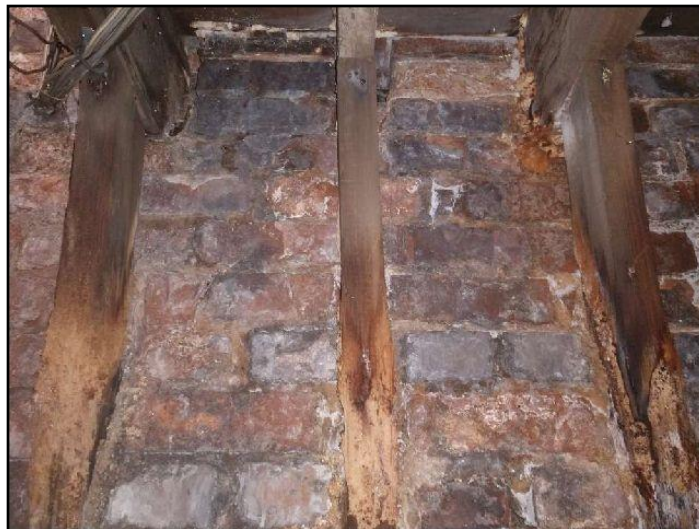
45. Masonry walls are weeping

Condition: • Masonry walls are weeping

Location: South Basement wall

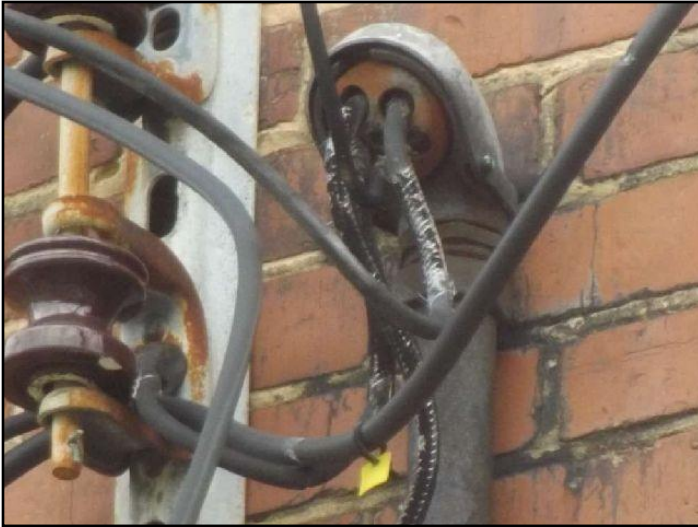
46. Insulation missing or damaged

Condition: • [Insulation missing or damaged](#)

Implication(s): Fire hazard

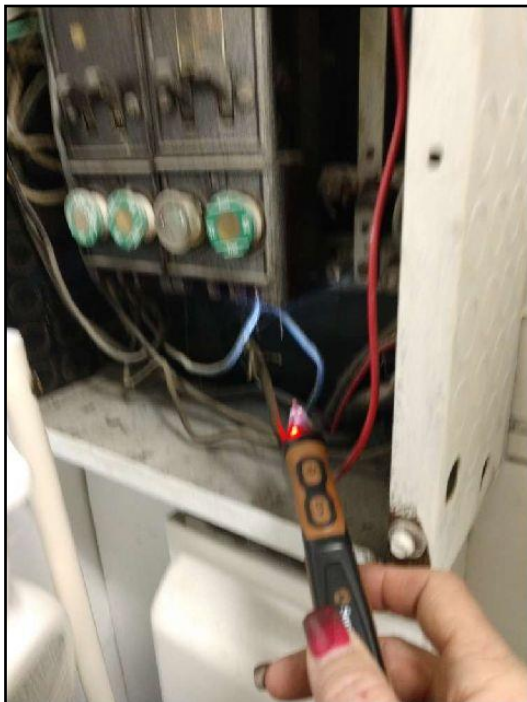
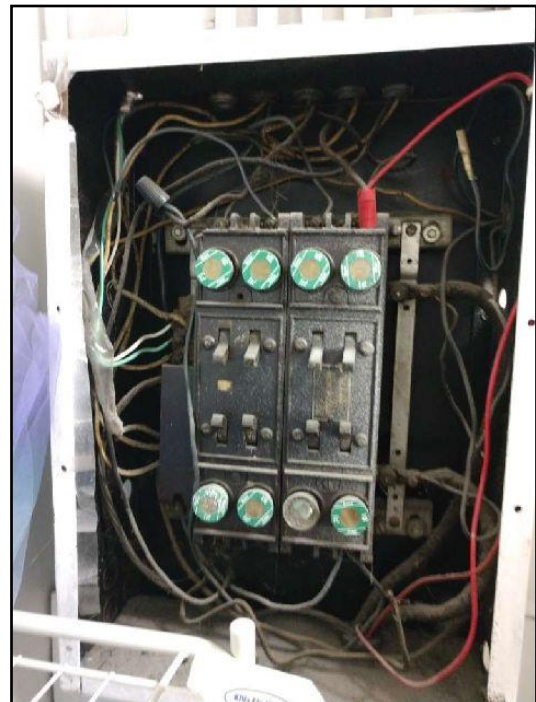
48. Abandoned wires in panel

Condition: • [Abandoned wires in panel](#)

There is a fuse and breaker box in the back of the century retail space that is missing the cover and has abandoned wires that are electrified that are accessible. I highly recommend this be further evaluated by a licensed electrician

Implication(s): Electric shock

Location: Center First Floor

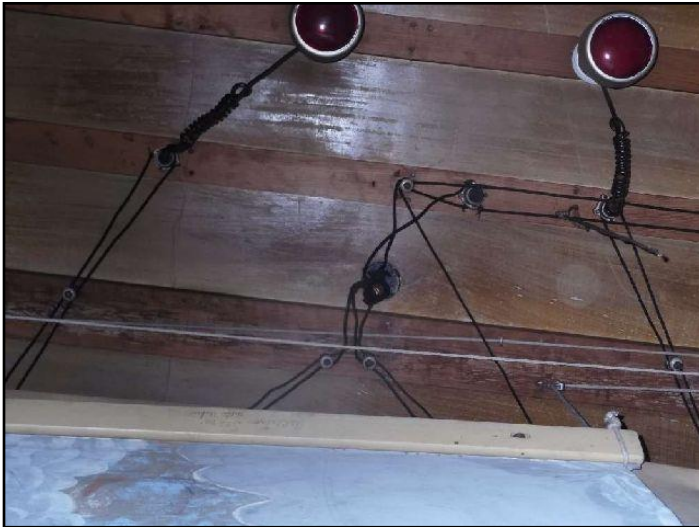
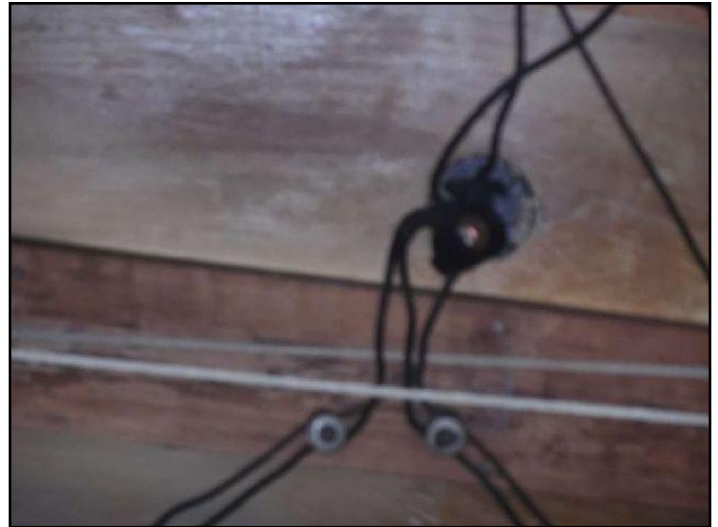
50. Outdated

Condition: • [Outdated](#)

Implication(s): Nuisance | Potential problem when obtaining home insurance

Location: Basement and stage area and closets of third floor

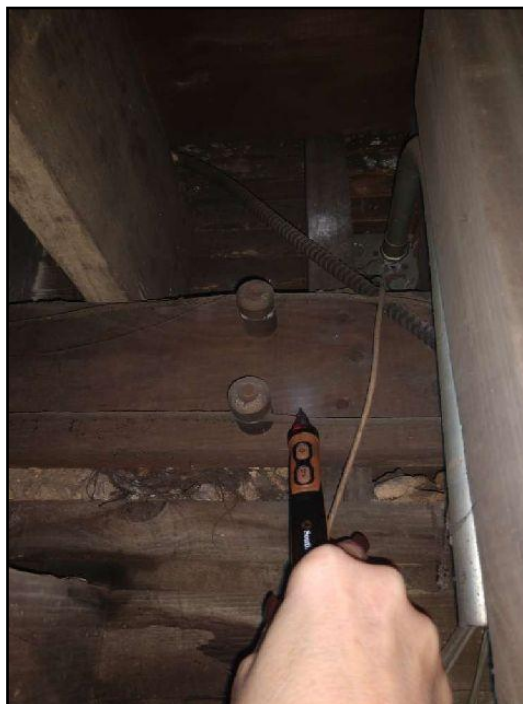
52.

Condition: • Active knob and tube located in basement

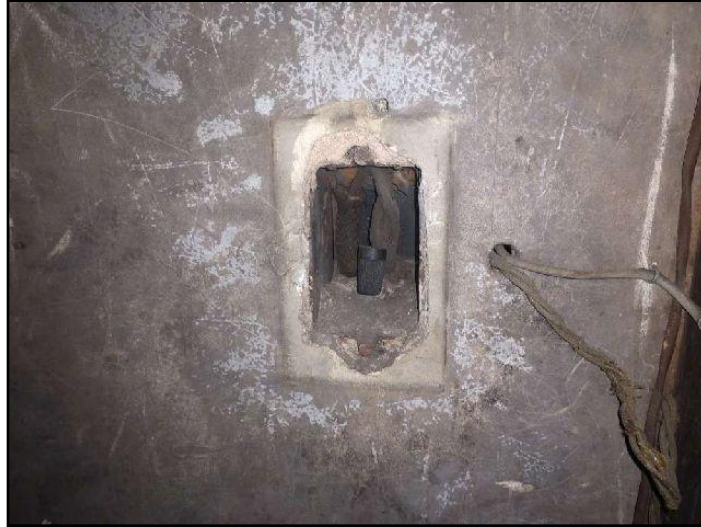
53. Cover loose or missing

Condition: • [Cover loose or missing](#)

Implication(s): Electric shock | Fire hazard

Location: First Floor Staircase

Task: Provide

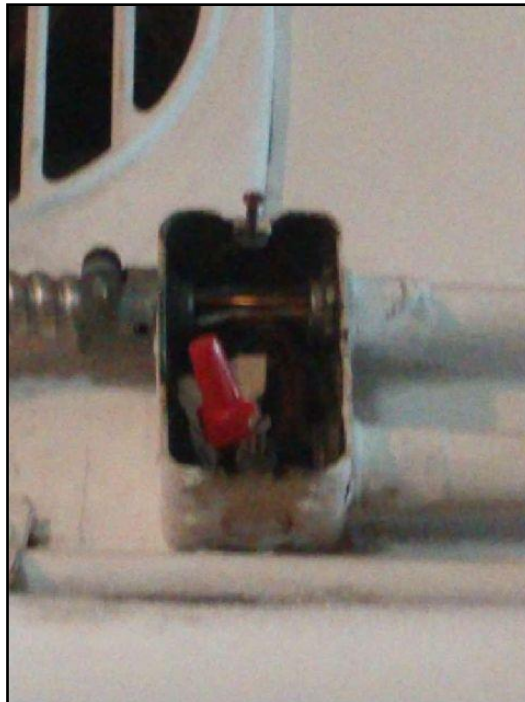
54. Cover loose or missing

Condition: • [Cover loose or missing](#)

Implication(s): Electric shock | Fire hazard

Location: Second Floor

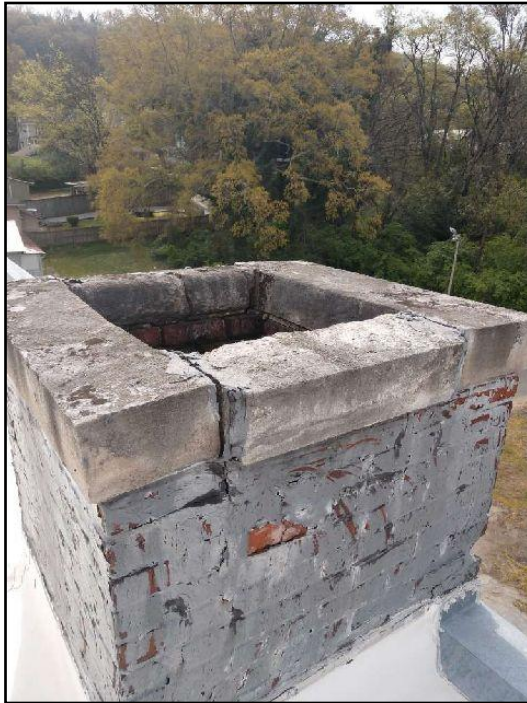
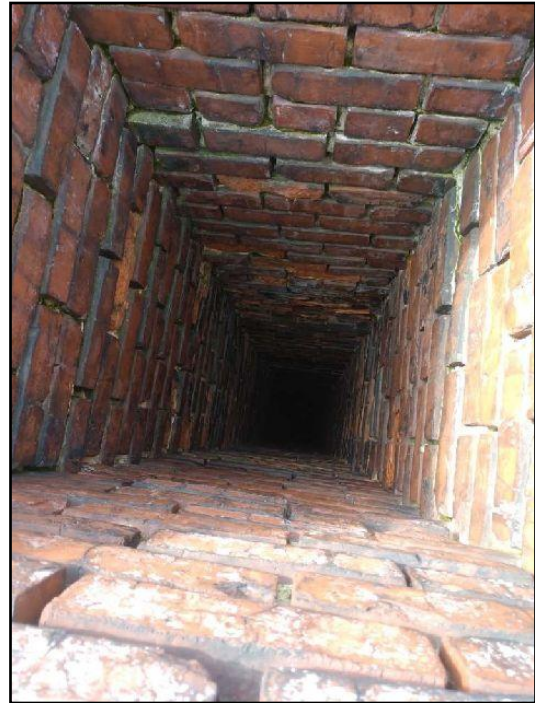
Condition: • There is an old chimney still present that appears to go all the way to the basement that has nothing covering the top. Some of the masonry around the top is loose and failing. I recommend just to prevent damage to the roof that this be secured and covered. This could help with some of the water issues in the basement

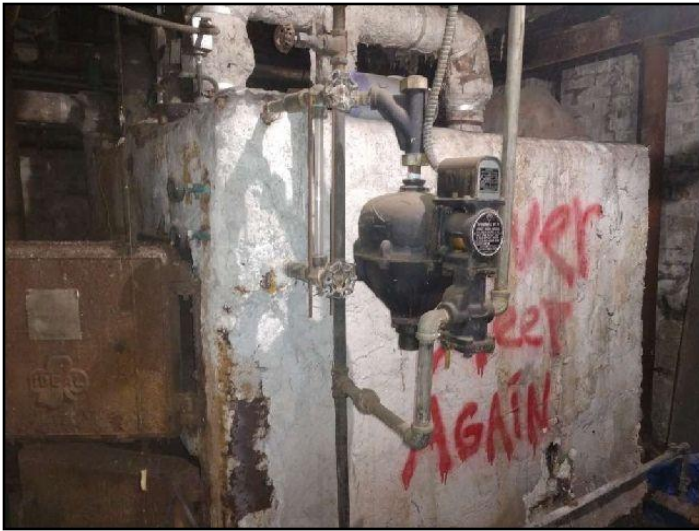
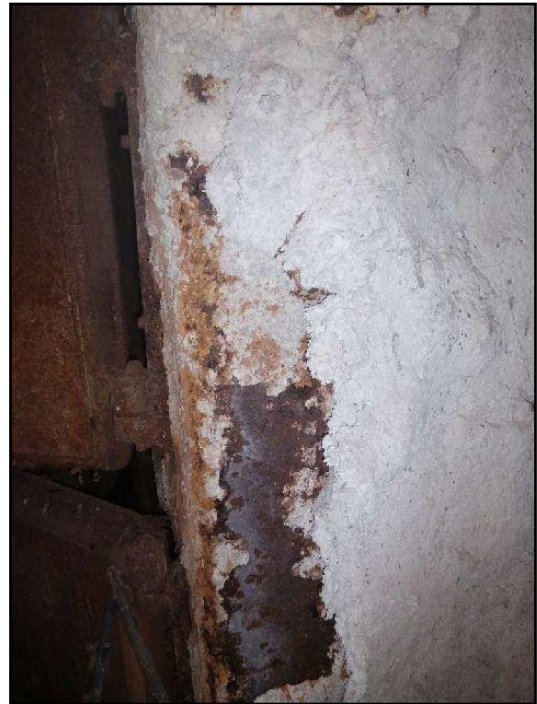
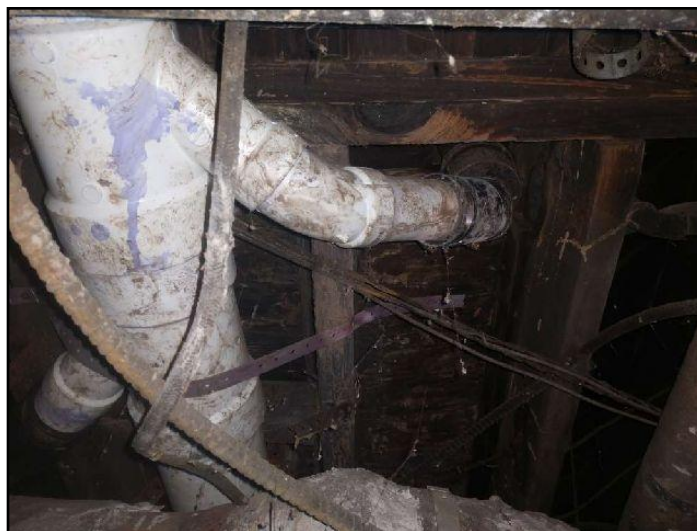
Condition: • There is what appears to be an old boiler in the basement that has got suspected asbestos coating on the boiler and the piping. The asbestos is not in a solid state. there is also significant water intrusion causing rust in the unit which will cause it to deteriorate and rust out from under the asbestos which could cause a larger risk. I recommend that the proper authority be brought in to evaluate the options for dealing with this equipment. The framing above this boiler is in extremely poor condition for to rot and infestation and will need to be accessed. Don't do without dealing with the asbestos on the boiler could be harmful.

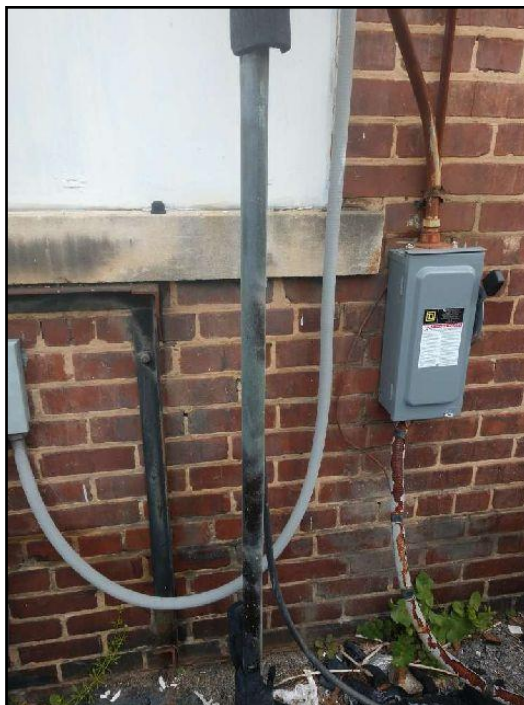
60. Insulation - missing

Condition: • [Insulation - missing](#)

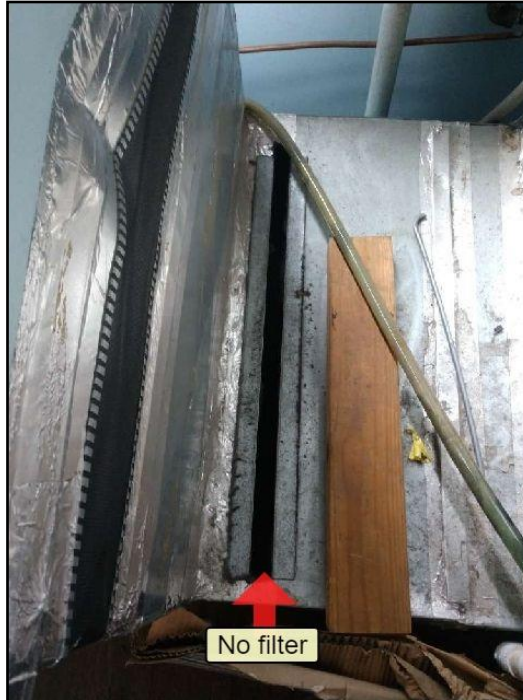
61. Missing return filter

Condition: • Missing return filter

Location: First Floor

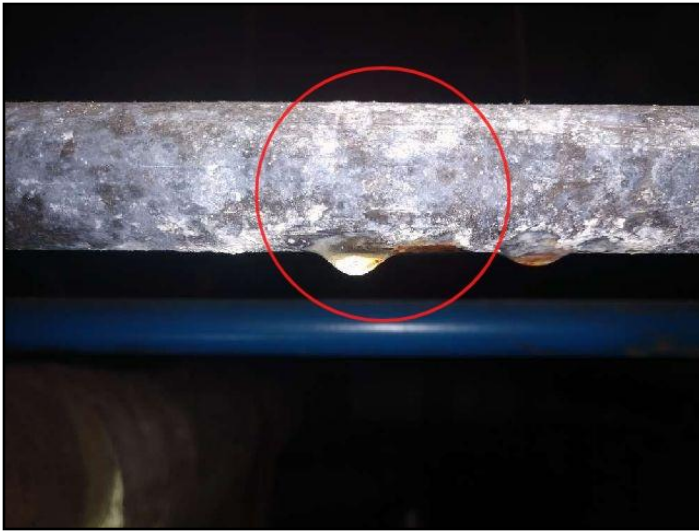
62. Leak

Condition: • [Leak](#)

Implication(s): Chance of water damage to structure, finishes and contents | Damage to equipment

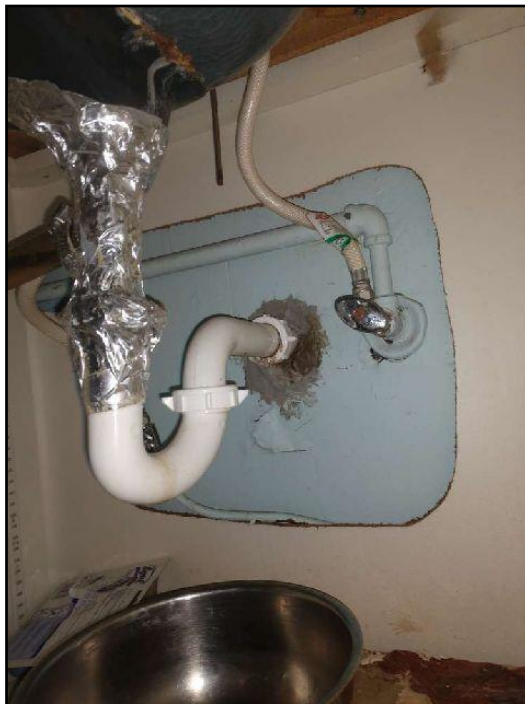
64. *Drip, leak*

Condition: • [Drip, leak](#)

the water was turned off to the laboratory at the time of the inspection. When the inspector started turn it on she made Italy figure it out it was because of a severe leak in the supplies and there also appears to be a leak in the drain system.

Implication(s): Chance of water damage to structure, finishes and contents

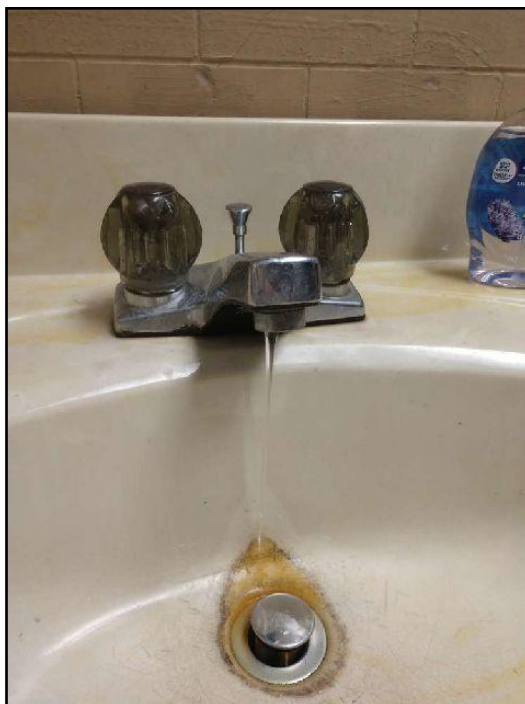
65. *Flow lower than balance of home*

Condition: • Flow lower than balance of home

The hot water flow is less than expected. the hot water valve was turned off at the time of the inspection. The inspector turned it on to test and turned it back off

Location: Second Floor men's restroom Mount lavatory sink

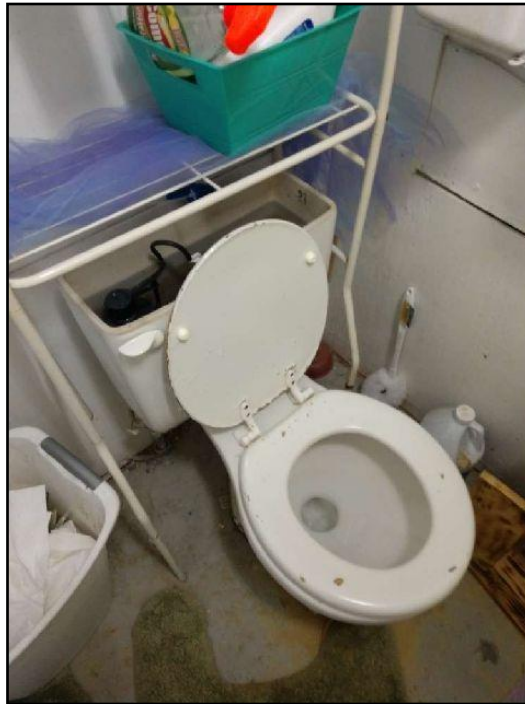
66. Loose

Condition: • [Loose](#)

Implication(s): Chance of water damage to structure, finishes and contents | Sewage entering the building | Possible hidden damage

Location: First Floor middle space

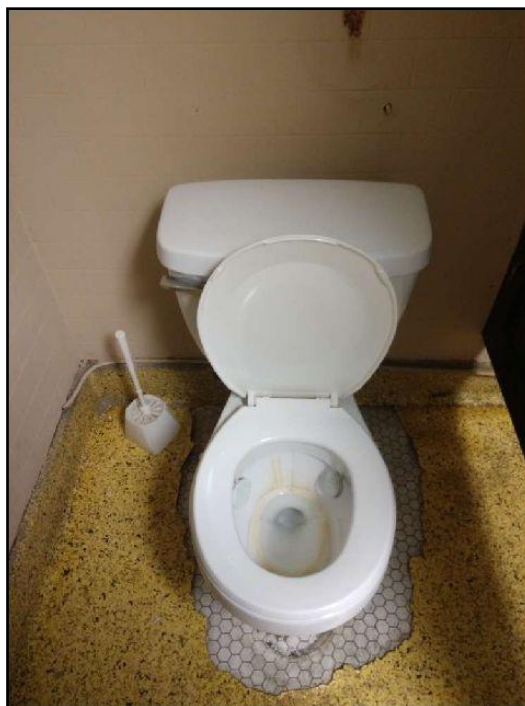
67. Toilet loose at floor - Note: This inspecto...

Condition: • Toilet loose at floor - Note: This inspector gently pushes on the toilet both left and right and lifts the front of the toilet using her knee. The toilet should not move at all when this is done. If the toilet is loose, it is a good idea to always have the toilet removed so the area below, including the plumbing and subfloor, can be checked for leaks/damage. A new wax ring needs to be installed whenever a toilet is unbolted/moved.
