Your Inspection Report

123 Any Street
Any Town, TN 54321

INSPECTION DATE:
Friday, March 29, 2019

RE: Report No. 4601, v.5
123 Any Street
Any Town, TN
54321

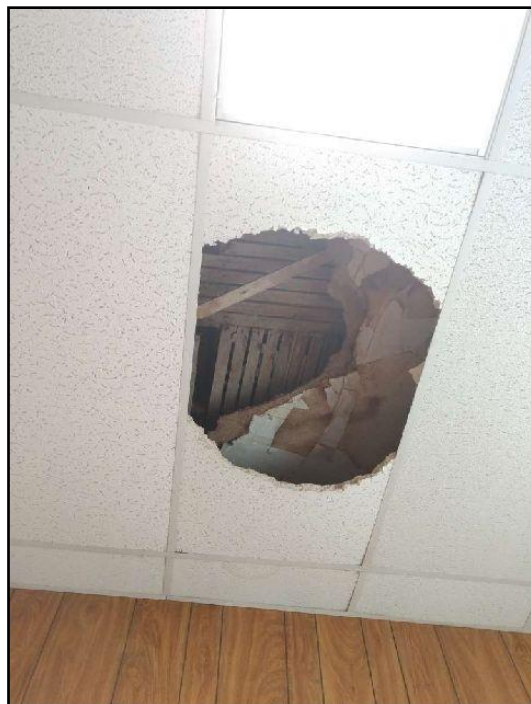
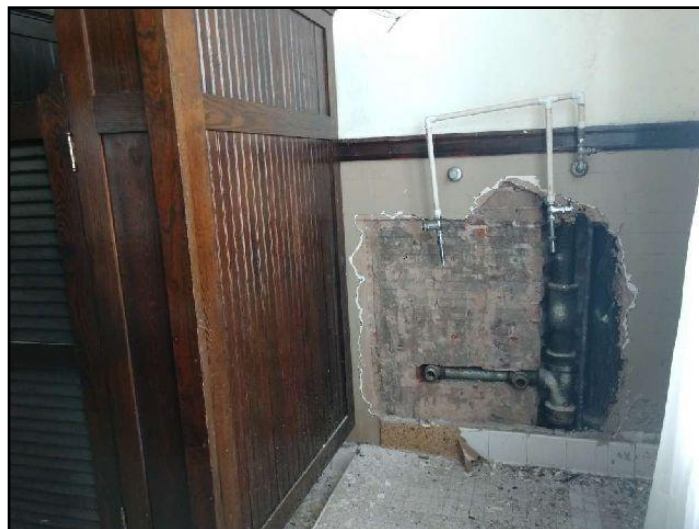
Condition: • [Water damage](#)

damaged tile on the suspended ceiling in the office is underneath a bathroom that the sellers representative stated had a prior leak. The water to the restroom was turned off and never repaired to the buyer's representative knowledge.

Implication(s): Chance of movement | Rot | Leakage

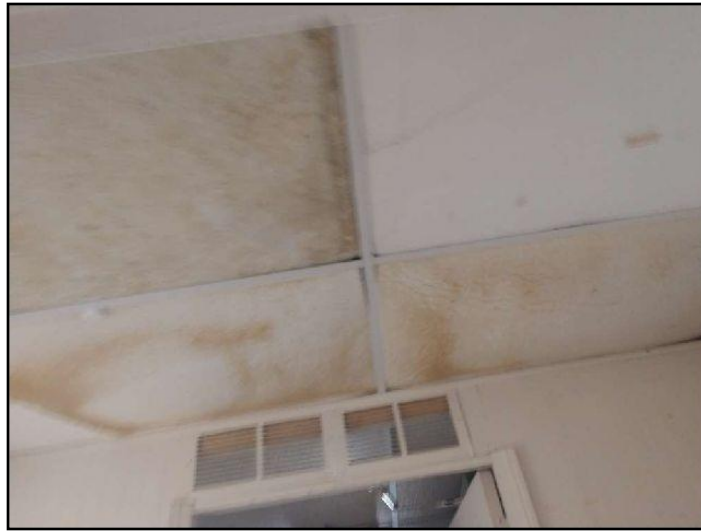
73. Water damage

Condition: • [Water damage](#)

Sales representative stated that they damage to the suspended ceiling in the first floor front suite is from where the bathroom upstairs leaked at one point. No active moisture was found when examined using infrared thermography

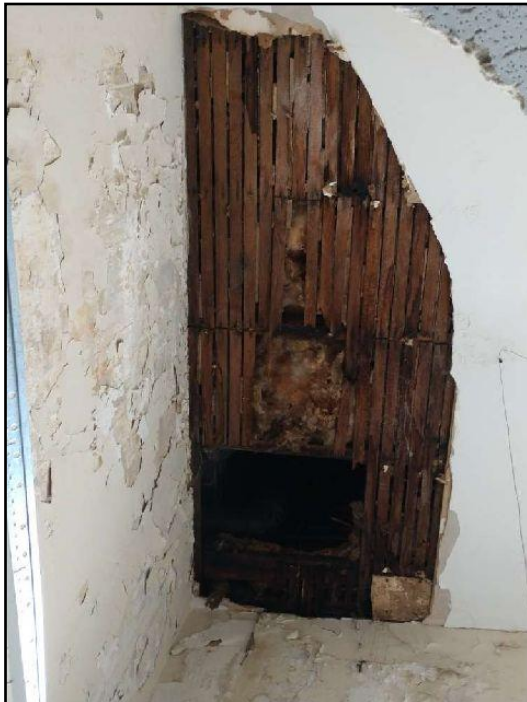
74. Damaged

Condition: • Damaged

Location: Various Third Floor

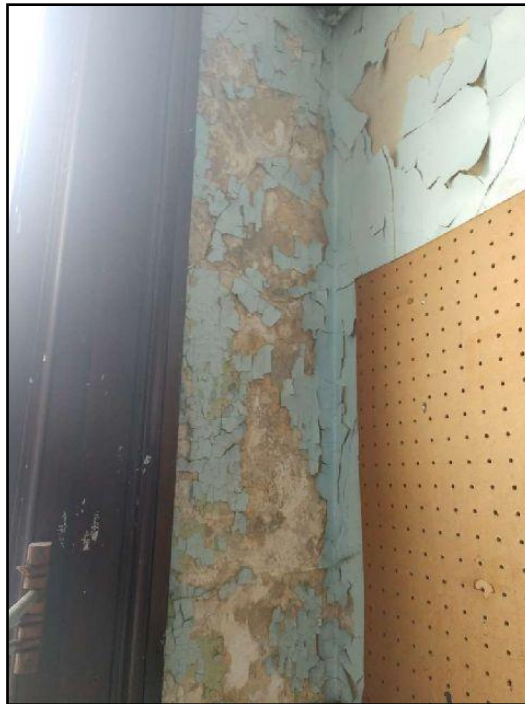
77.

Condition: • Suspected lead paint in kitchen flaking. I recommend scraping all loose and sealing with new latex paint

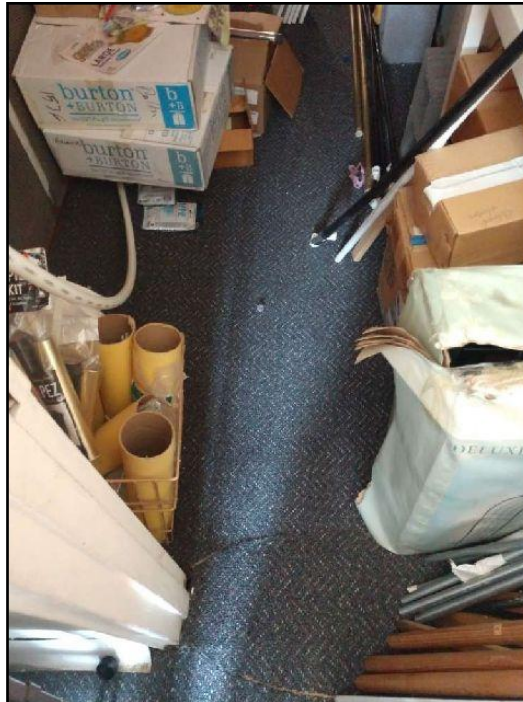
78.

Condition: • the floor under the carpet and the back area of the front retail sweet is extremely soft underneath the carpeting as if the subfloor is damaged.

Location: Front First Floor

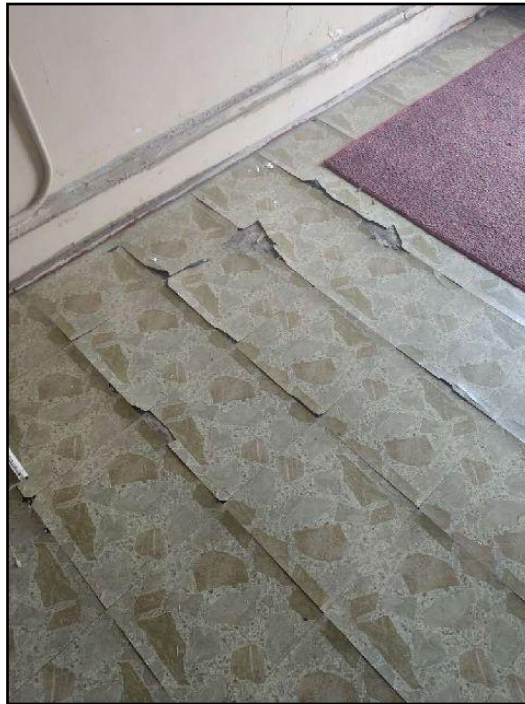
79. Damage

Condition: • [Damage](#)

Implication(s): Material deterioration | Trip or fall hazard

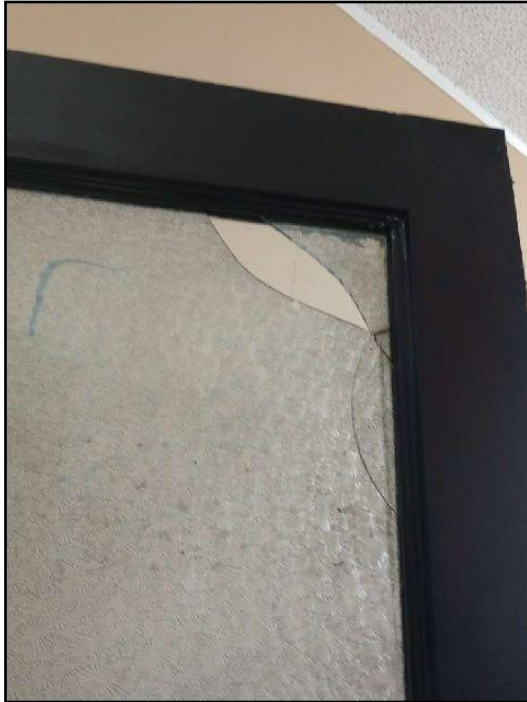
80. Broken

Condition: • [Broken](#)

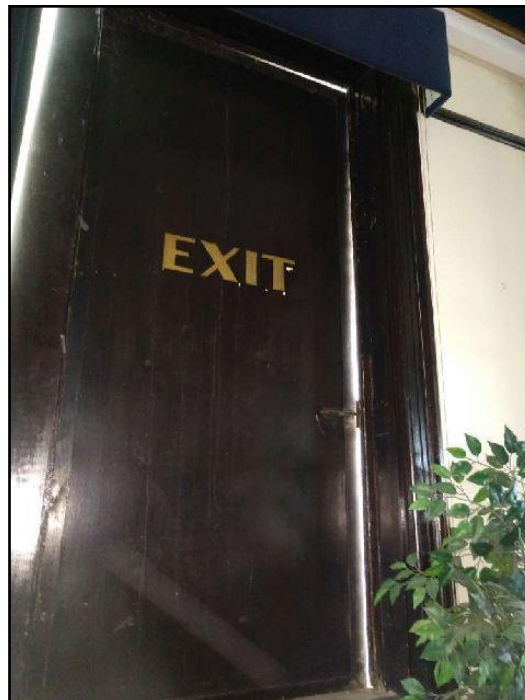
82. Damaged

Condition: • Damaged

The bolts on the fire stick during the third floor is damaged and needs to be repaired

Location: Rear Third Floor fire escape

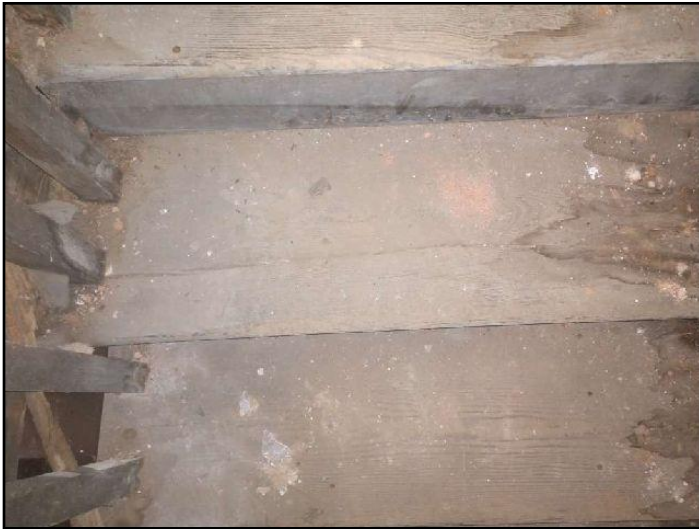
83. Worn or damaged

Condition: • [Worn or damaged](#)

Implication(s): Weakened structure | Trip or fall hazard

Location: Basement Staircase

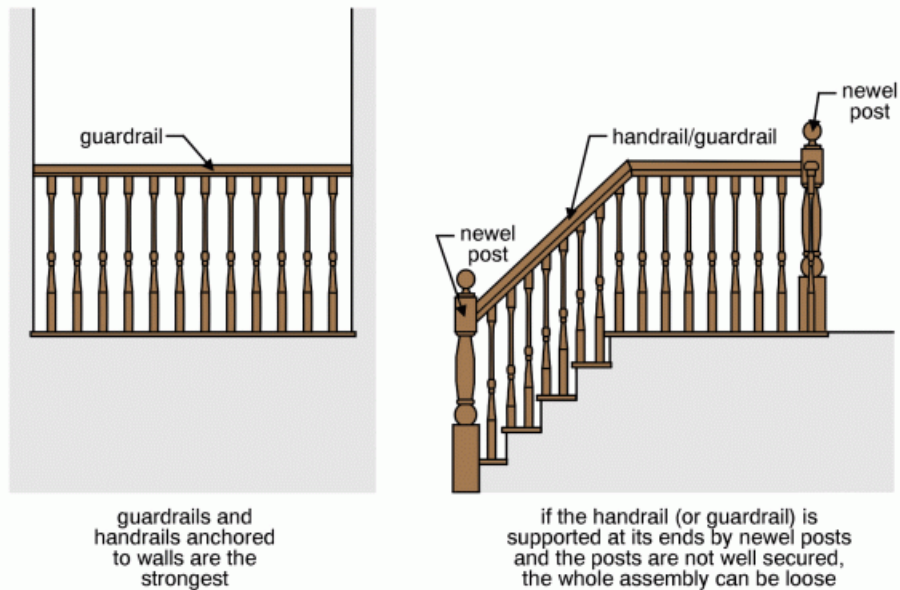
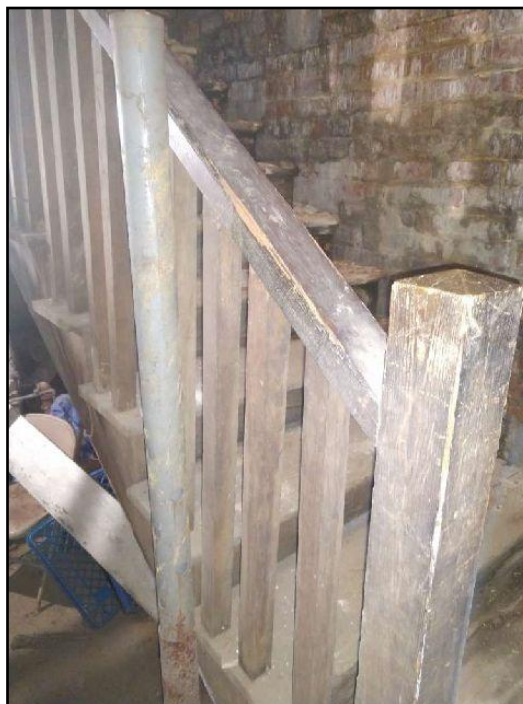
86. Loose

Condition: • [Loose](#)

Implication(s): Fall hazard

Location: Basement Staircase

Handrail support

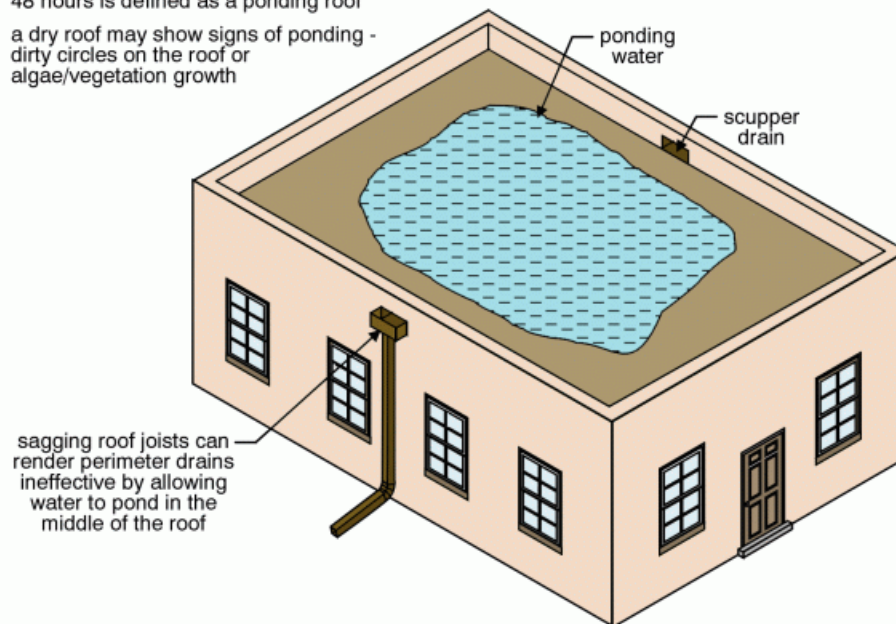
1. Condition: • [Ponding](#)

At the bottom of the pitch of the roof there were areas near all of the interior roof drains that had signs of ponding. This roof does not appear to be old and is well-installed with the exception of these areas. I recommend having the roofing company that installed this roof if they can be located modify these areas or the roof drains so water completely sheds.

Implication(s): Chance of water damage to structure, finishes and contents

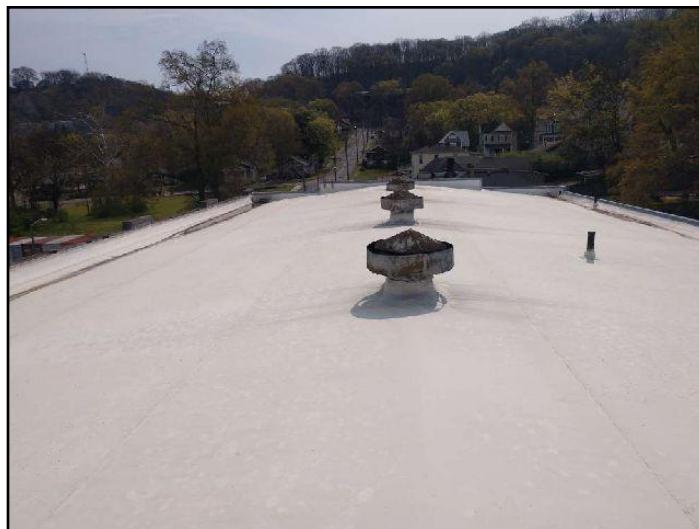
91. Gable

Roof has been raised in the center to do away with the flat roof and direct water to the roof drains and wall-penetrating drain passages.

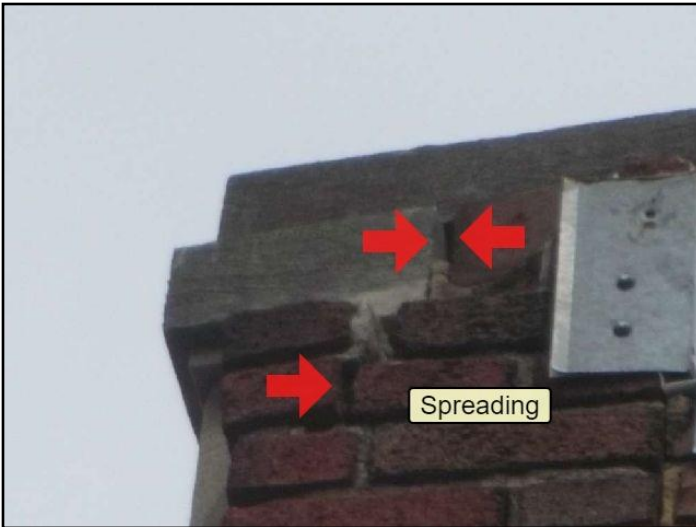
92. Masonry deterioration

2. Condition: • [Masonry deterioration](#)

The front right top corner of the masonry needs repair to prevent further damage and possible injury if materials fell.

Implication(s): Weakened structure | Chance of structural movement

Location: Right Side Exterior

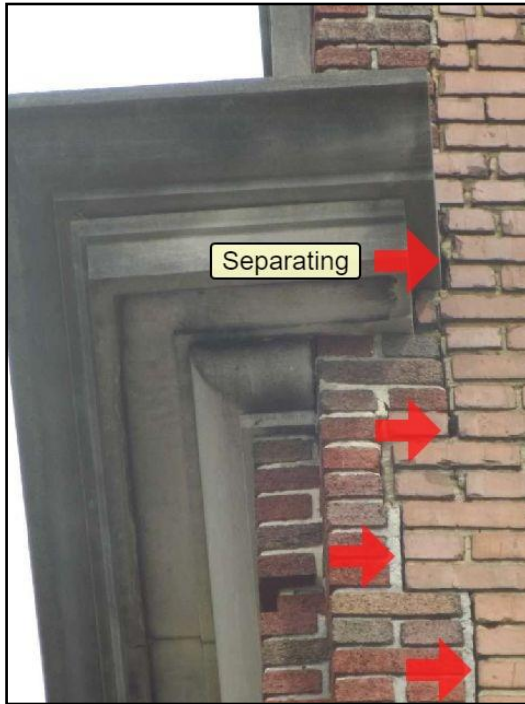
94. Masonry deterioration

3. Condition: • [Masonry deterioration](#)

The concrete soffit above the third-floor windows below the front of the building seems to be sagging. The mortar supporting it and the bricks below it seemed to be deteriorating. If this were to fall that could be very damaging or cause injury or death. I highly recommend that a masonry specialist come in and perform maintenance on this part of the structure to prevent damage or injury.

A masonry company that this inspector knows is experienced in repair of older masonry is Gentry Painter Masonry (G&P Masonry) They are located at 2901 S. Orchard Knob Ave., Chattanooga 37407 and their number is 423-624-9953. (This inspector is a certified masonry inspector and has dealt direct with (overseen) this company in the past)

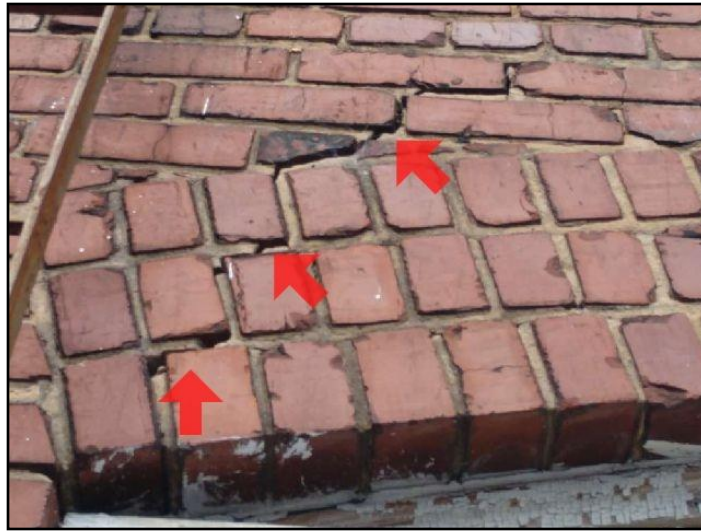
97.

5. Condition: • Arched brick lintel sagging over third floor fire-escape door

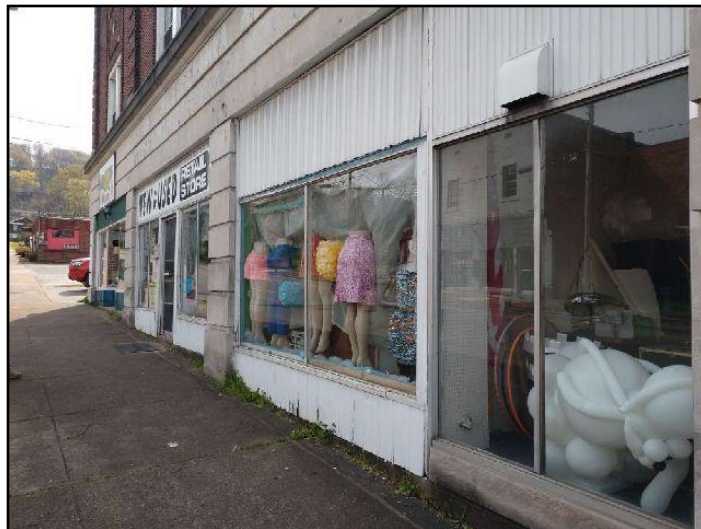
98. Safety glass not installed

6. Condition: • Safety glass not installed

Implication(s): Physical injury

Location: Left Side

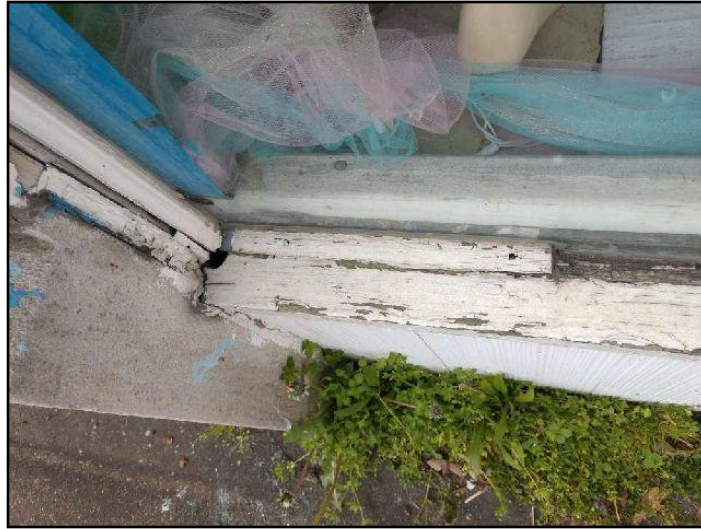
99. *Paint or stain needed*

7. Condition: • [Paint or stain needed](#)

Implication(s): Chance of water damage to structure, finishes and contents | Material deterioration

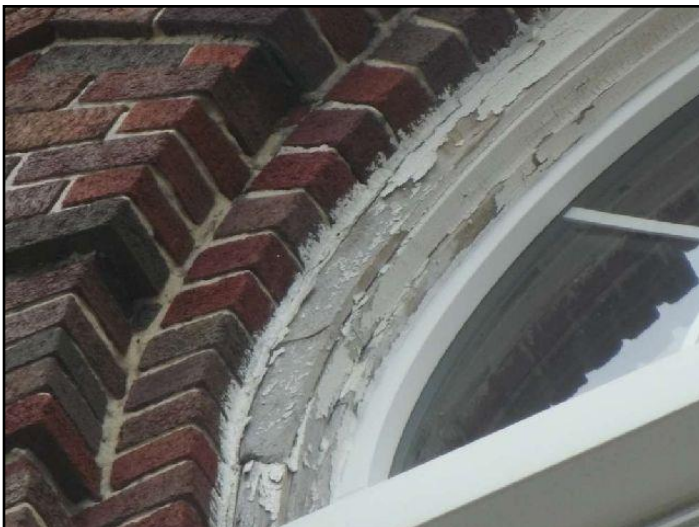
100. *Paint or stain needed*

8. Condition: • [Paint or stain needed](#)

Implication(s): Chance of water damage to structure, finishes and contents | Material deterioration

Location: Front Third Floor

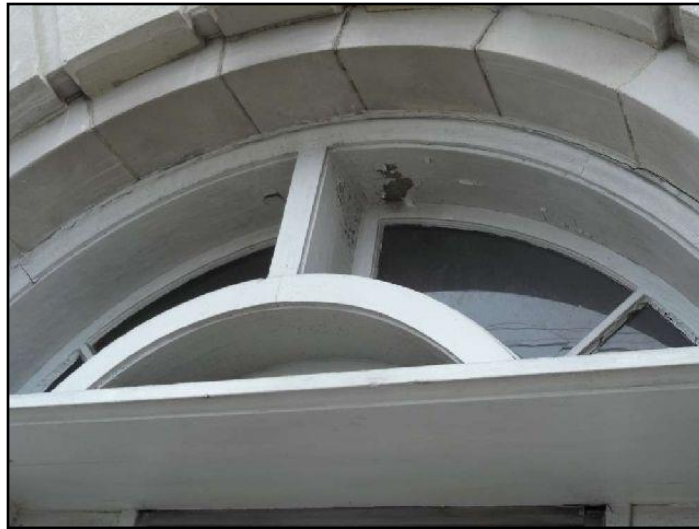
102. Paint or stain needed

9. Condition: • [Paint or stain needed](#)

Implication(s): Chance of water damage to structure, finishes and contents | Material deterioration

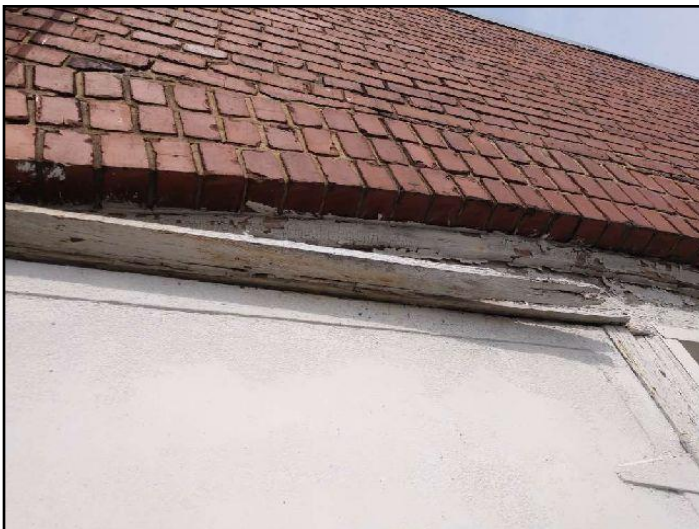
103. Rot

10. Condition: • [Rot](#)

Implication(s): Chance of damage to finishes and structure

Location: Rear Third Floor

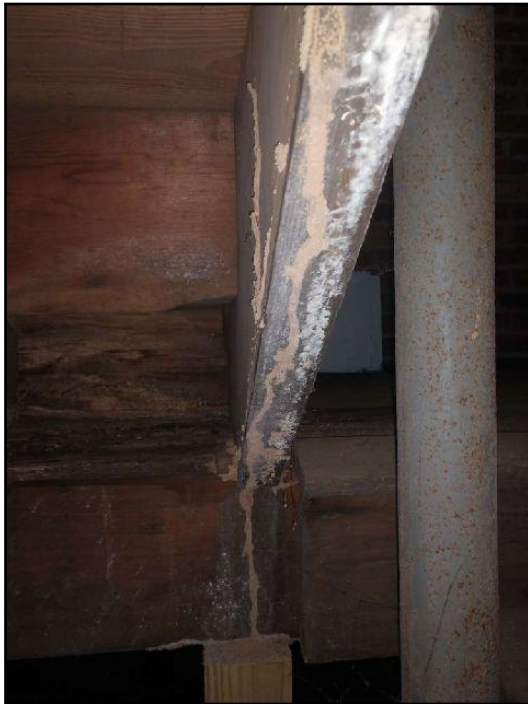
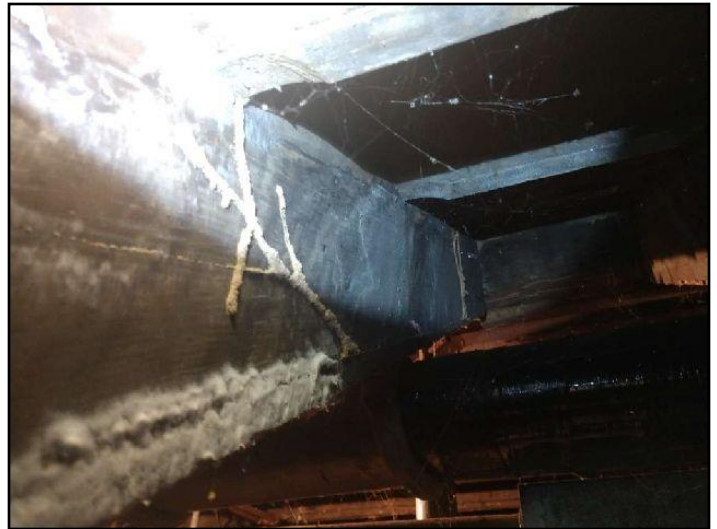
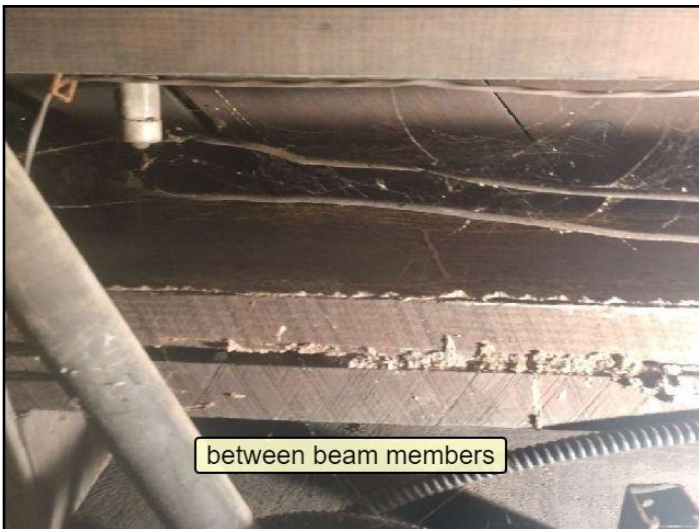
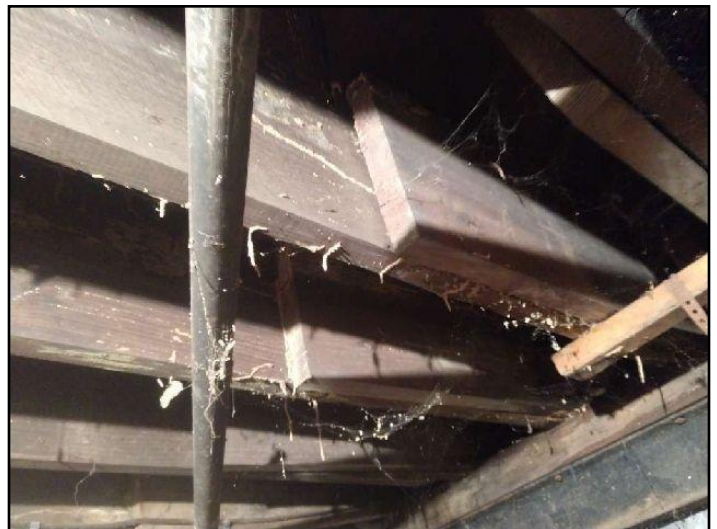
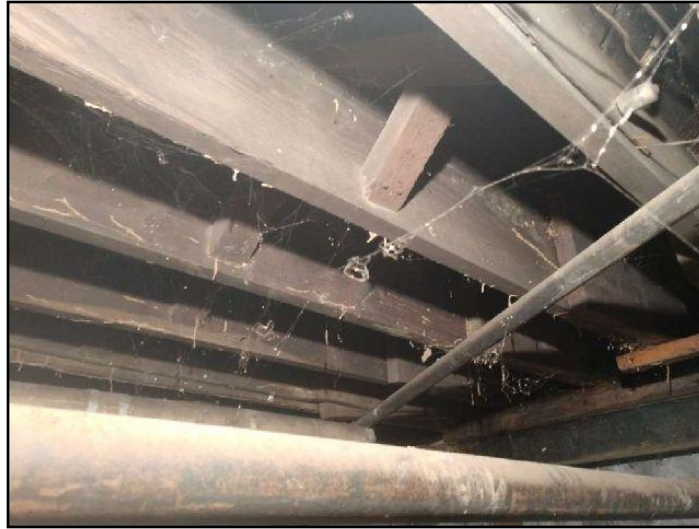
11. Condition: • Signs of infestation in wood. (Past or present)

The activity is primarily isolated to the south and east perimeters reaching approximately half way accross the basement area with isolated spot areas observed also.

Location: Front Left Side Basement

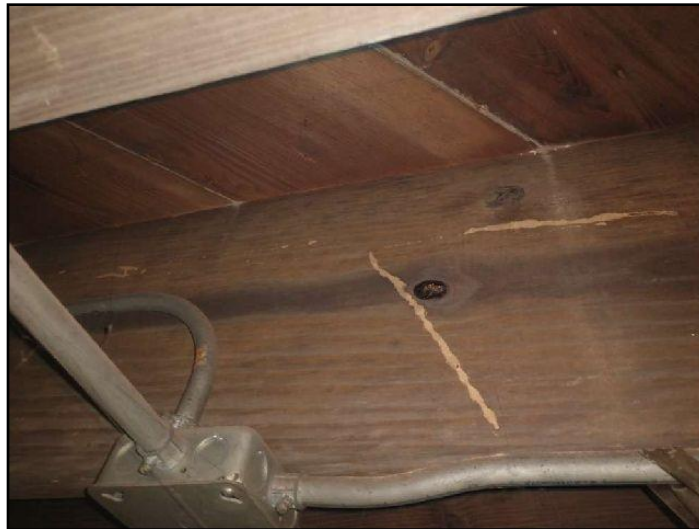
111. Signs of infestation in wood. (Past or...

12. Condition: • Signs of infestation in wood. (Past or present)

Location: Center front Basement

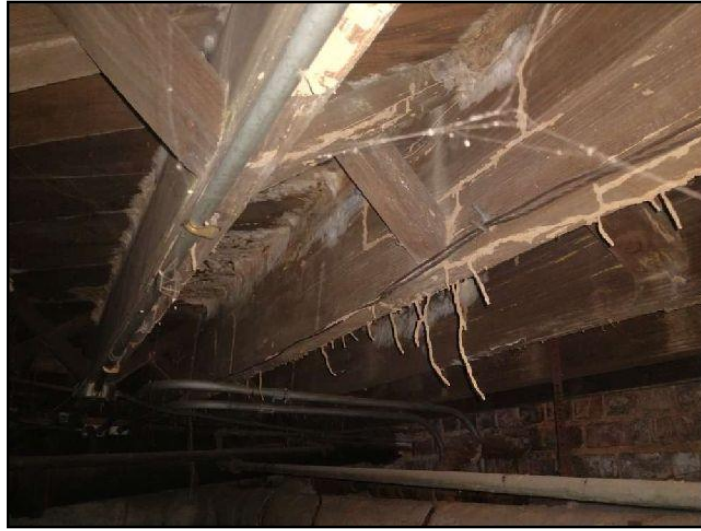
112. Signs of infestation in wood. (Past or...

13. Condition: • Signs of infestation in wood. (Past or present)

Location: Front Basement

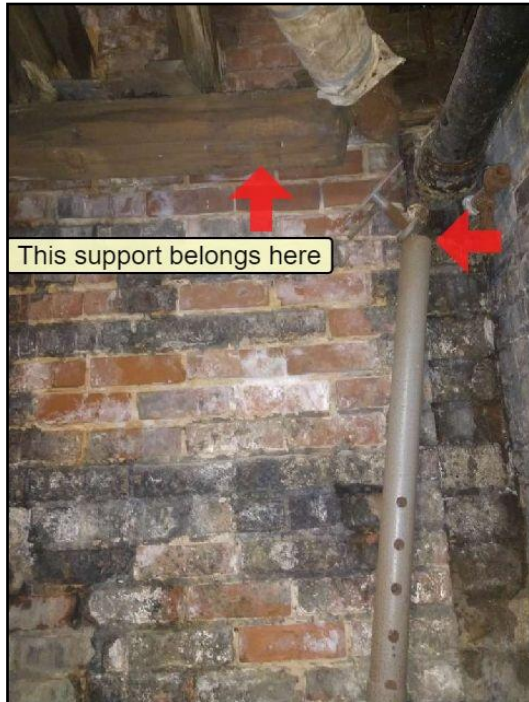
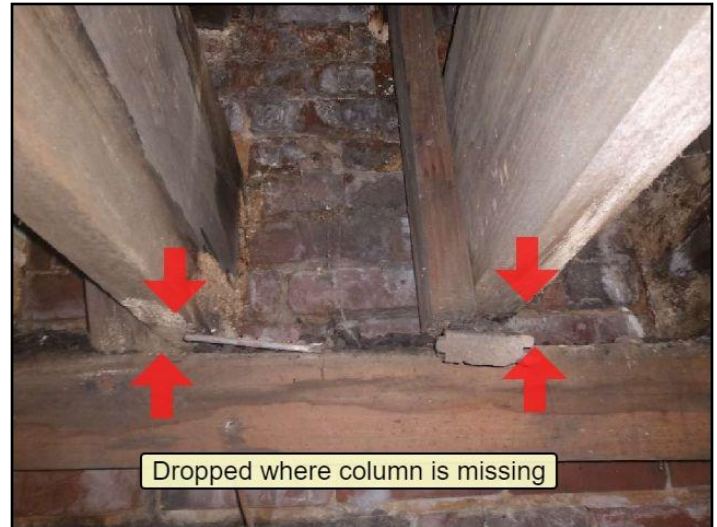
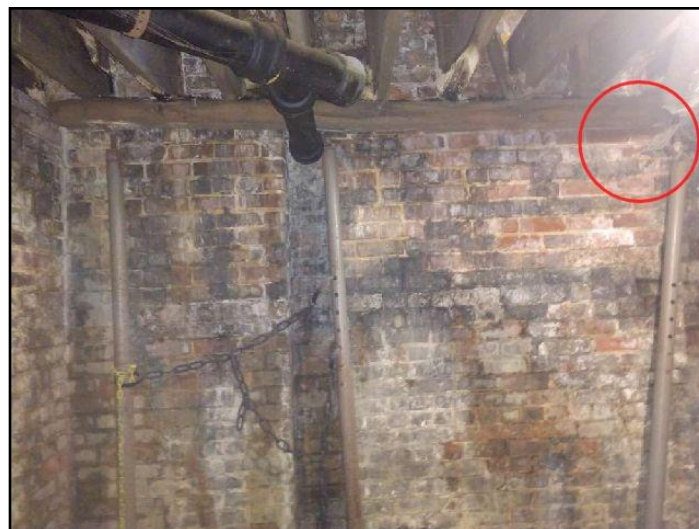
15. Condition: • [Missing](#)

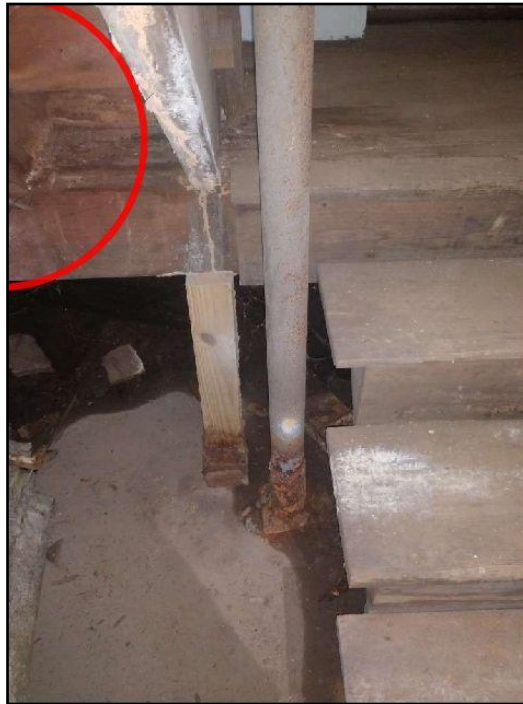
122.

16. Condition: • There is a metal column supporting the landing of the basement staircase that does not appear to be secured at the bottom. The bottom is also resting significantly and this appears to be carrying a substantial load

Location: Basement

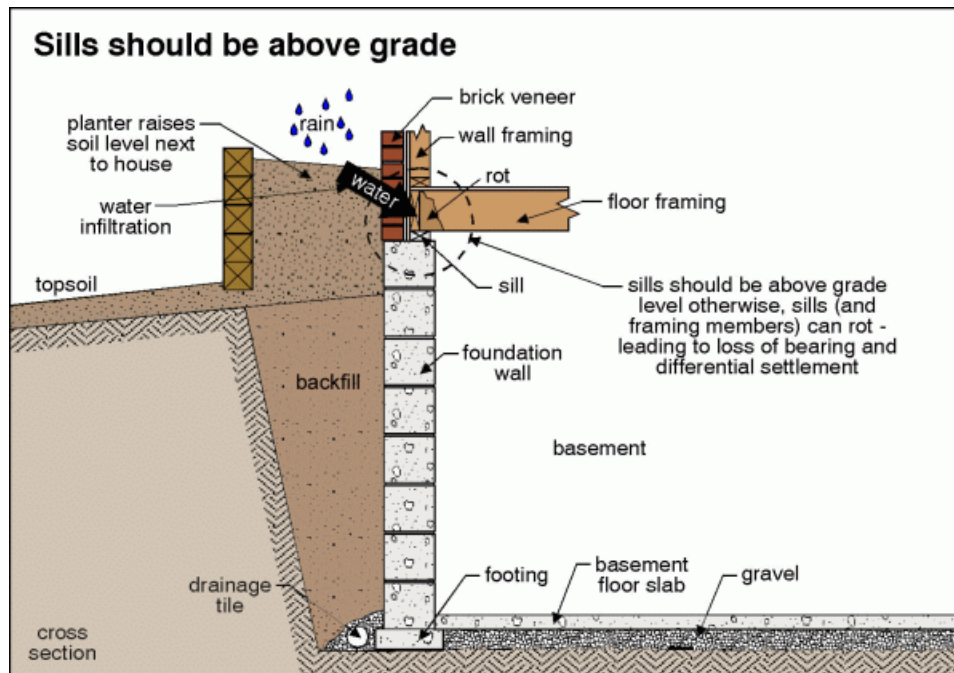
17. Condition: • [Rot or insect damage](#)

Implication(s): Weakened structure

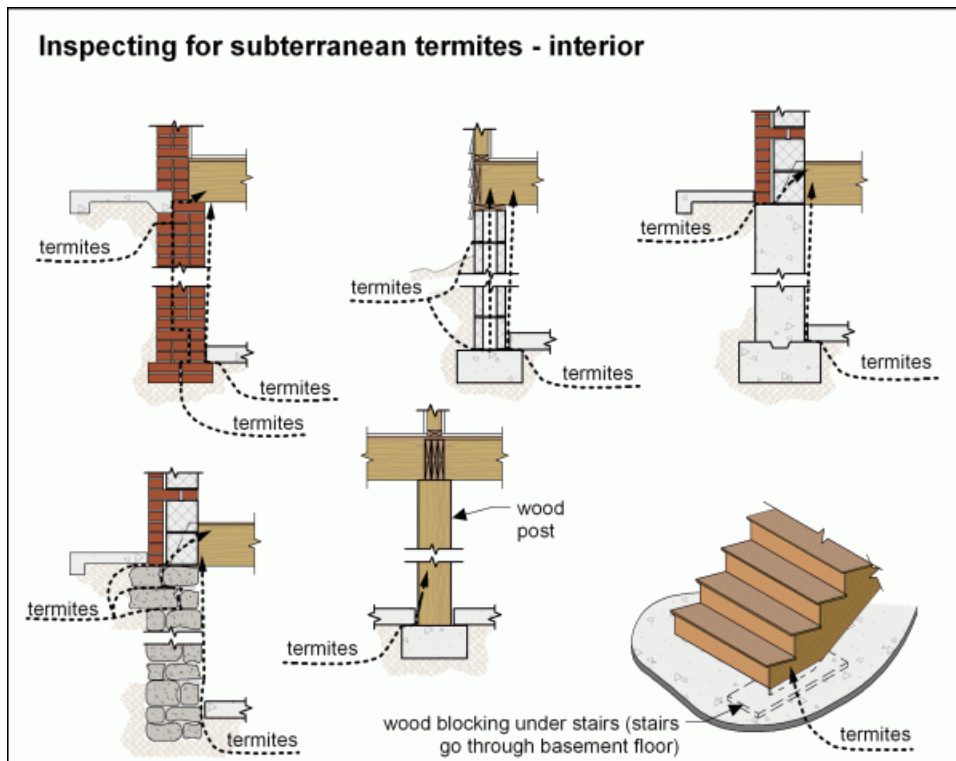
18. Condition: • [Rot, insect or fire damage](#)

is this inspector opinion that the entire area over the old boiler in the basement over to the staircase and in front of the staircase on the other side of the wall is sacrificed and needs major structural replacement. This area has a severe infestation of wood-boring insects and rot along the main beam and sill plate around the exterior wall of the structure.

Implication(s): Weakened structure

Location: Basement

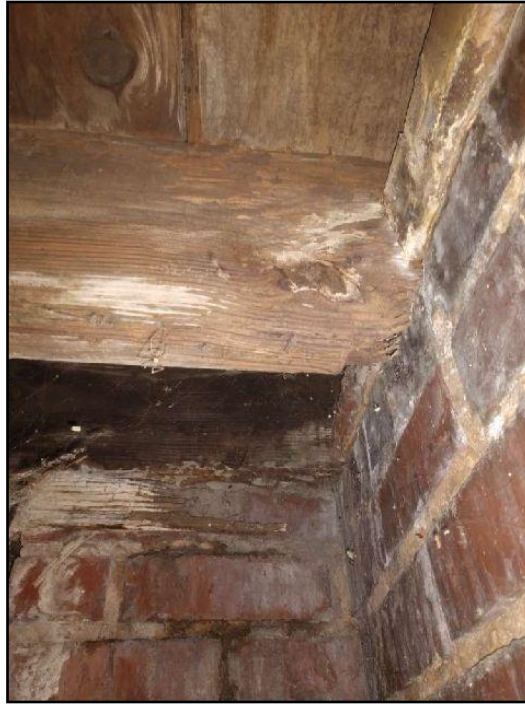
129. Rot, insect or fire damage

19. Condition: • [Rot, insect or fire damage](#)

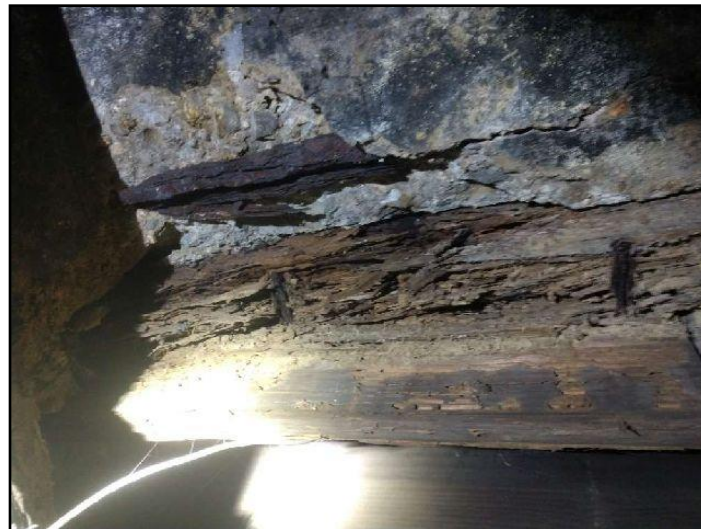
130. Rot, insect or fire damage

20. Condition: • [Rot, insect or fire damage](#)

Implication(s): Weakened structure

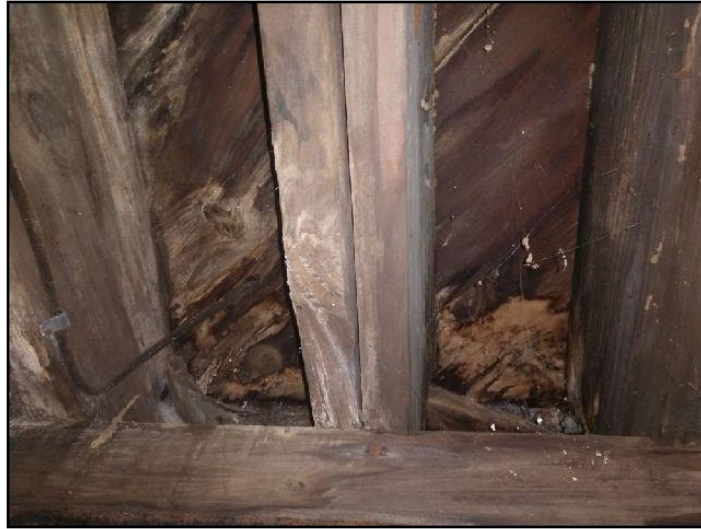
134. Rot

22. Condition: • Rot

Implication(s): Weakened structure | Chance of structural movement

Location: Rear Right Side Basement

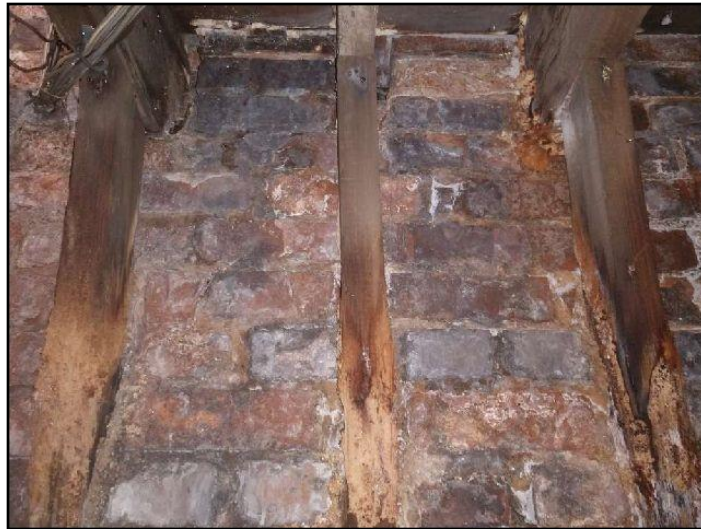
135. Masonry walls are weeping

23. Condition: • Masonry walls are weeping

Location: South Basement wall

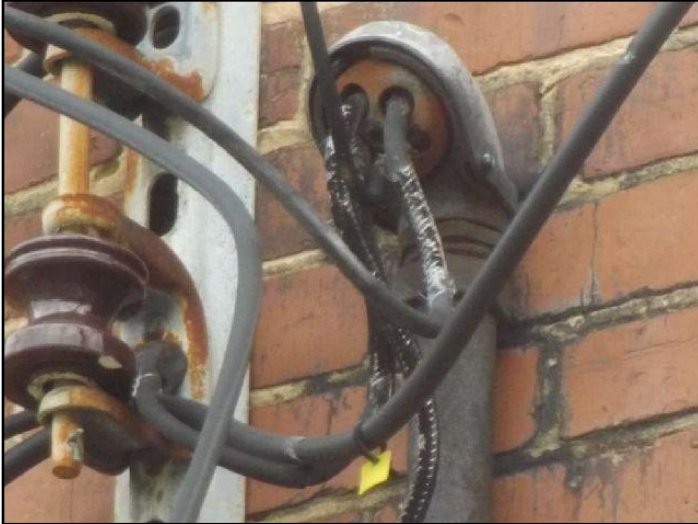
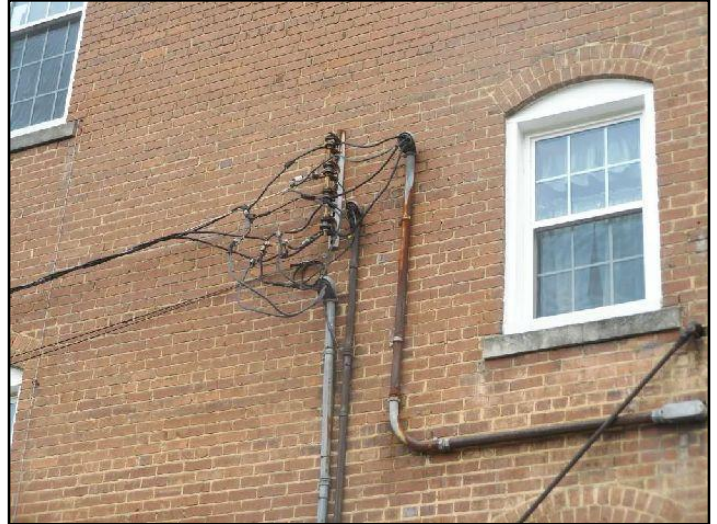
24. Condition: • [Insulation missing or damaged](#)

Implication(s): Fire hazard

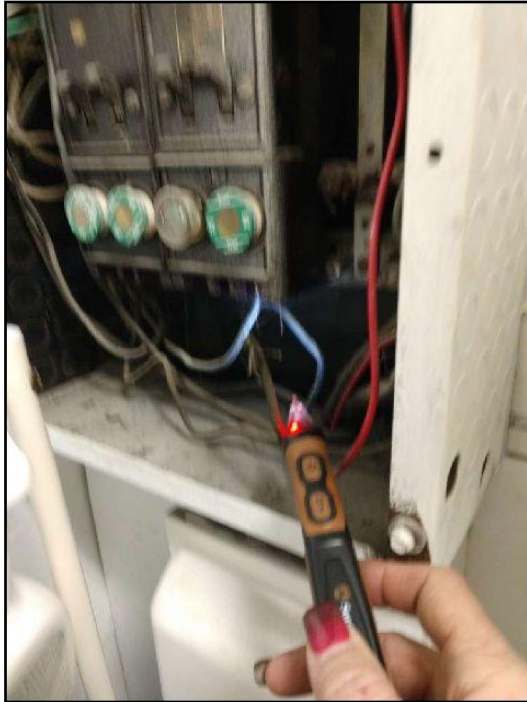
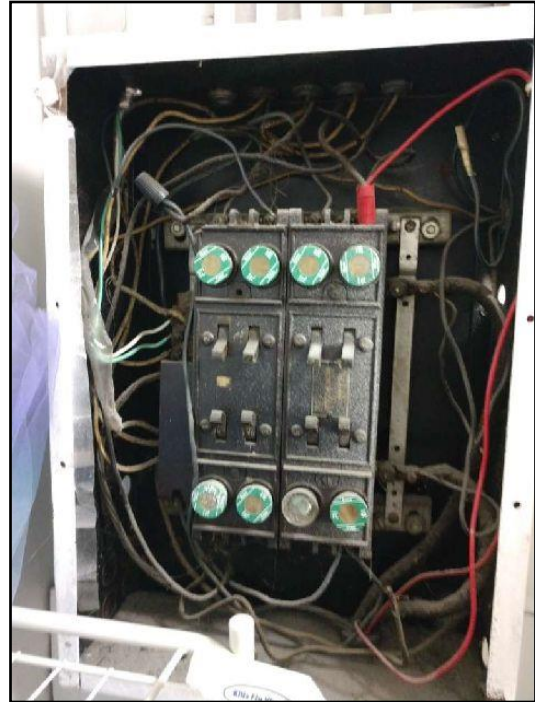
25. Condition: • [Abandoned wires in panel](#)

There is a fuse and breaker box in the back of the century retail space that is missing the cover and has abandoned wires that are electrified that are accessible. I highly recommend this be further evaluated by a licensed electrician

Implication(s): Electric shock

Location: Center First Floor

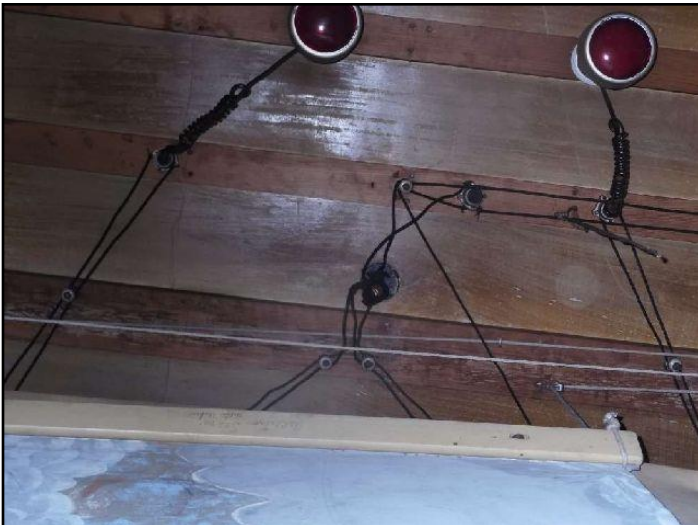
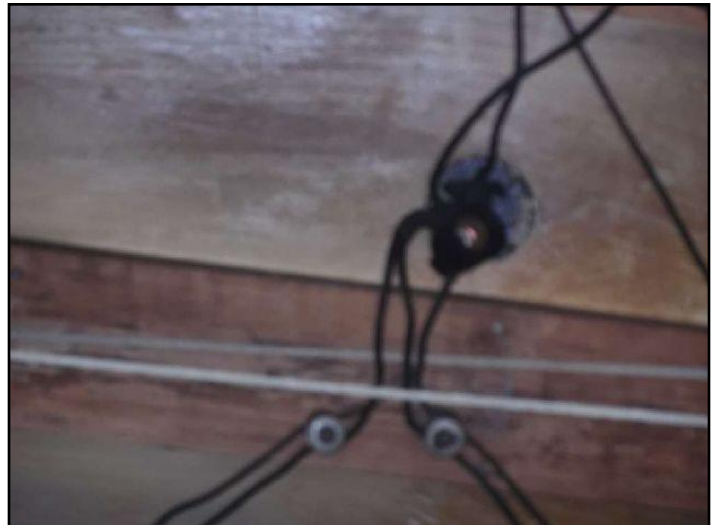
26. Condition: • [Outdated](#)

Implication(s): Nuisance | Potential problem when obtaining home insurance

Location: Basement and stage area and closets of third floor

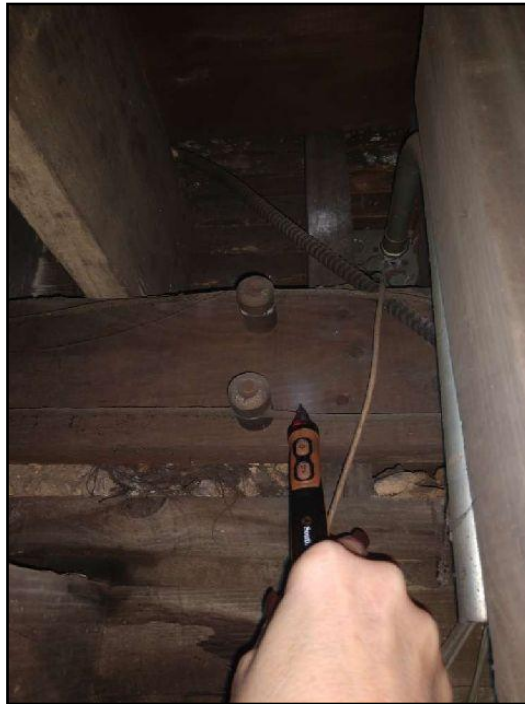
142.

27. Condition: • Active knob and tube located in basement

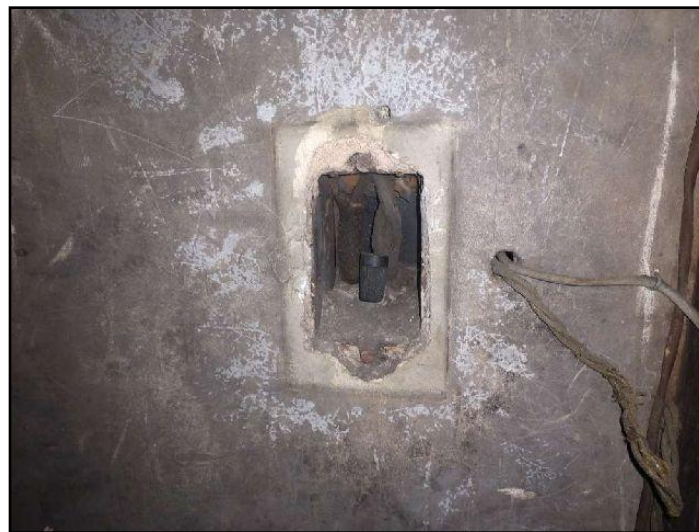
143. Cover loose or missing

28. Condition: • [Cover loose or missing](#)

Implication(s): Electric shock | Fire hazard

Location: First Floor Staircase

Task: Provide

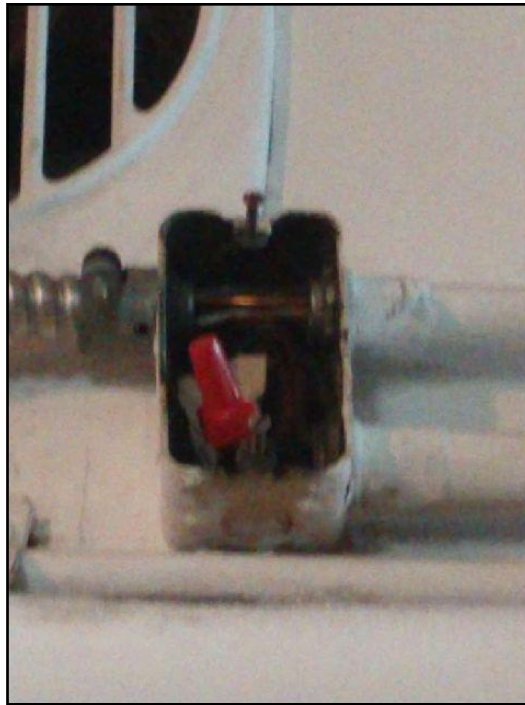
29. Condition: • [Cover loose or missing](#)

Implication(s): Electric shock | Fire hazard

Location: Second Floor

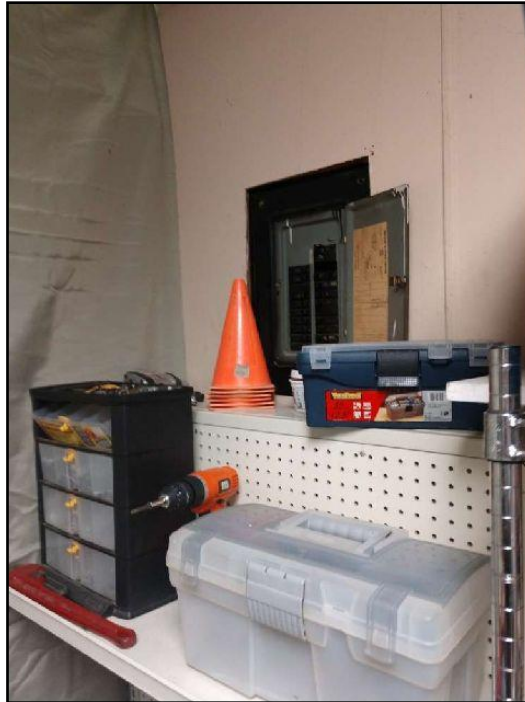
147. 100 Amps

There is a 100 amp square d breaker box appears to be older located in the rear suite. There are 13 circuits installed and one opening in the panel that needs to be sealed. Give me the location of the panel the cover cannot be removed

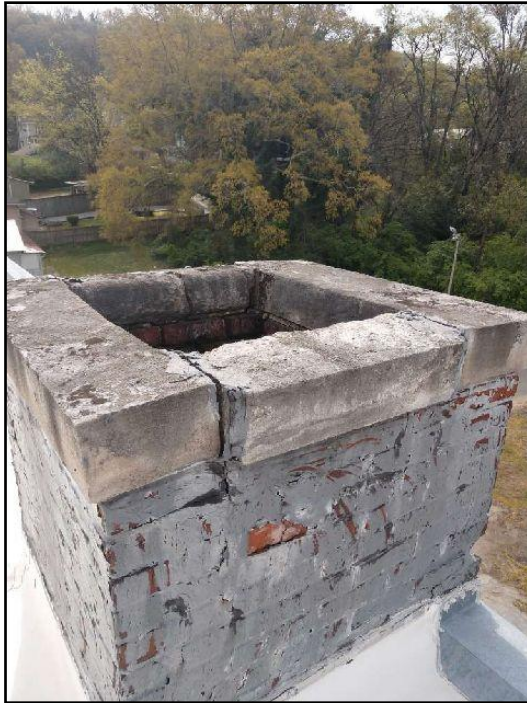
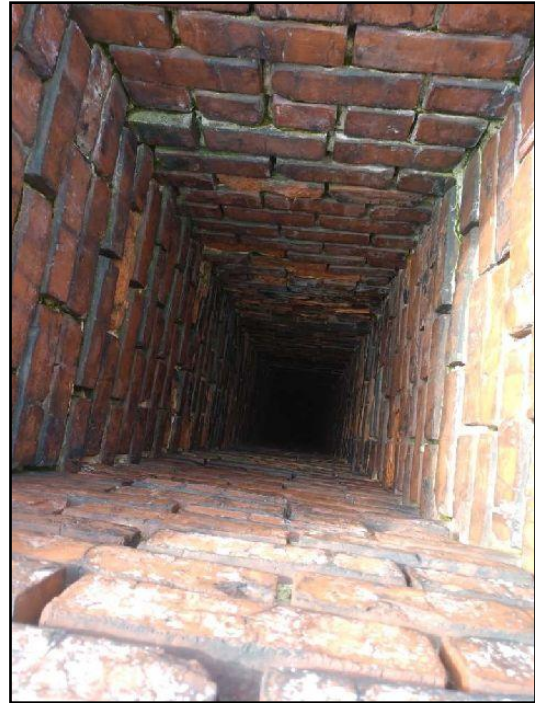
31. Condition: • There is an old chimney still present that appears to go all the way to the basement that has nothing covering the top. Some of the masonry around the top is loose and failing. I recommend just to prevent damage to the roof that this be secured and covered. This could help with some of the water issues in the basement

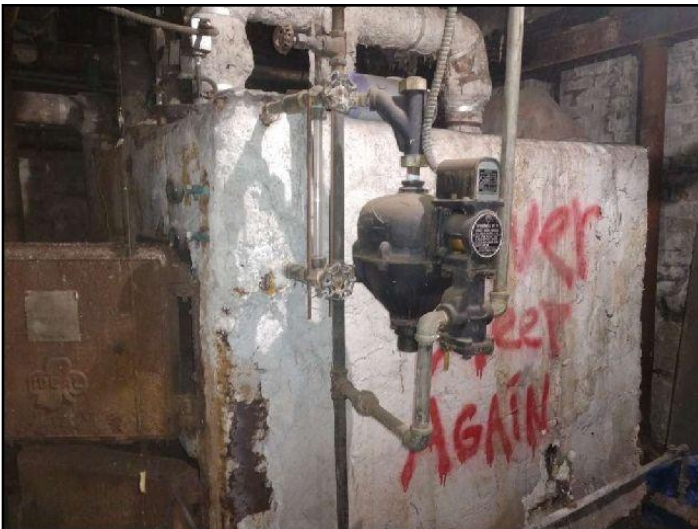
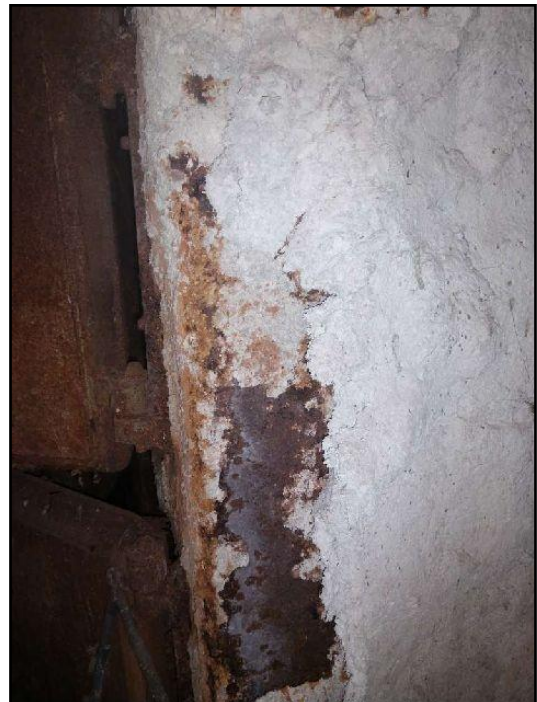
32. Condition: • There is what appears to be an old boiler in the basement that has got suspected asbestos coating on the boiler and the piping. The asbestos is not in a solid state. there is also significant water intrusion causing rust in the unit which will cause it to deteriorate and rust out from under the asbestos which could cause a larger risk. I recommend that the proper authority be brought in to evaluate the options for dealing with this equipment. The framing above this boiler is in extremely poor condition for to rot and infestation and will need to be accessed. Don't do without dealing with the asbestos on the boiler could be harmful.

Location: Basement

Task: Further evaluation
