Your Inspection Report

123 Any Street
Any Town, TN 54321

INSPECTION DATE:
Friday, March 29, 2019

RE: Report No. 4601, v.5
123 Any Street
Any Town, TN
54321

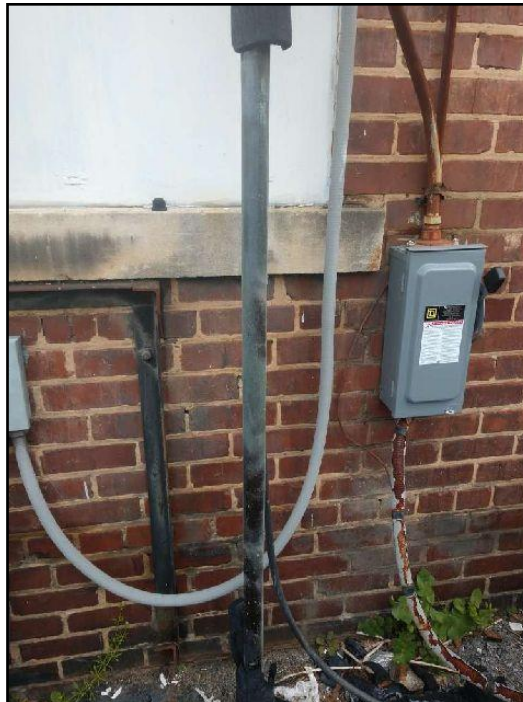
159. Insulation - missing

33. Condition: • [Insulation - missing](#)

Implication(s): Reduced system life expectancy | Increased cooling costs | Reduced comfort

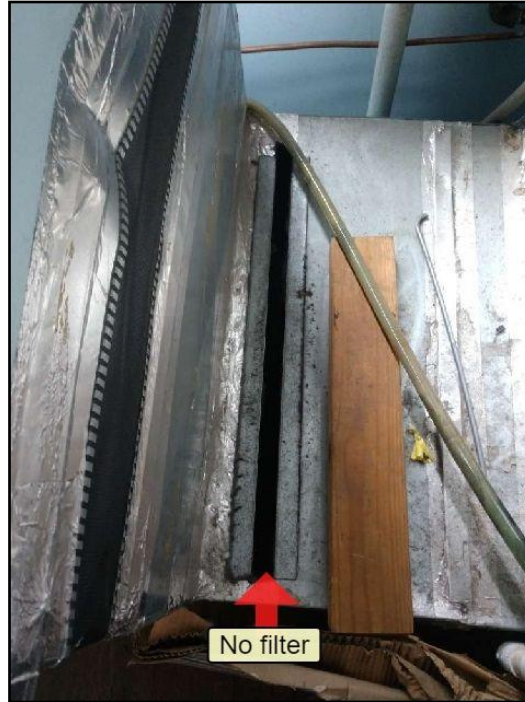
160. *Missing return filter*

34. Condition: • Missing return filter

Location: First Floor

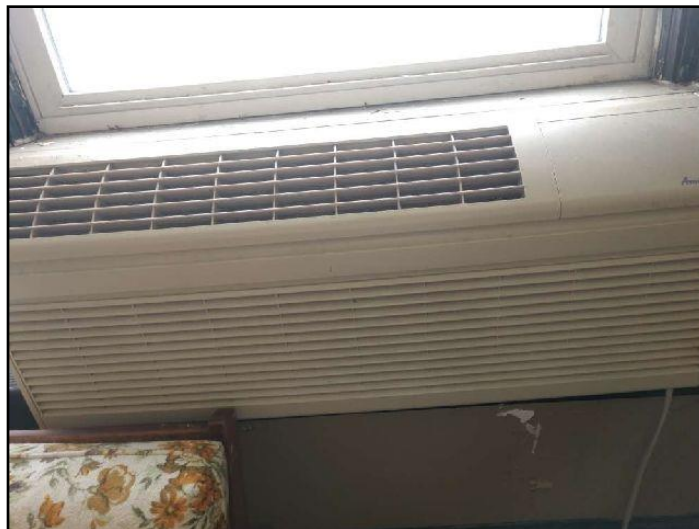
162. *Wall unit*

Amana 1.0 ton TPAC installed in the front room of the third floor. Was in serviceable condition at the time of the inspection

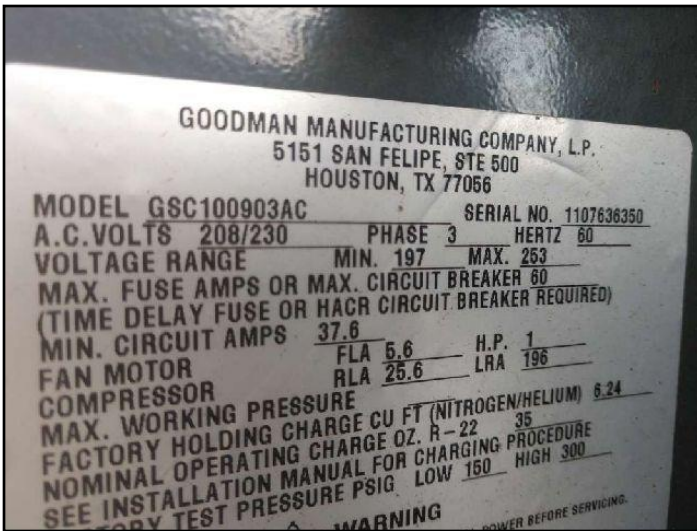
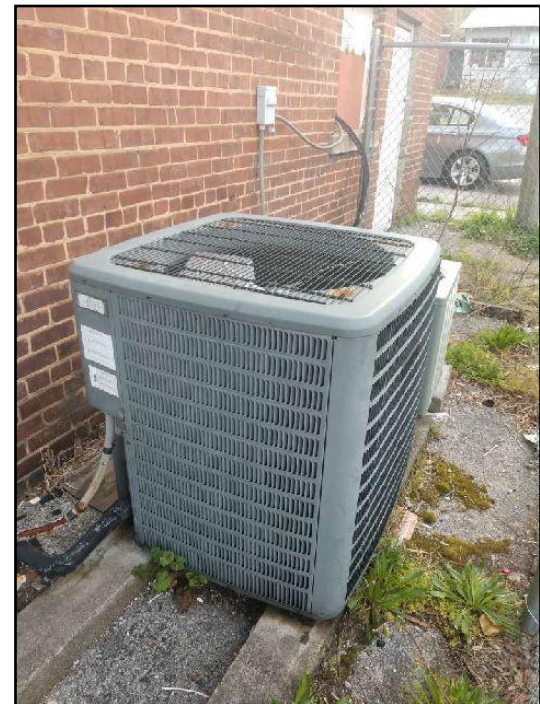
167. Goodman

Goodman unit appears to be a 10 ton unit manufactured in 2011 that is running on r22 refrigerant

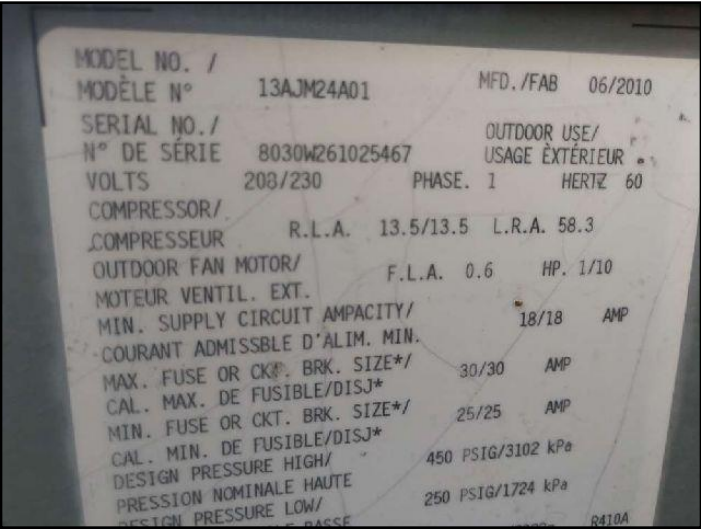
170. Rheem

2 ton air compressor manufactured 2010. Appears to be well maintained and in serviceable condition for its age. Refrigerant is r410a. This unit appears to service the rear retail suite. The unit appears to be operating as expected

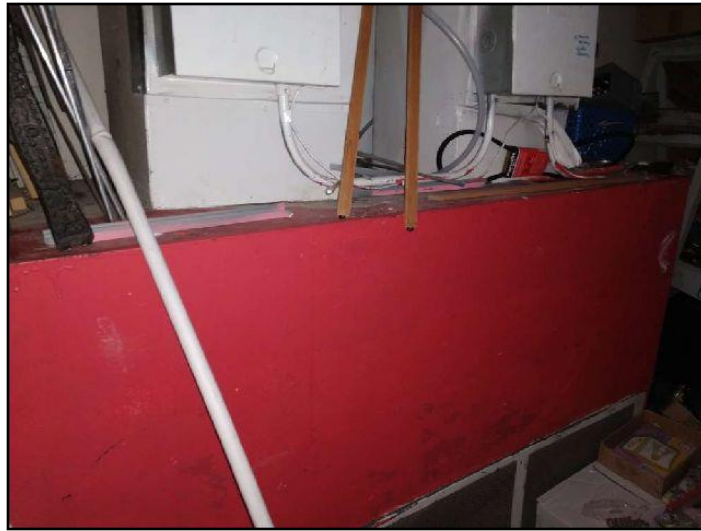
173. York

• York
The front retail space has got a York air handler of undetermined age and size installed. It seemed to be running adequately at the time of the inspection

- It is always a good idea, when purchasing a home, to have any mechanical systems cleaned/serviced as soon as possible to optimize the efficiency of the equipment and establish a maintenance schedule to insure the best performance from your equipment.

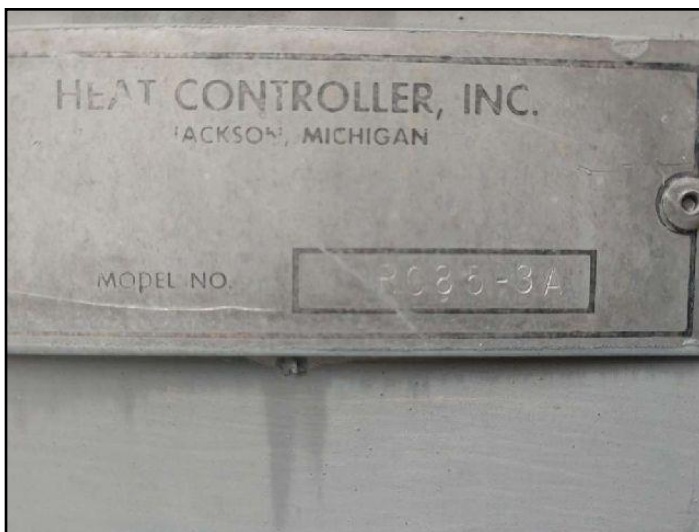
174.

Manufacturer: • Comfort-Aire manufactured in 2003 is an electric package unit heating and air. The unit has r22 refrigerant. See the disclosure on r22 refrigerant included in the report under cooling

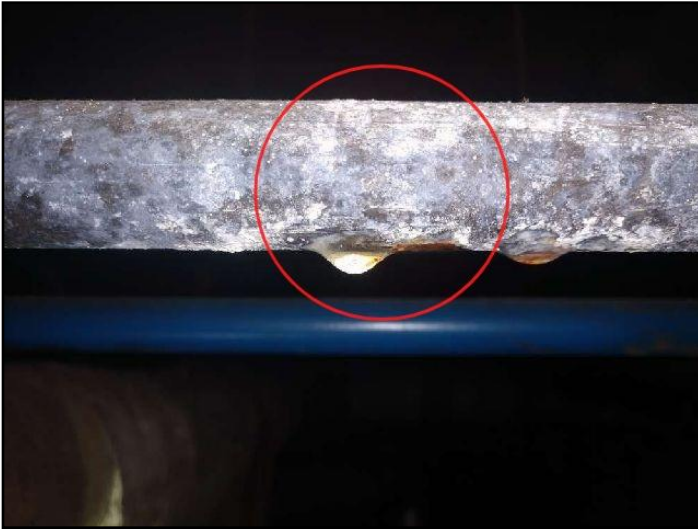
38. Condition: • [Leak](#)

Implication(s): Chance of water damage to structure, finishes and contents | Damage to equipment

Location: Basement

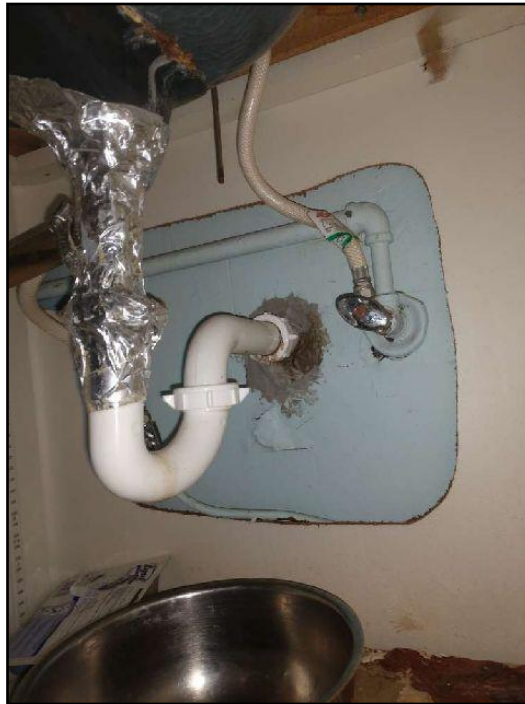
39. Condition: • [Drip, leak](#)

the water was turned off to the laboratory at the time of the inspection. When the inspector started turn it on she made Italy figure it out it was because of a severe leak in the supplies and there also appears to be a leak in the drain system.

Implication(s): Chance of water damage to structure, finishes and contents

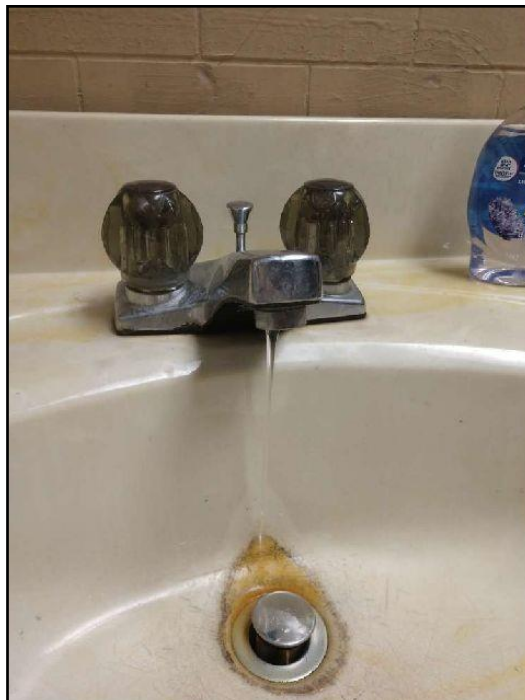
40. Condition: • Flow lower than balance of home

The hot water flow is less than expected. the hot water valve was turned off at the time of the inspection. The inspector turned it on to test and turned it back off

Location: Second Floor men's restroom Mount lavatory sink

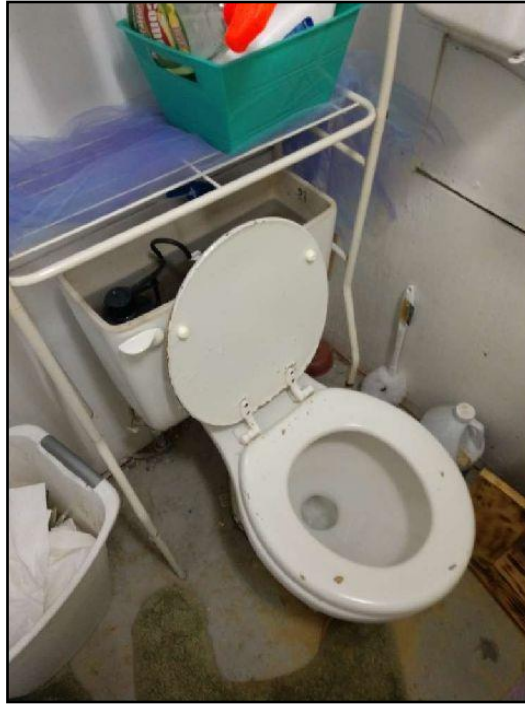
41. Condition: • [Loose](#)

Implication(s): Chance of water damage to structure, finishes and contents | Sewage entering the building | Possible hidden damage

Location: First Floor middle space

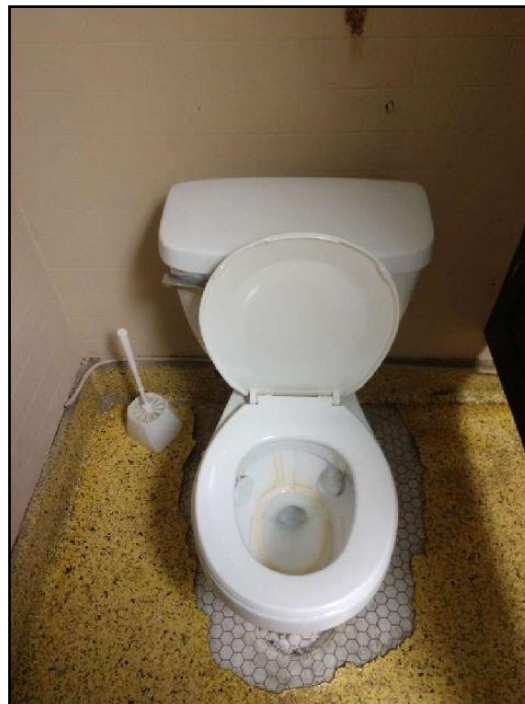
42. Condition: • Toilet loose at floor - Note: This inspector gently pushes on the toilet both left and right and lifts the front of the toilet using her knee. The toilet should not move at all when this is done. If the toilet is loose, it is a good idea to always have the toilet removed so the area below, including the plumbing and subfloor, can be checked for leaks/damage. A new wax ring needs to be installed whenever a toilet is unbolted/moved.

Location: Men's restroom

Loose toilet

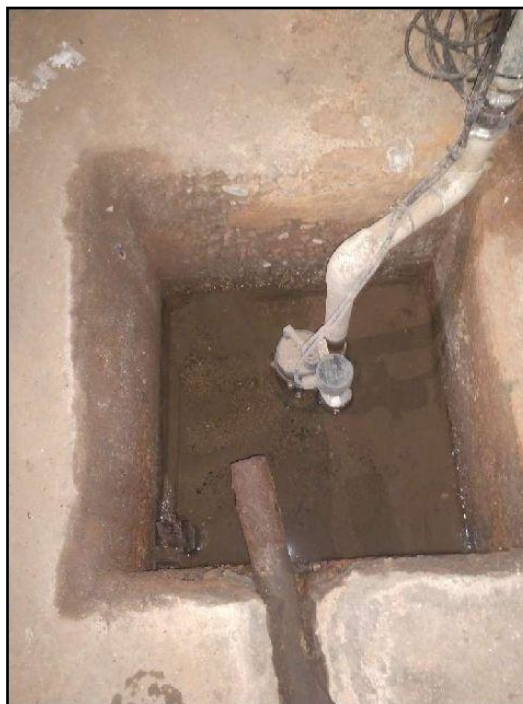
- [Sump pump](#)
- Sump pump performed satisfactorily at time of inspection

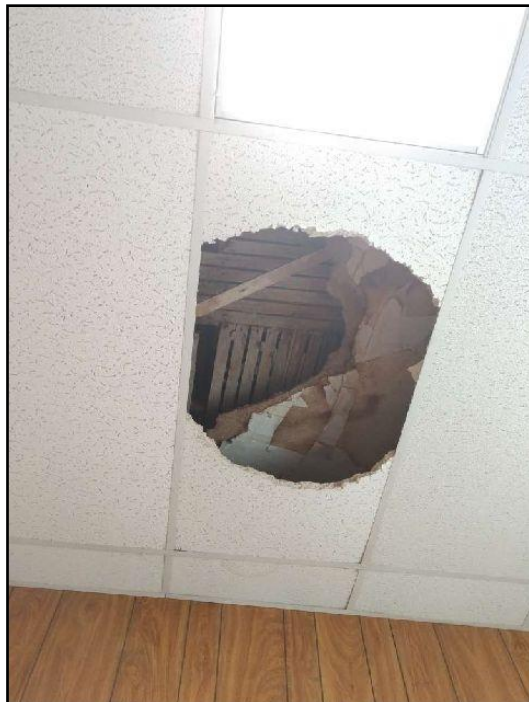
43. Condition: • [Water damage](#)

damaged tile on the suspended ceiling in the office is underneath a bathroom that the sellers representative stated had a prior leak. The water to the restroom was turned off and never repaired to the buyer's representative knowledge.

Implication(s): Chance of movement | Rot | Leakage

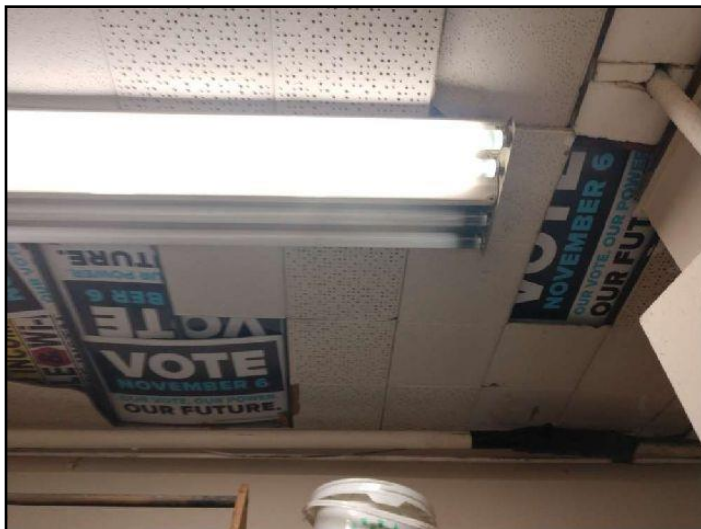
44. Condition: • [Water damage](#)

Sales representative stated that they damage to the suspended ceiling in the first floor front suite is from where the bathroom upstairs leaked at one point. No active moisture was found when examined using infrared thermography

Implication(s): Chance of movement | Rot | Leakage

Location: First Floor

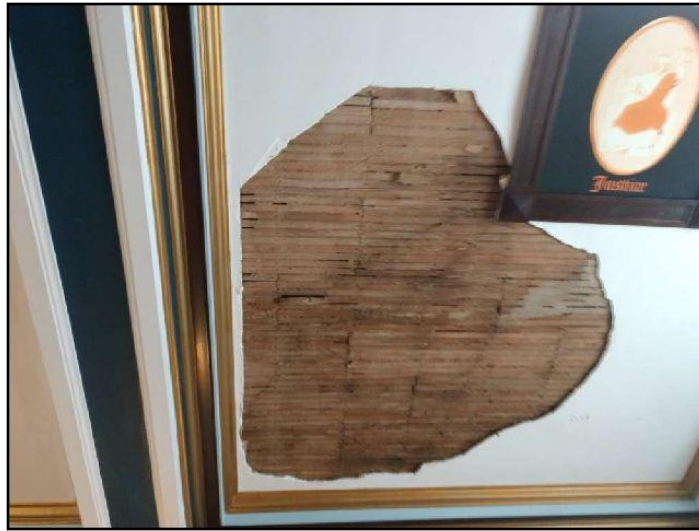
45. Condition: • Damaged

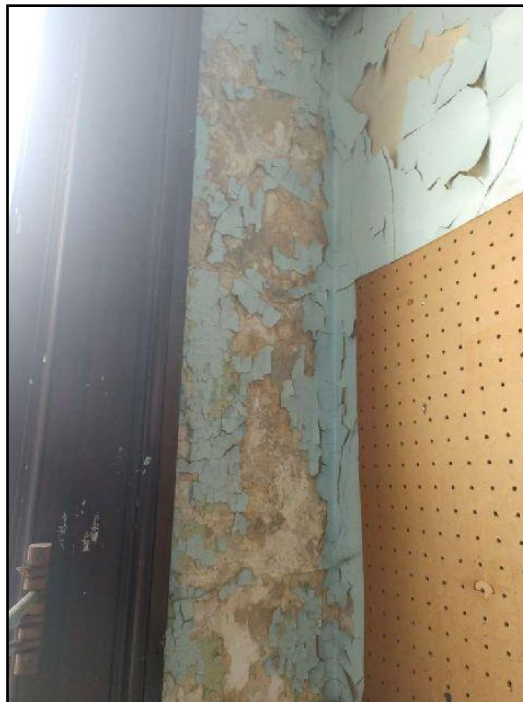
195.

46. Condition: • Water damage

There are signs on the interior walls and ceilings of the upper floors that coincide with a roof leak from the drainage system being stopped up according to the seller's representative. There are doors that are water damaged and paneling but no active moisture was found when observed using infrared thermography

47. Condition: • Suspected lead paint in kitchen flaking. I recommend scraping all loose and sealing with new latex paint

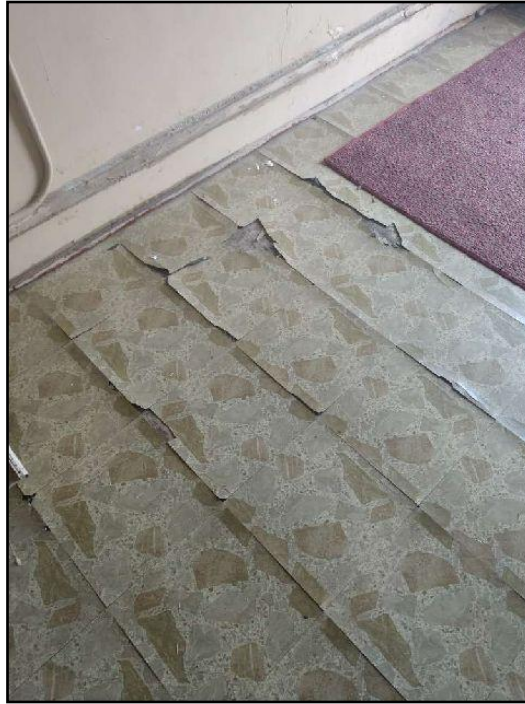
49. Condition: • [Damage](#)

Implication(s): Material deterioration | Trip or fall hazard

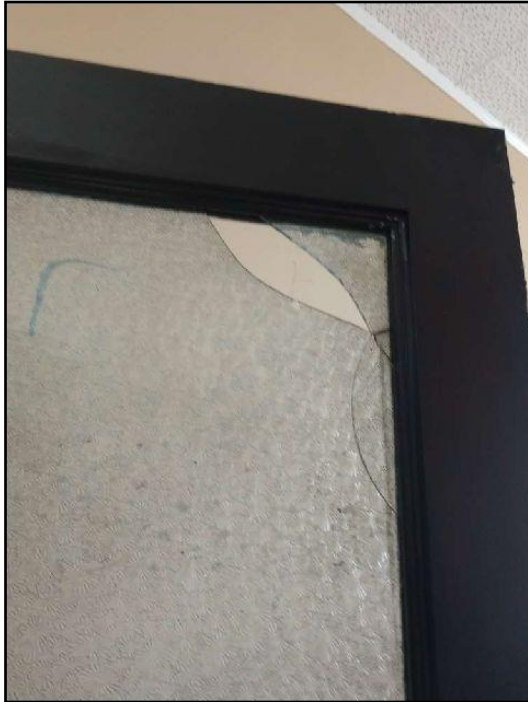
50. Condition: • [Broken](#)

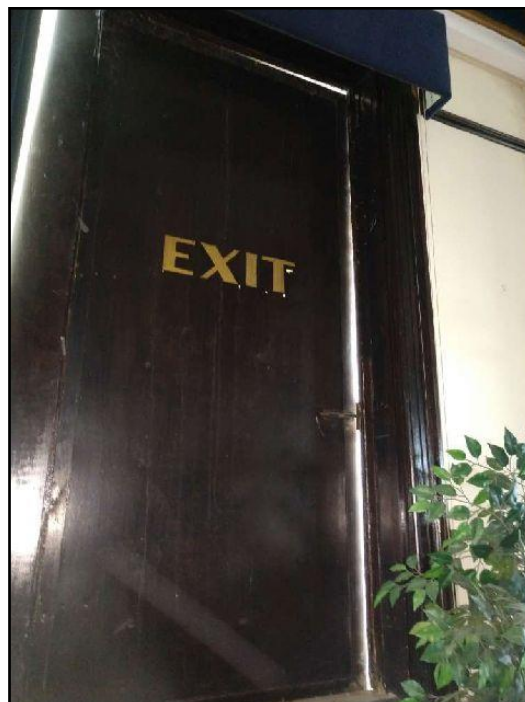
200. Damaged

51. Condition: • Damaged

The bolts on the fire stick during the third floor is damaged and needs to be repaired

Location: Rear Third Floor fire escape

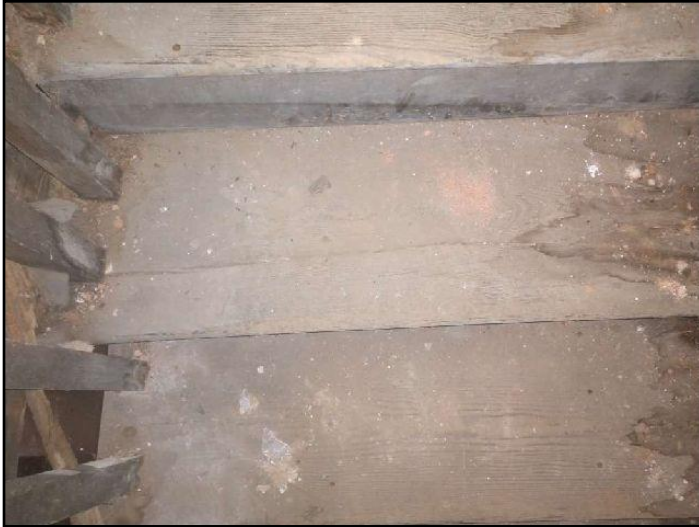
201. Worn or damaged

52. Condition: • [Worn or damaged](#)

Implication(s): Weakened structure | Trip or fall hazard

Location: Basement Staircase

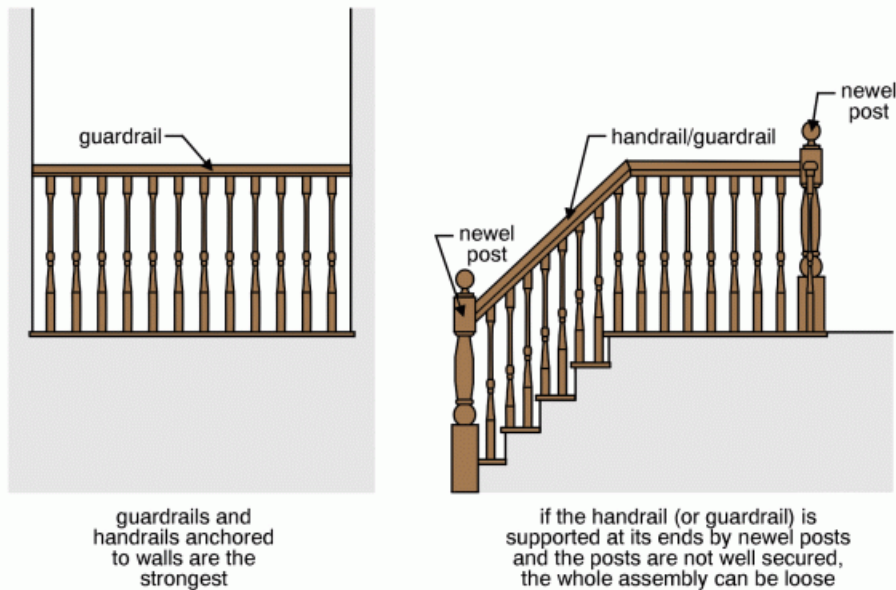
204. Loose

53. Condition: • [Loose](#)

Implication(s): Fall hazard

Location: Basement Staircase

Handrail support
