INSPECTION REPORT

For the Property at:
1030 W ADDISON
CHICAGO, IL

Prepared for: ROBERT ELLIOTT
Inspection Date: Saturday, March 31, 2007
Prepared by: robert elliott

ELLIOTT HOME INSPECTION

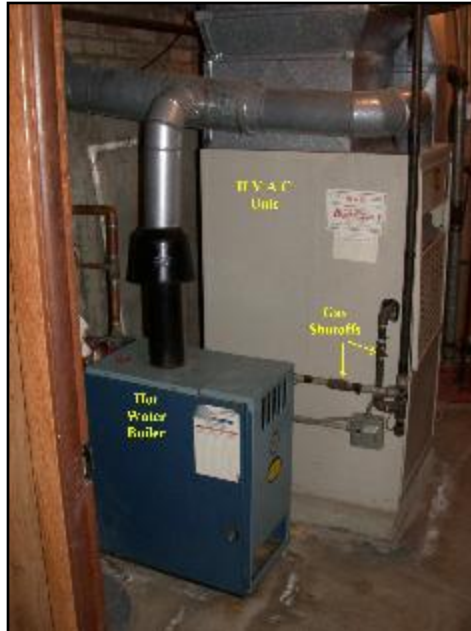
8.

Note: Secodary unit is a small 45,000 btu hotwater boiler used for the basement with a baseboard distribution system. Age not determined, but functional with it's own thermostat.

Condition: • [Cracks, holes or rust](#)

Implication(s): Reduced system life expectancy | Hazardous combustion products entering home

Note: Noted some rust on visible portion of heat exchanger.

This should be checked by a qualified contractor. Also the life expectancy of a heat exchanger is 20 to 25 years so replacement of the furnace will be needed at that time. Another concern is that Carrier is presently involved in a class action lawsuit involving the exchangers alleging they are inferior steel.
