INSPECTION REPORT

KING ST
ANYWHERE, ON

Inspection Date: Tuesday, January 12, 2016

RE: Report No. 1001, v.2
King St
Anywhere, ON

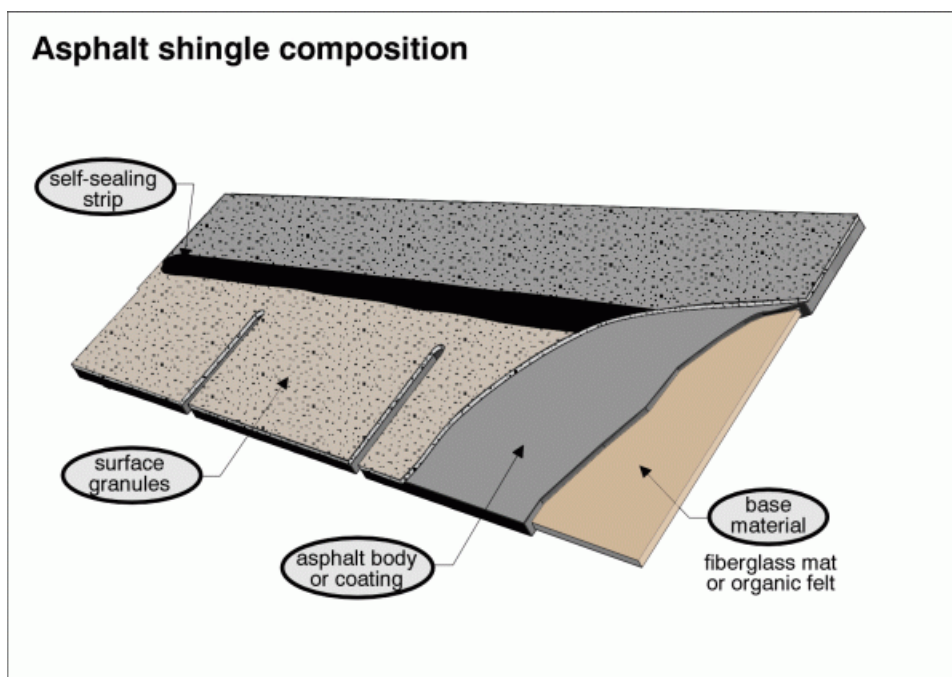
1. Condition: • [Granule loss](#)

Implication(s): Chance of water damage to contents, finishes and/or structure

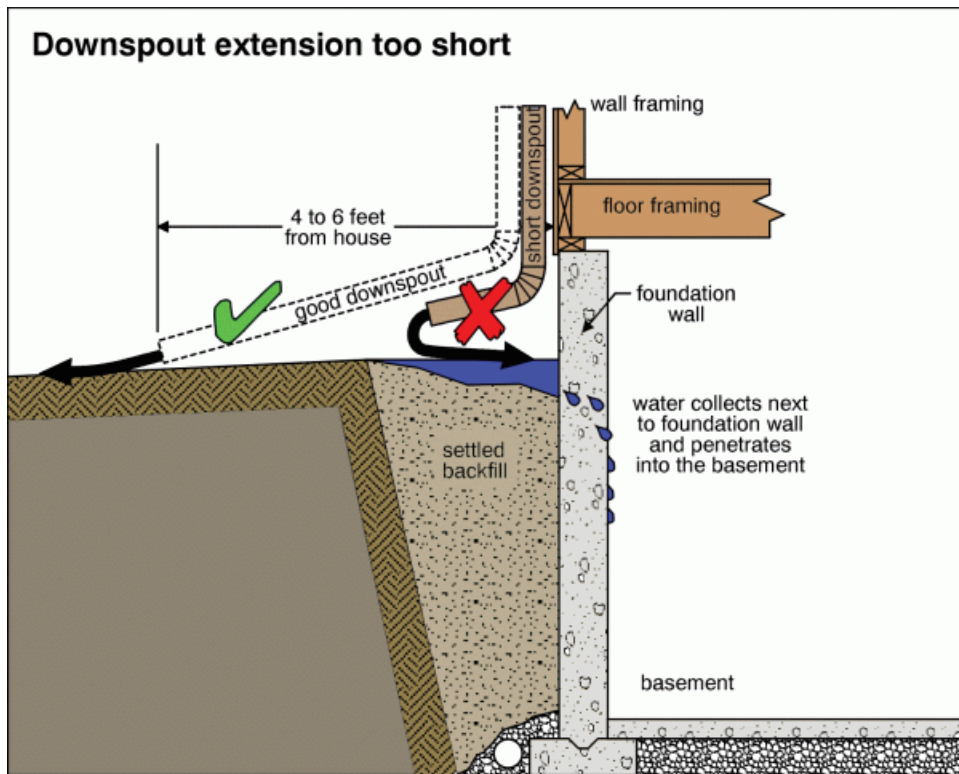
3. Condition: • [Downspouts end too close to building](#)

Implication(s): Chance of water damage to contents, finishes and/or structure

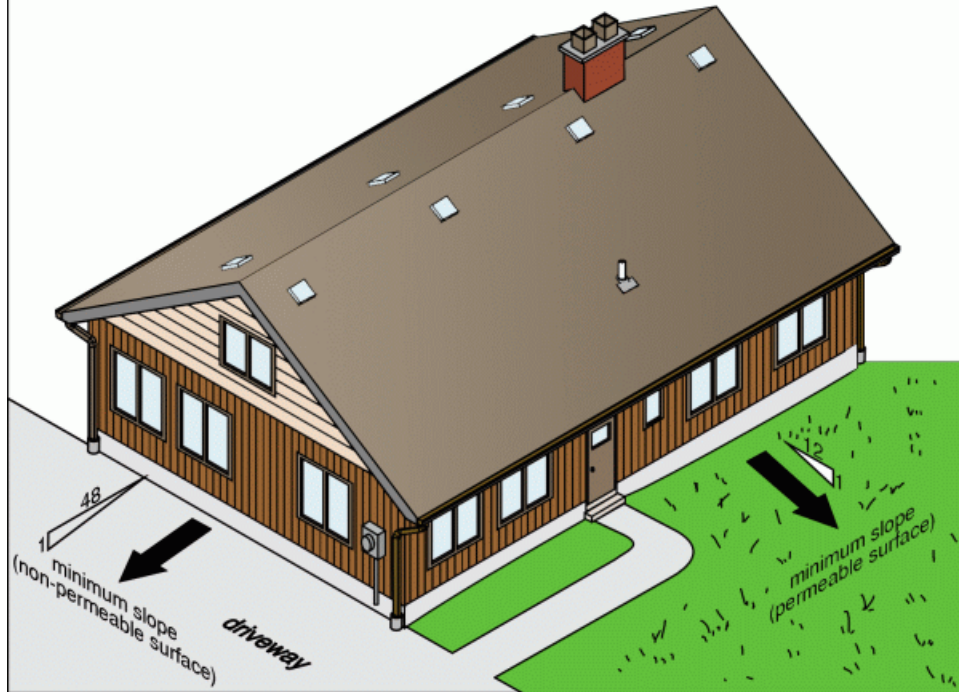
Recommended grading slopes

8. Condition: • [Improper slope](#)

Implication(s): Chance of water damage to contents, finishes and/or structure

Task: Repair

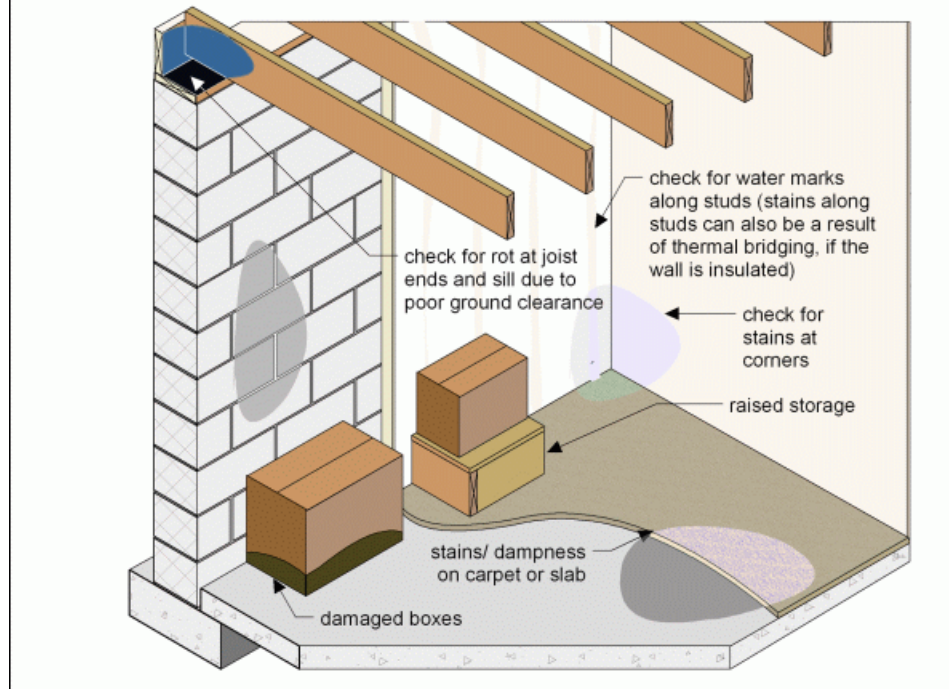
Basement leakage clues - rot, stains or water marks
