# INSPECTION REPORT

For the Property at:  
**374 ADELAIDE AVE WEST**  
OSHAWA, ON L1J 2R6

Prepared for: X X  
Inspection Date: Saturday, September 12, 2020  
Prepared by: Paul Christensen RHI, NCI

Report No. 1785

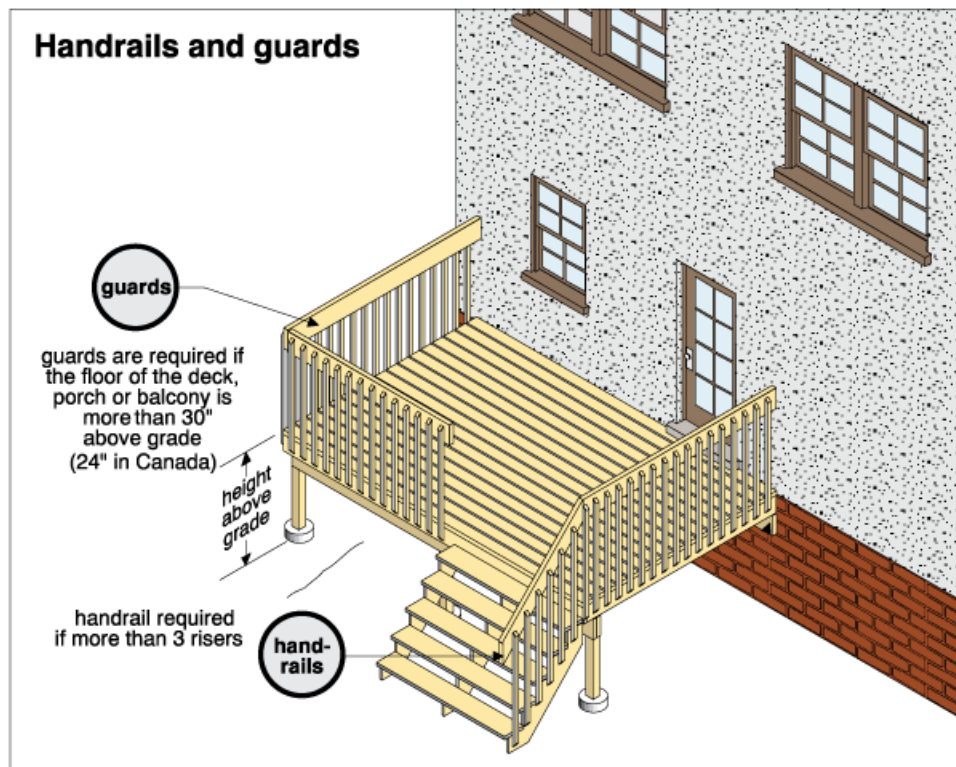
5. Condition: • Ineffective

Implication(s): Fall hazard

Location: Front

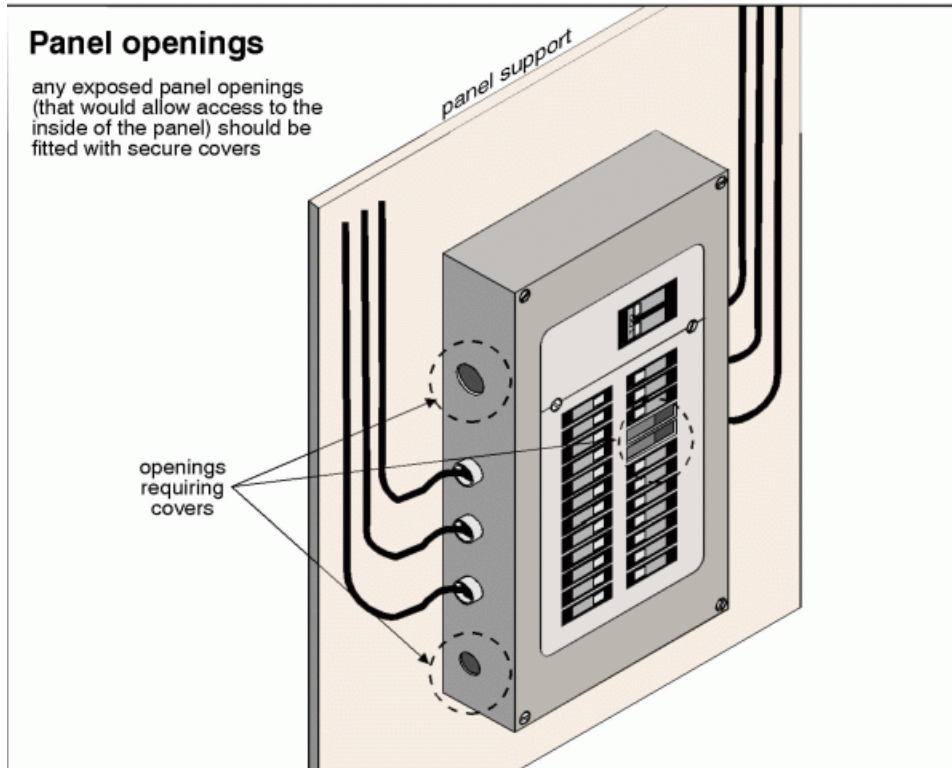
6. Openings in panel

**8. Condition:** • Openings in panel

**Implication(s):** Electric shock | Fire hazard

**Location:** Basement Front

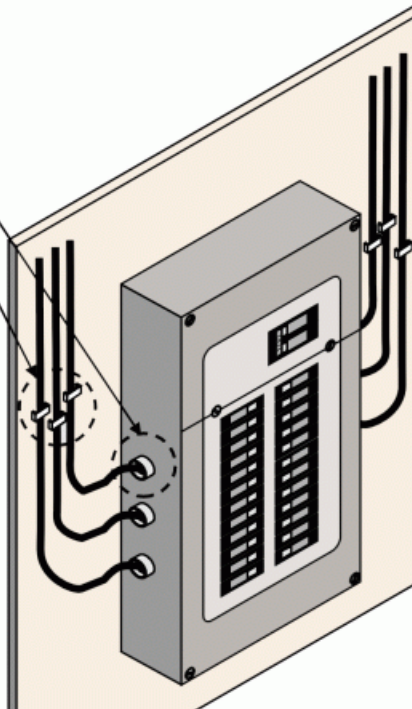
**10. Condition:** • Not well secured

**Implication(s):** Electric shock | Fire hazard

cables should be clamped where they enter the panel

they should also be secured within 12 inches of the panel

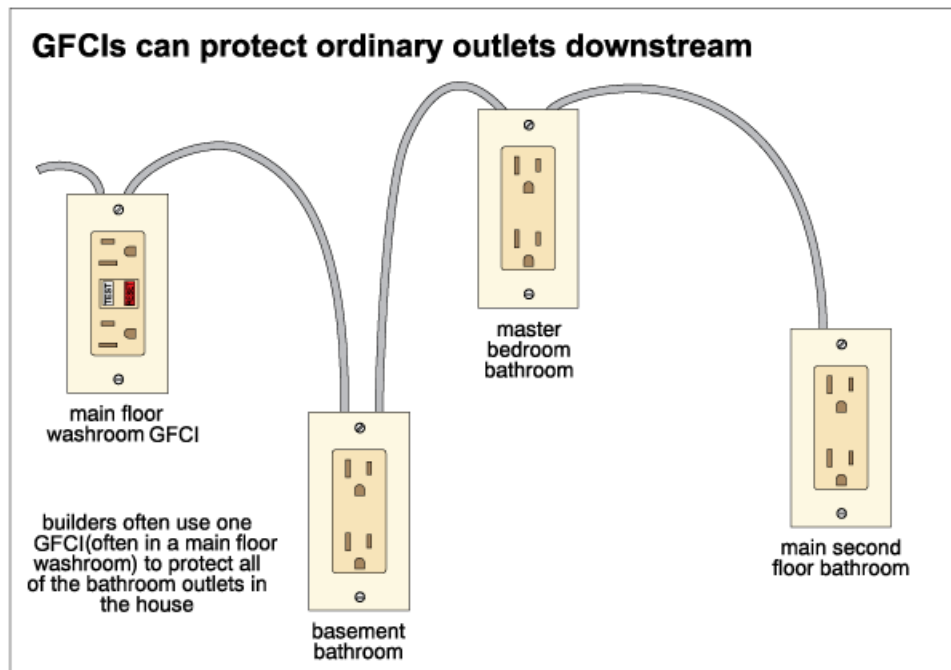
13. Condition: • Test GFI receptacle(s) monthly. Implications: Electric Shock.

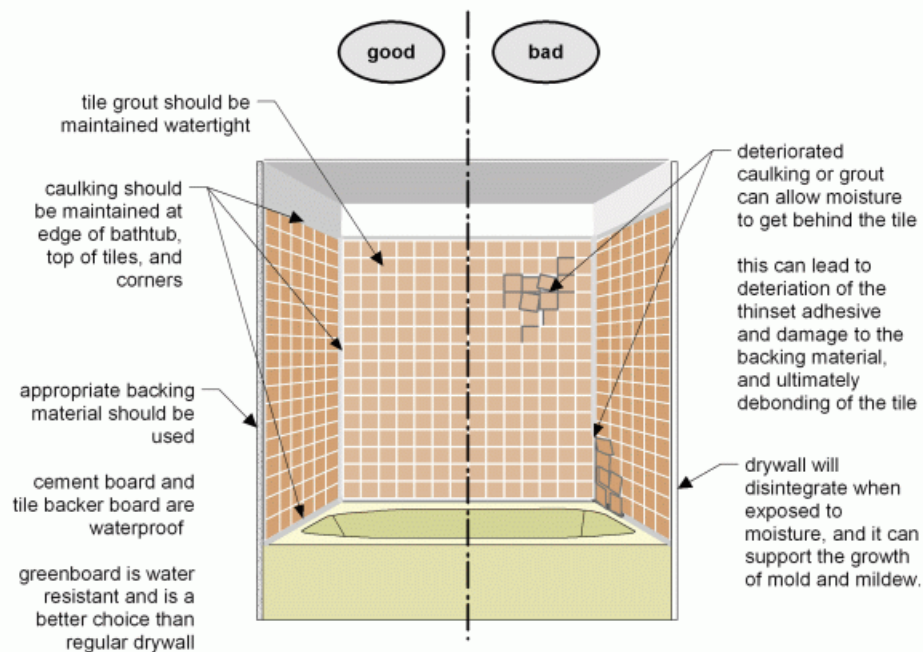
13. Caulking loose, missing or deteriorated

**25. Condition:** • Caulking loose, missing or deteriorated

**Implication(s):** Chance of water damage to structure, finishes and contents

**Location:** Second Floor Bathroom

## Expansion, debonding of tile due to moisture

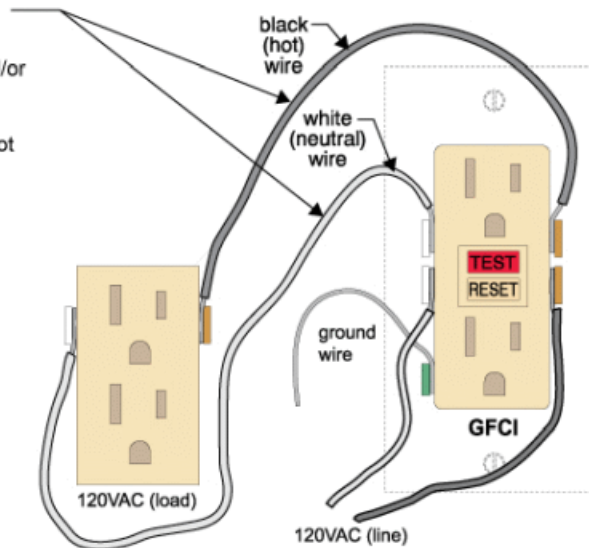
**26. Condition:** • No GFCI (Ground Fault Circuit Interrupter)

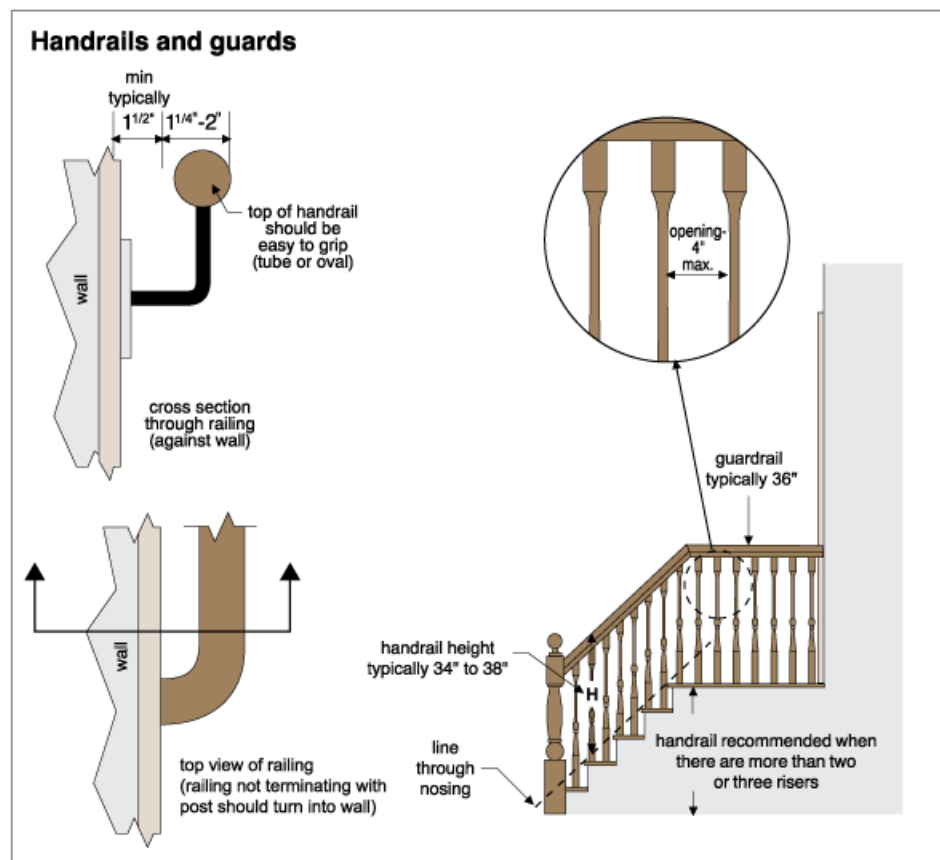
14. Missing

**28. Condition:** • Missing

Missing, under construction

**Implication(s):** Fall hazard

**Location:** Basement
