# Your Inspection Report

9 Sandcliff Rd  
Toronto, ON M6N 2M4

RE: Report No. 61620  
9 Sandcliff Rd  
Toronto, ON  
M6N 2M4

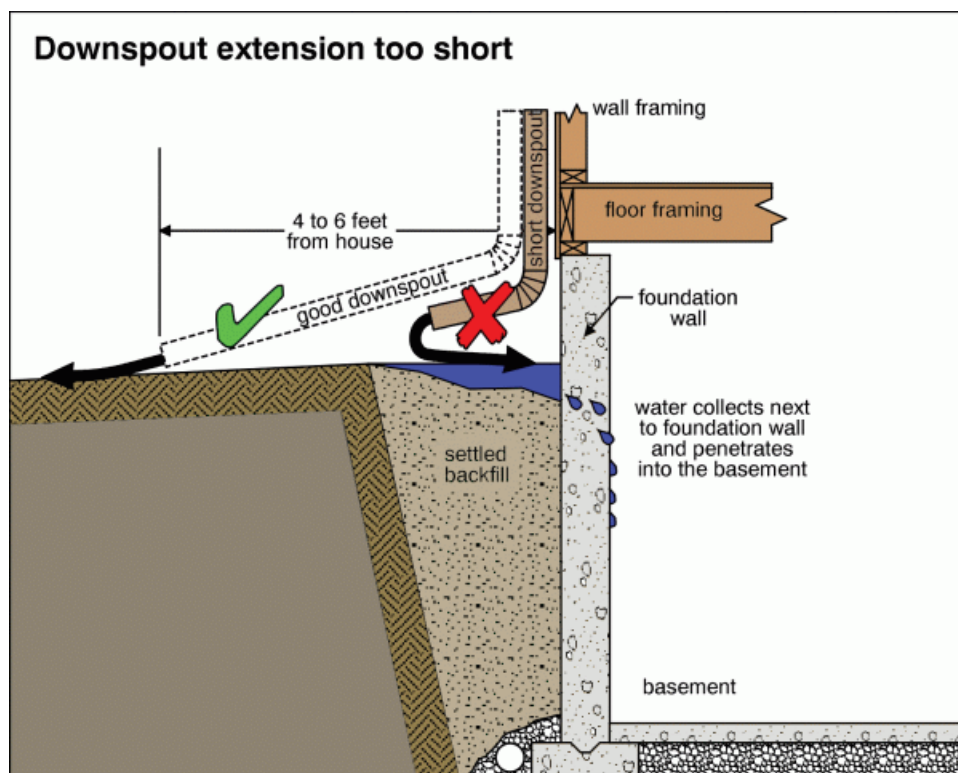
**Condition:** • Less-than-ideal downspout location

**Task:** Monitor / Improve

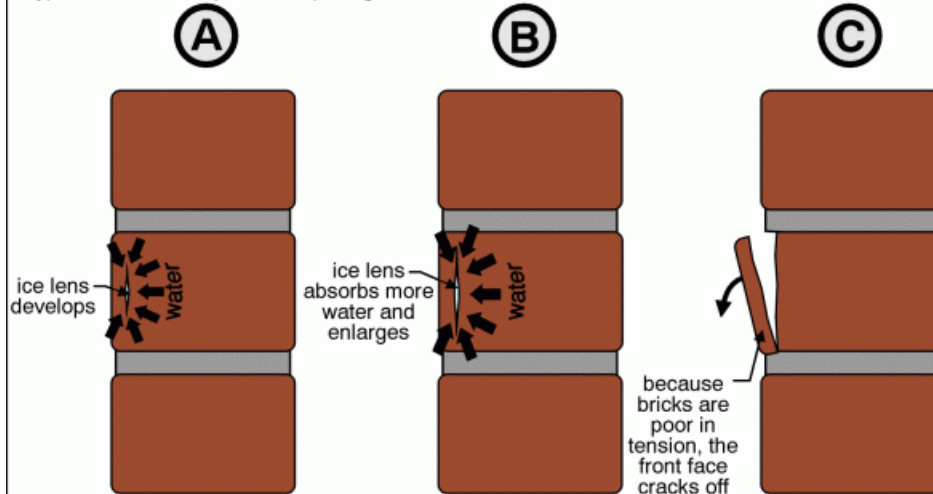
## Freezing water spalls bricks

**Condition:** • [Masonry deterioration](#)

Some brick doesn't handle water very well (it will absorb moisture and deteriorate).

freezing temperatures, saturated brick and a susceptible type of brick are required for spalling to occur

brick spalling is often a problem with bricks that have a tough glazed finish and a soft permeable core

Parging can be applied as a sacrificial material and/or the grades should be sloped away to minimize future damage.

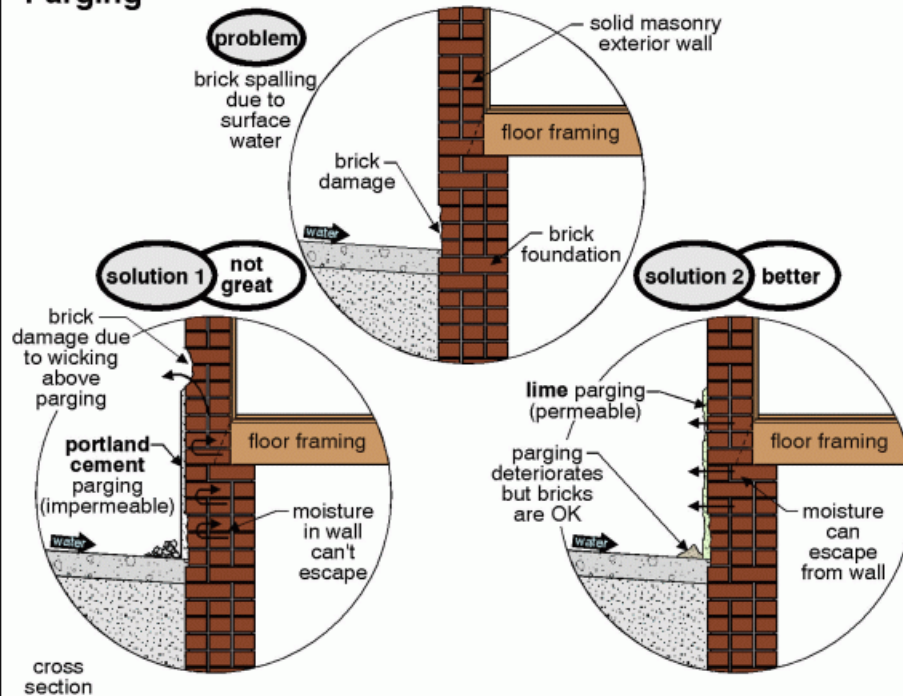
## Parging

Masonry deterioration

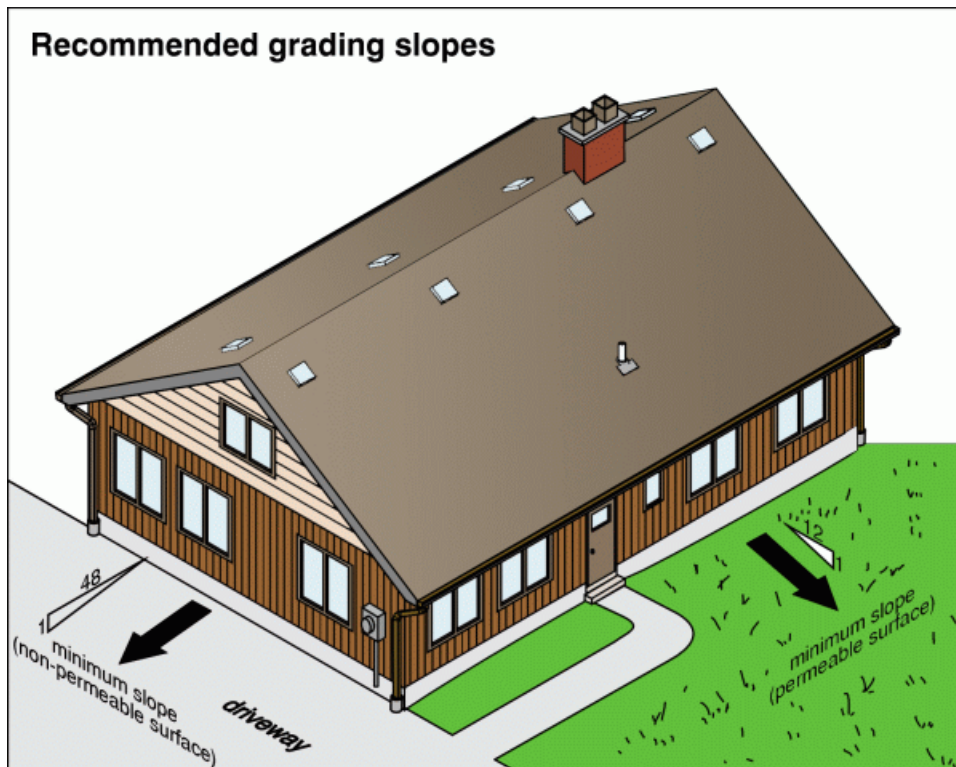
**Condition:** • Lot grading

**Implication(s):** When trying to minimize basement leakage, it is always best to be proactive and slope the grades away from the house.

**Task:** Monitor / Improve

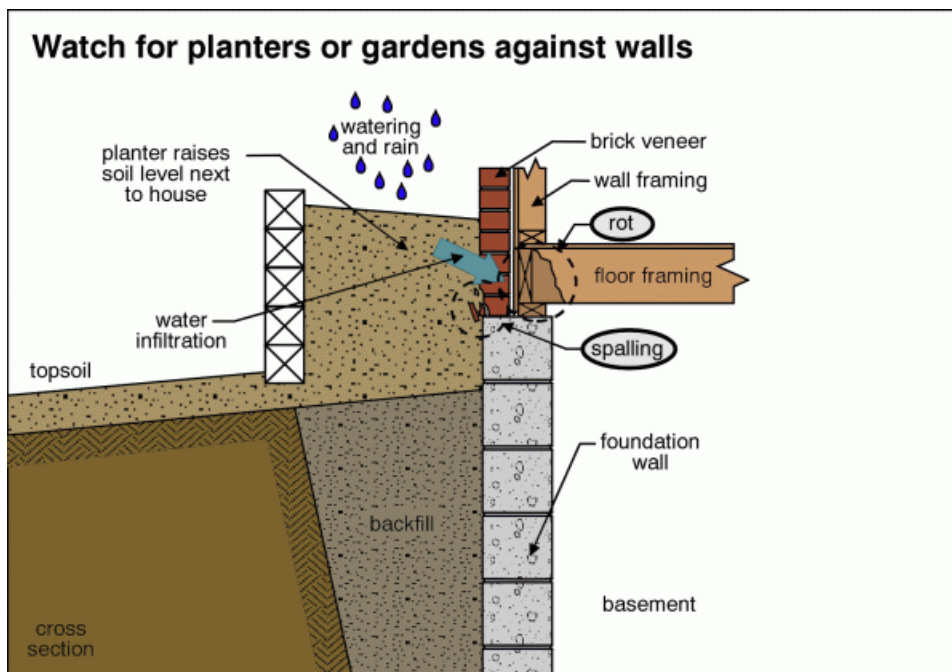
## Condition: • [Planters and gardens against walls](#)

Gardens and planters (and sprinklers) next to the house increase the risk of moisture problems in the basement, especially if they are watered regularly.

**Task:** Monitor / Improve

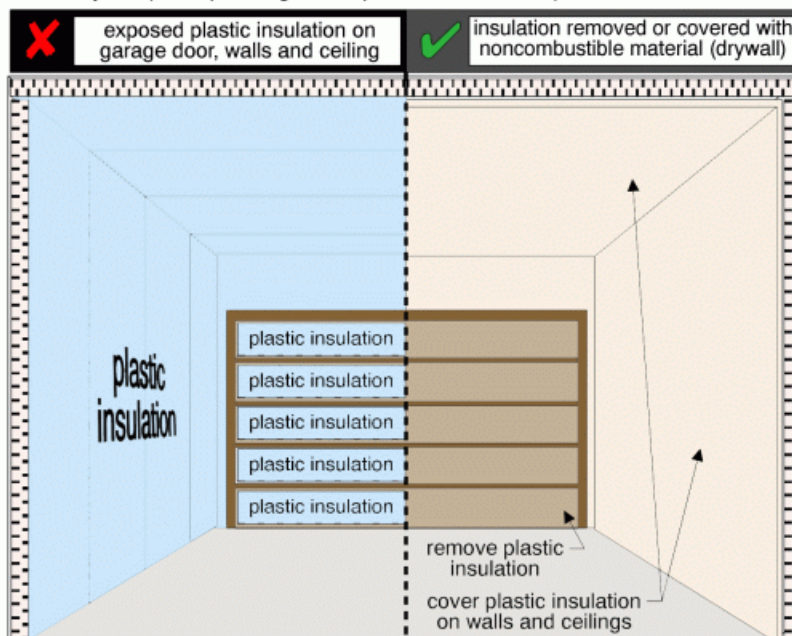
### **Exposed combustible insulation**

combustible insulation in basements, crawlspaces, garages or any other areas exposed to people, heating and/or electricity sources should be covered with drywall (wood paneling is acceptable in most areas)

*Exposed combustible insulation*
