Your Inspection Report

1 Sample St., Suite A,B,C,&D
Sacramento, CA 95820

INSPECTION DATE:
Tuesday, August 23, 2016

RE: Report No. 1036, v.4
1 Sample St., A,B,C,&D
Sacramento, CA
95820

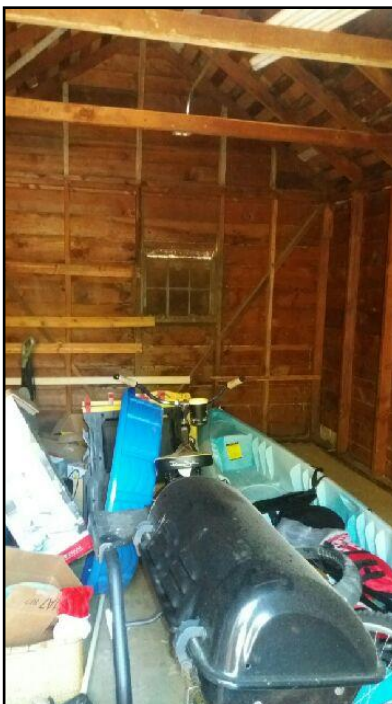
11. Storage in garage

Note: Storage in garage severely limited the inspection of the walls and floor of the garage

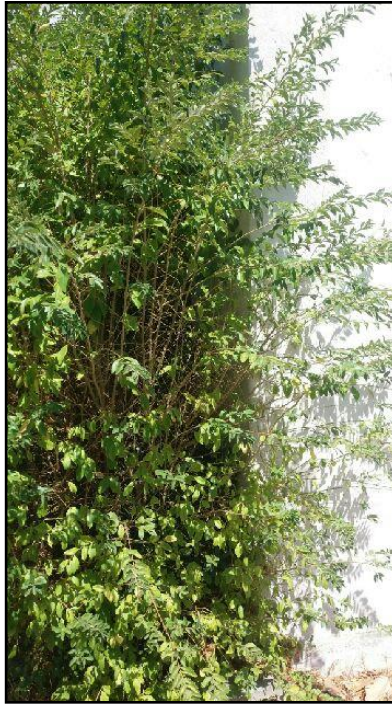
12. Vines/shrubs/trees against wall

- Vines/shrubs/trees against wall

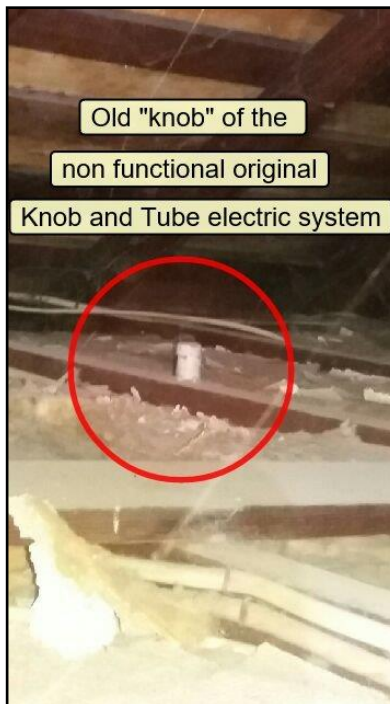
33.

Distribution wire material and type: • FYI. These structures were originally wired with Knob and Tube electrical system (see picture of a non functional evidence of this system). At the time of the inspection no knob and tube functional components were detected and it appears that all wires were replaced with the more modern Romex electrical wires.

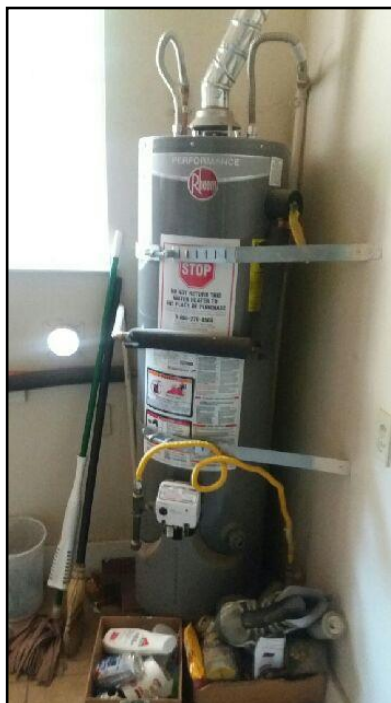
49. unit B water heater

New unit

28 gallons capacity

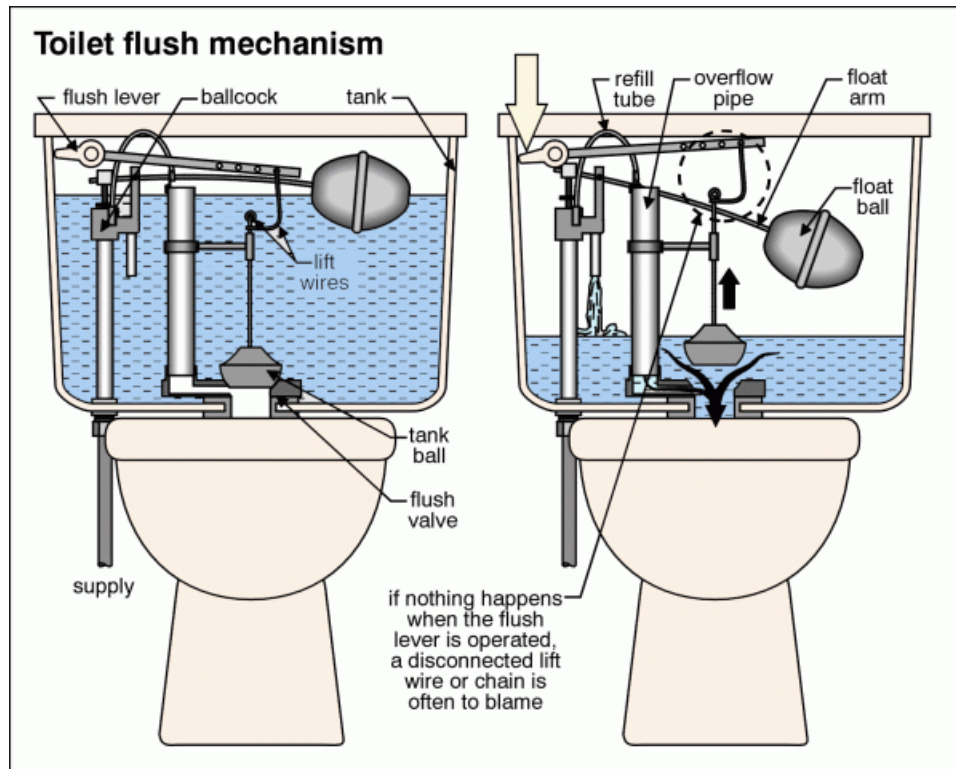
18. Condition: • [Flush mechanism inoperative](#)

I could not flush the water at Unit B although the tank was full and the valve was on. It appears to have an inoperative flush mechanism; repair/replace as needed.

Implication(s): Equipment failure | Sewage entering the building

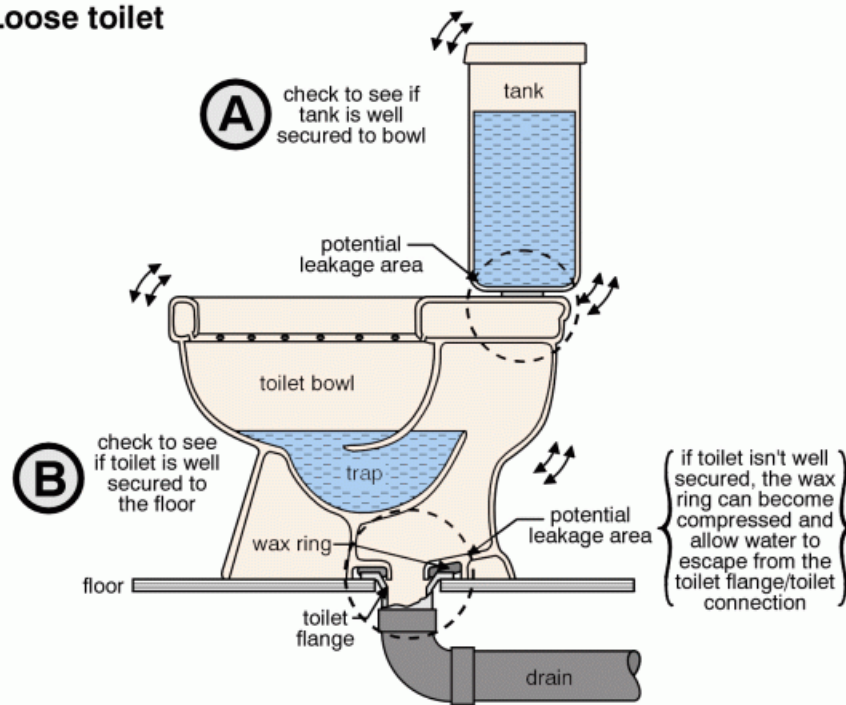
19. Condition: • [Loose](#)

The toilets in units C&D are loose and should be tightened/ anchored as needed.

Implication(s): Chance of water damage to contents, finishes and/or structure | Sewage entering the building

Loose toilet

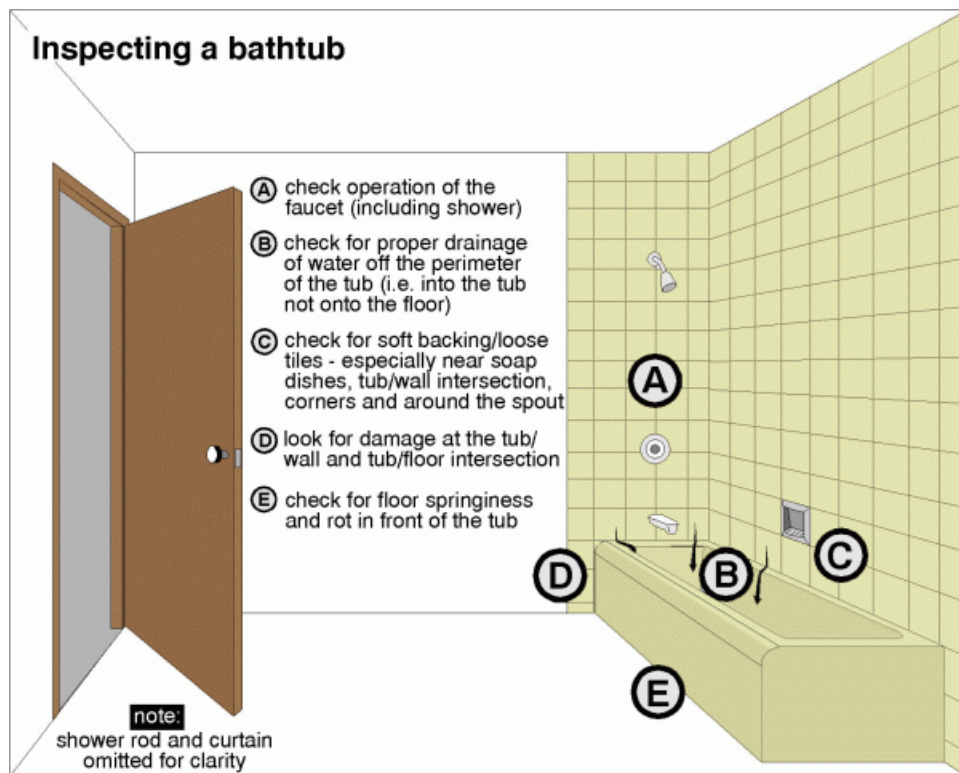
53. Slow drain

20. Condition: • [Slow drain](#)

Very slow drain at the unit D tub. Repair/improve as needed.

Implication(s): Chance of water damage to contents, finishes and/or structure

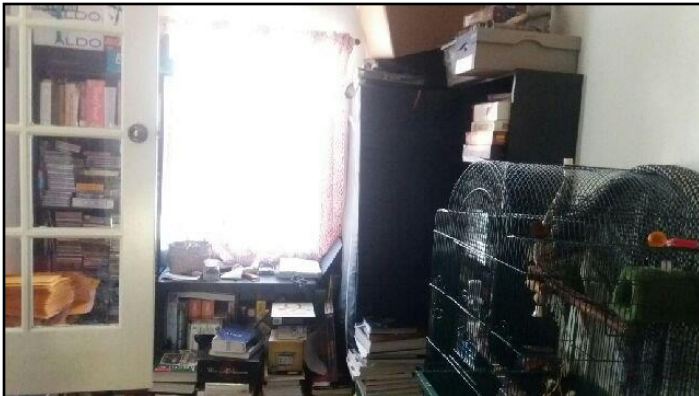
54. Storage/furnishings

Storage in all of the units sometimes severely limited inspection

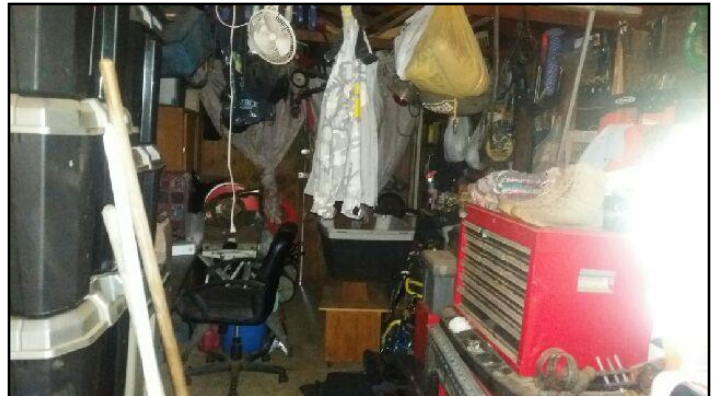
55. Storage/furnishings

- Storage in closets/cupboards
