# YOUR INSPECTION REPORT

FOR THE PROPERTY AT:  
245 Indian Grove  
Toronto, ON M6P 2H4

INSPECTION DATE:  
Friday, September 8, 2023

RE: Report No. 7267, v.3  
245 Indian Grove  
Toronto, ON  
M6P 2H4

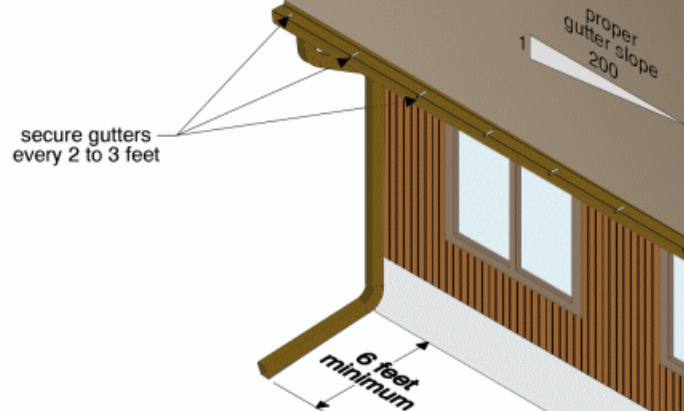
## Gutter and downspout installation

**Condition:** • [Discharge too close to building](#)

**Cost:** Minor

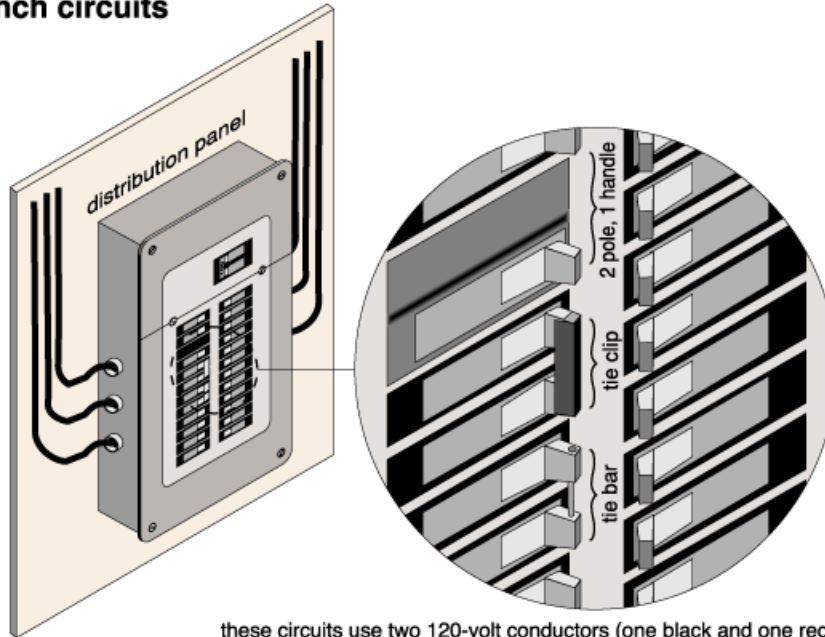
## Special circuit breaker for 240-volt and multi-wire branch circuits

these circuits use two 120-volt conductors (one black and one red)  
we need to disconnect both to work on circuit safely  
these special breakers ensure both are turned off

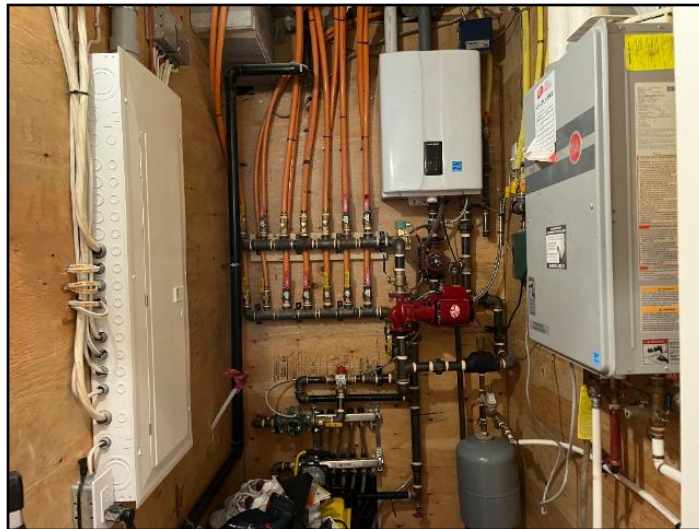
28. Premium custom installation

**General:** • Premium boiler with professional custom installation manifolds of both hydronic hot water distribution to radiators and in floor heating.
