YOUR INSPECTION REPORT

98 Willingdon Boulevard
Toronto, ON M8X 2H7

INSPECTION DATE:
Thursday, January 31, 2019

RE: Report No. 2395
98 Willingdon Boulevard
Toronto, ON
M8X 2H7

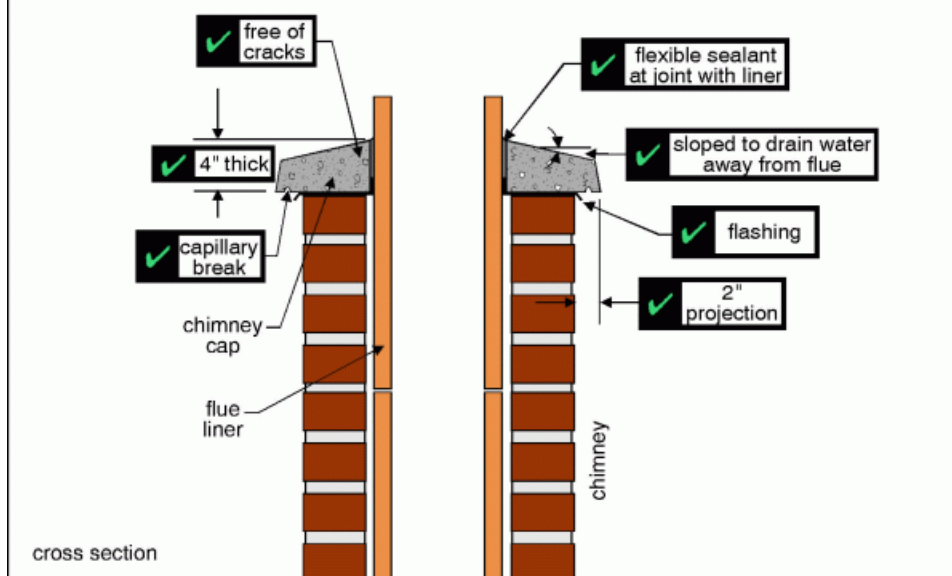
Drip edge on cap

What makes a good chimney cap?

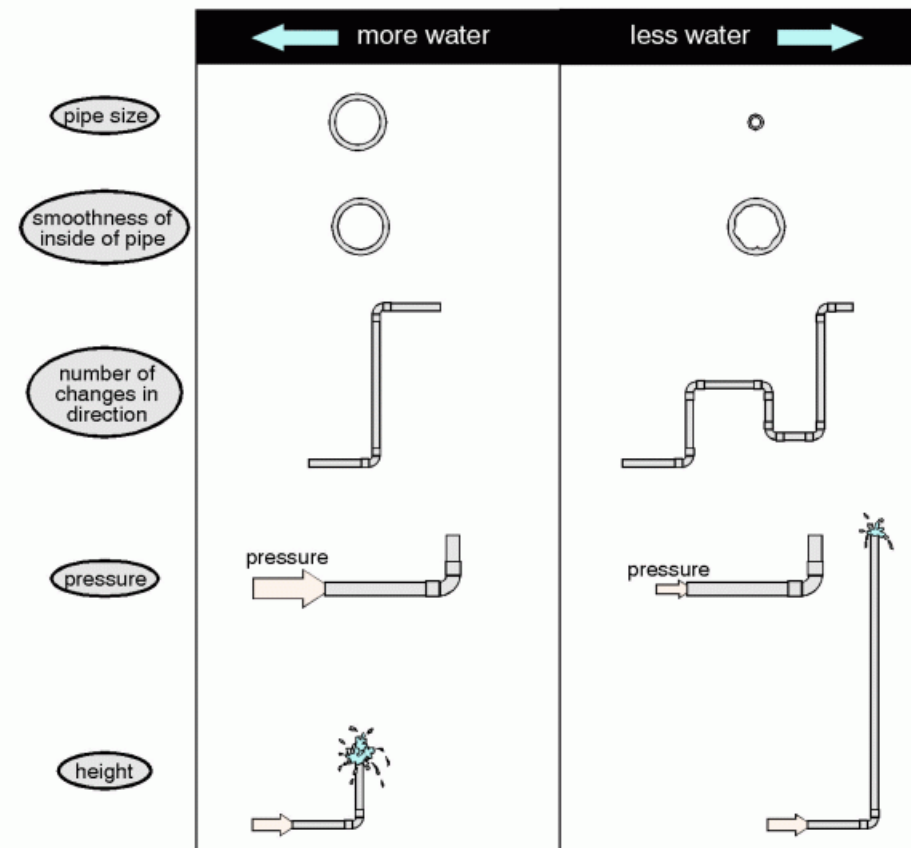
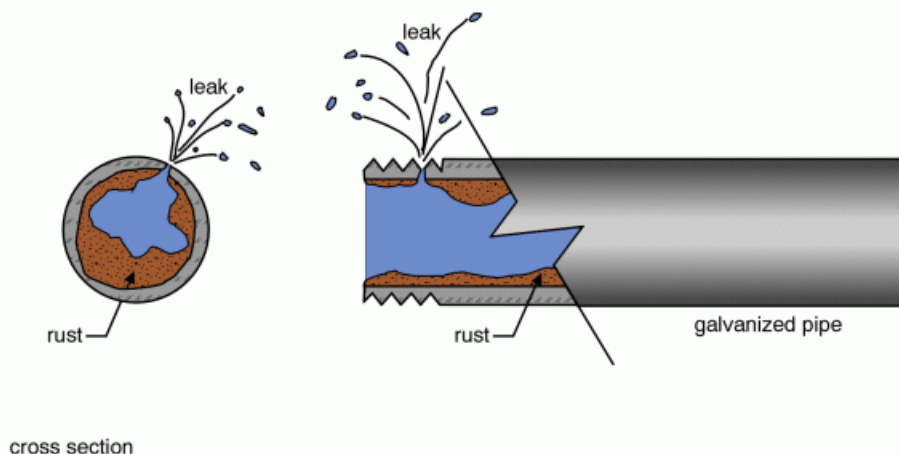
Insurance companies will not insure homes with active Galvanized plumbing and therefore replacement is required. The galvanized piping is corroded which affects the pressure / flow and is high leak risk. Click on the blue link for more information.

Galvanized steel pipe

rusting of galvanized pipe can greatly reduce water pressure and will eventually cause leaks as rust creates holes in the pipe walls

problems are likely to occur soonest on pipes carrying hot water, horizontal pipes and at threaded (thinner) sections

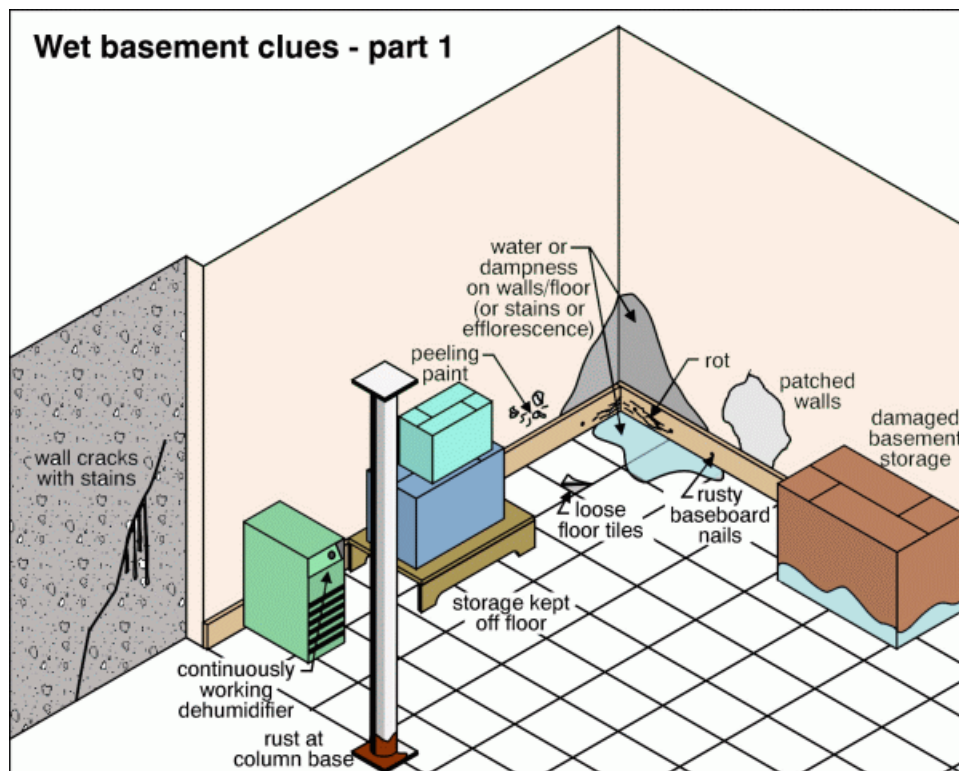
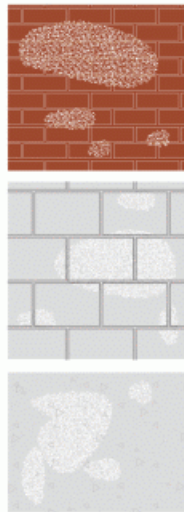
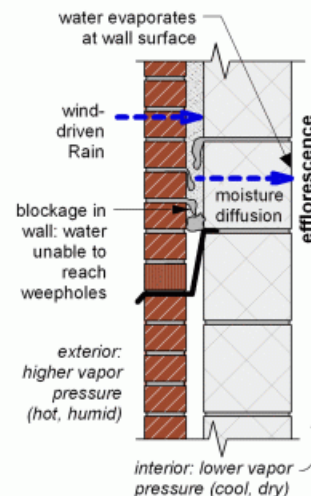
Basement leakage clues - efflorescence

efflorescence is a powdery, white substance that appears when water with dissolved minerals evaporates

efflorescence may form because of water on the surface of the wall, either from leaks or from condensation, for example:

efflorescence may also form because of moisture diffusion through a wall

concrete and clay are not water-tight

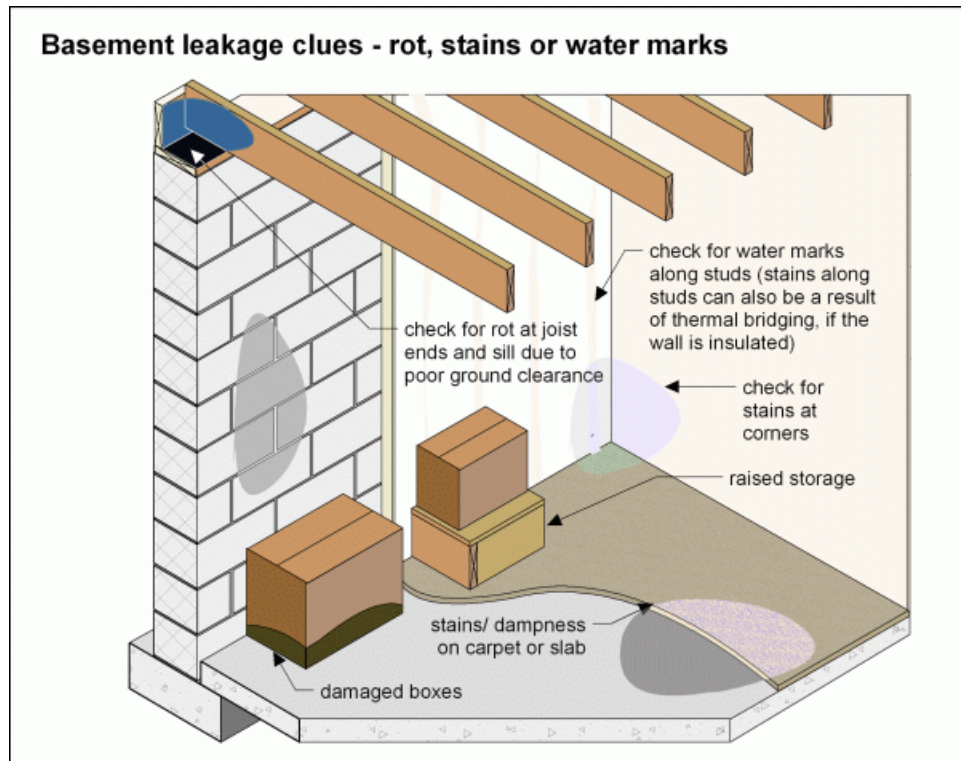
Basement leakage clues - rot, stains or water marks

It is common to find stains in a home of this age. No active water leakage was observed during the inspection. Homeowner noted that the cold room will see a minor amount of moisture after heavy sustained rainfalls.
