YOUR INSPECTION REPORT

719 Durie Street
Toronto, ON M6S 3H4

INSPECTION DATE:
Thursday, August 1, 2019

RE: Report No. 2509
719 Durie Street
Toronto, ON
M6S 3H4

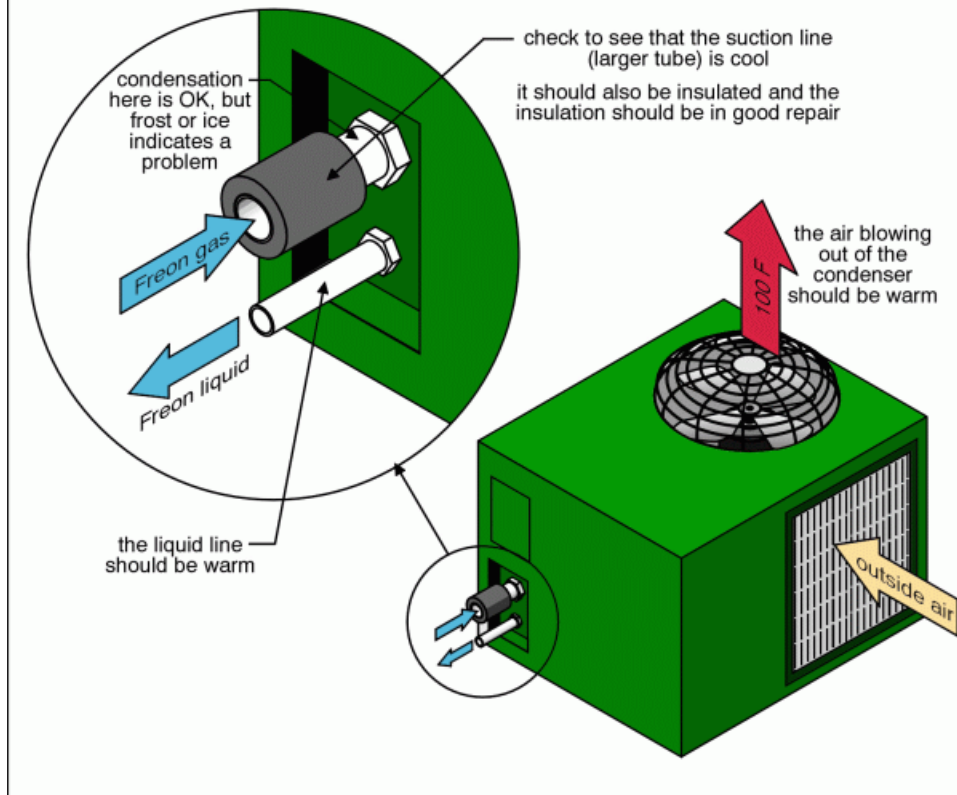
Condition: • Evidence of prior condensate leak. Was not active at time of inspection. May have occurred at any time in the past.

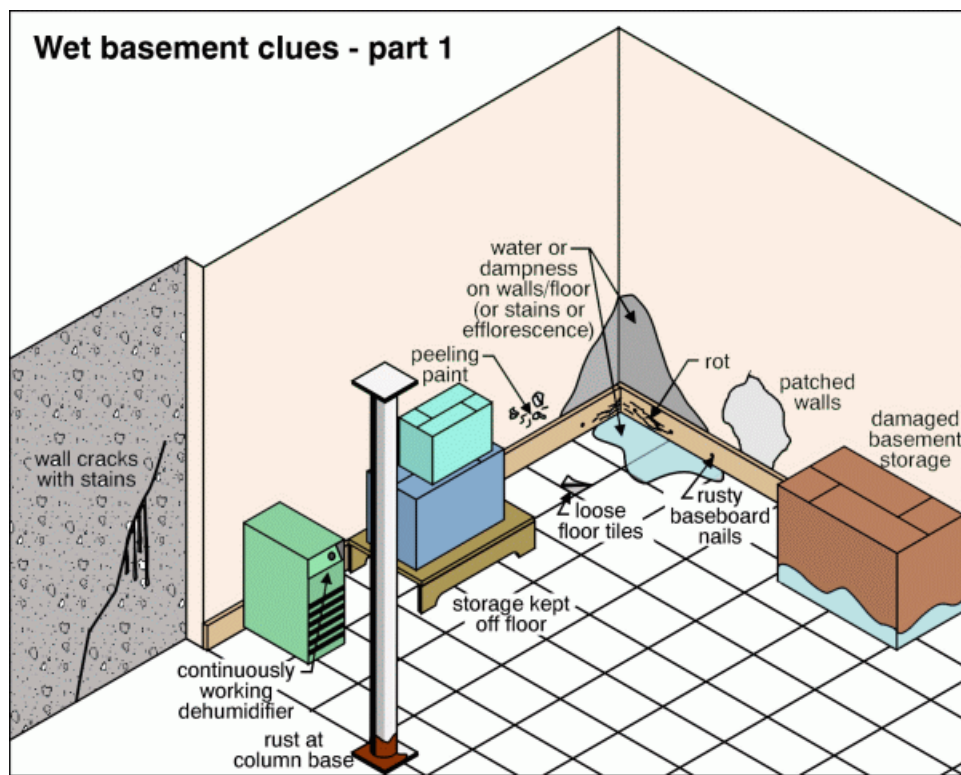
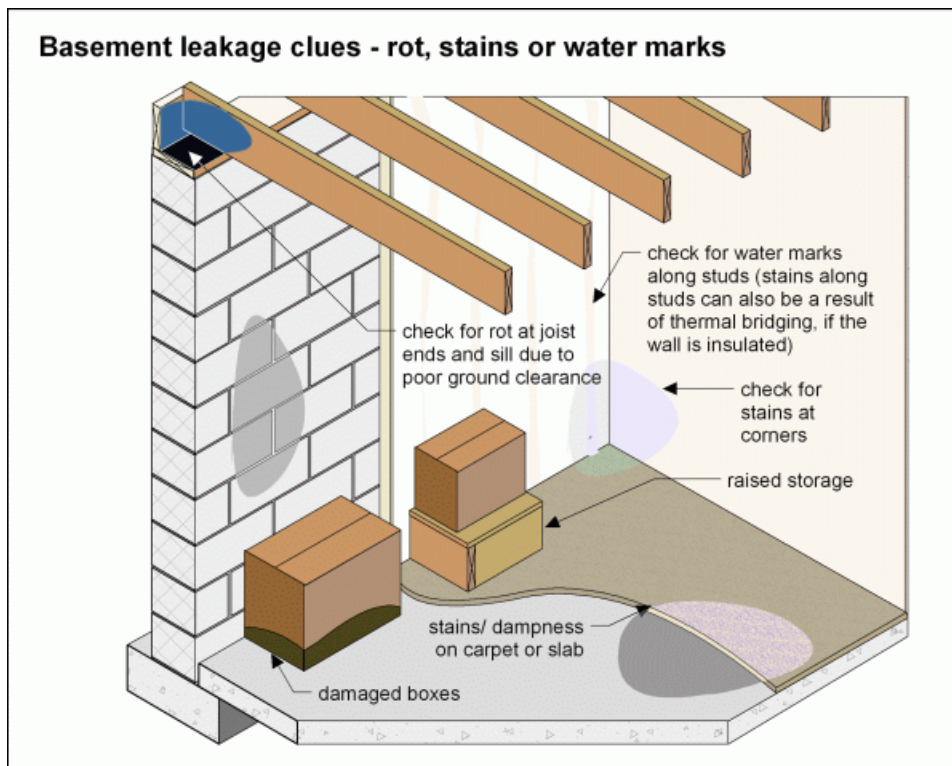
Condition: • Typical of many homes with stone, brick, or block foundations, some moisture can be expected from time to time and is not unusual. Exterior grading and water management improvements are generally effective at reducing basement moisture. A dehumidifier can also be used to keep humidity levels down.
