# YOUR INSPECTION REPORT

FOR THE PROPERTY AT:  
85 Prince Edward Drive South  
Toronto, ON M8Y 3V5

INSPECTION DATE:  
Wednesday, May 23, 2018

RE: Report No. 2277  
85 Prince Edward Drive South  
Toronto, ON  
M8Y 3V5

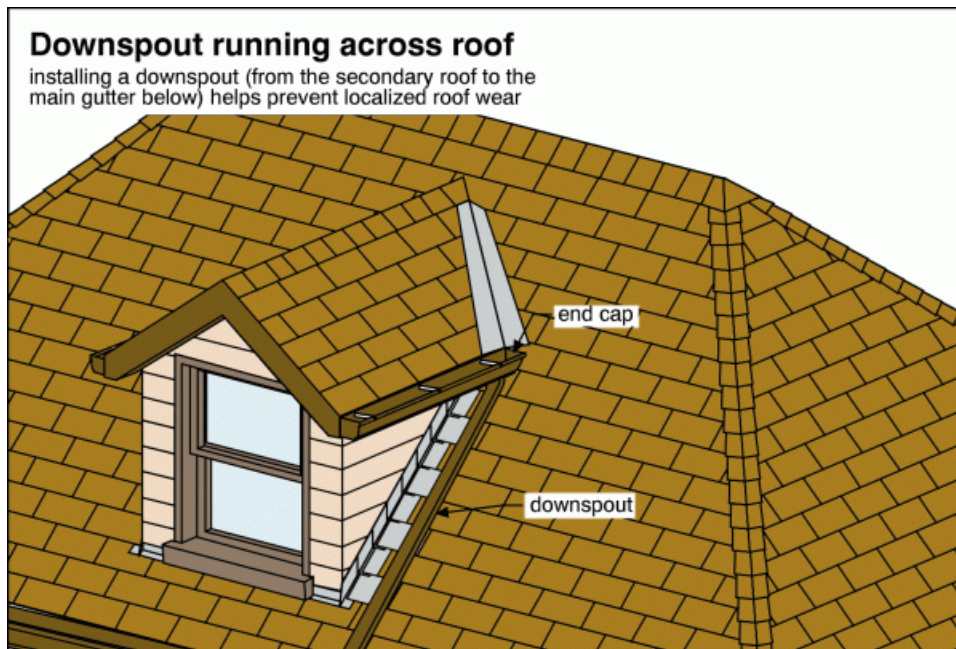
Condition: • [Discharge onto roofs](#)

**Implication(s):** Chance of water damage to contents, finishes and/or structure

Improvement recommendation. Extend Downspouts to lower gutter to protect roof from premature wear.

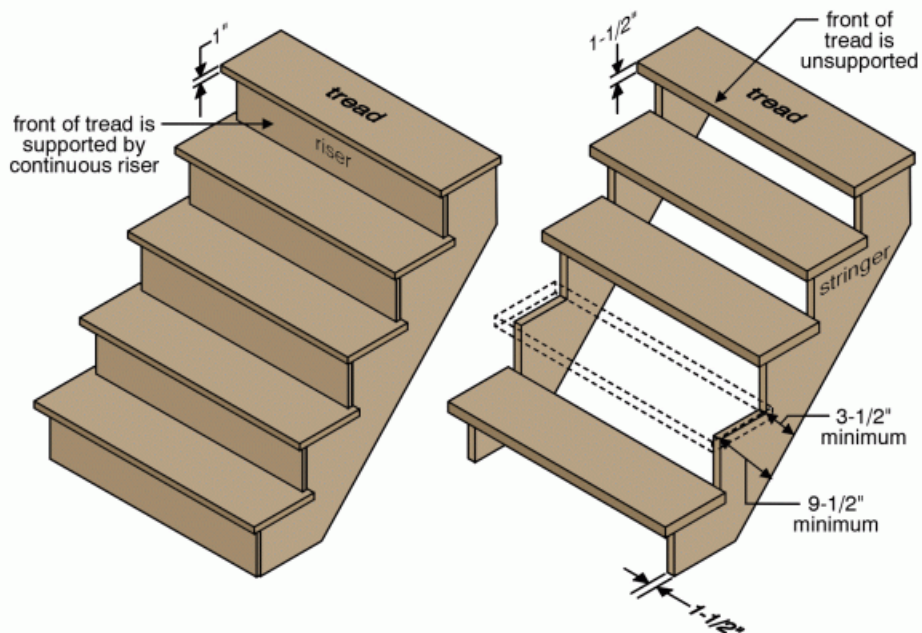
7. Damage

**Condition:** • [Damage](#)

**Task:** Replace

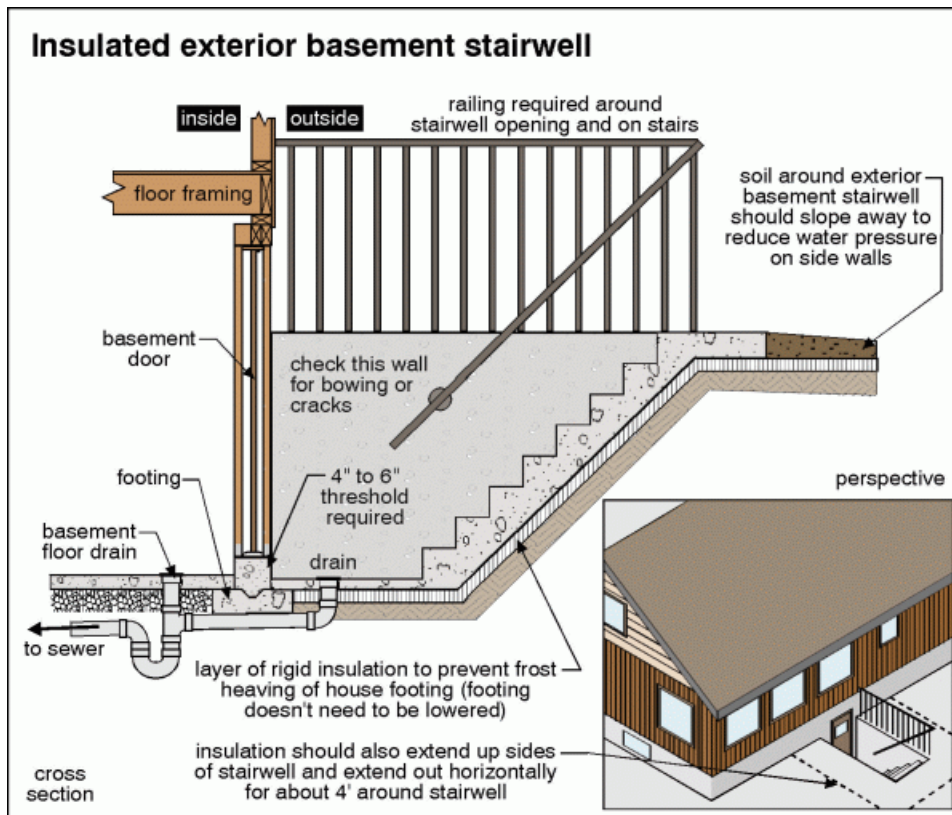
**Condition:** • [Guard and handrail problems](#)

**Implication(s):** Fall hazard
