INSPECTION REPORT

For the Property at:
123 SAMPLE WAY
FLOWERY BRANCH, GA 30542

Prepared for: SAMPLE HOME INSPECTION
Inspection Date: Monday, August 3, 2020
Prepared by: Keith Kerr

RE: Report No. 1015, v.2
123 Sample Way
Flowery Branch, GA
30542

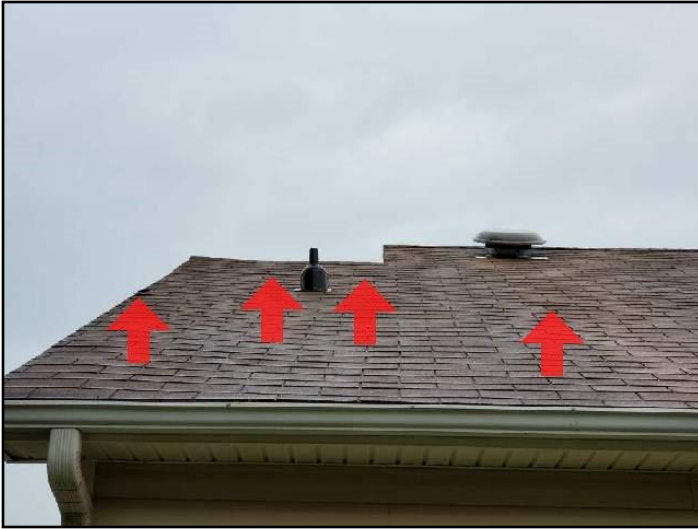
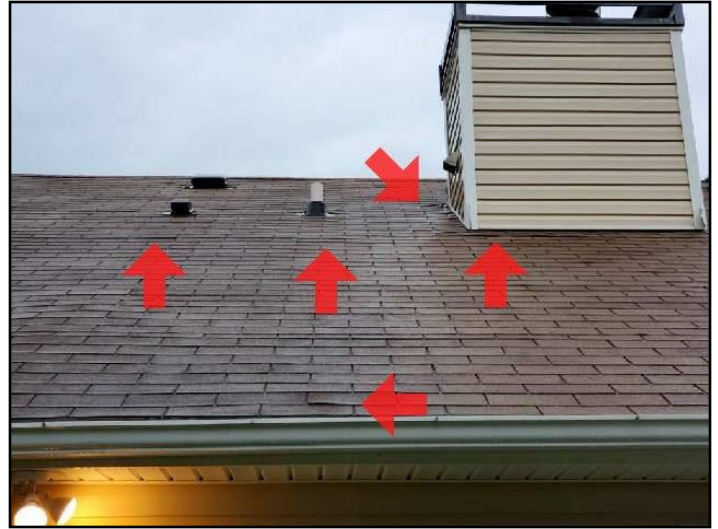
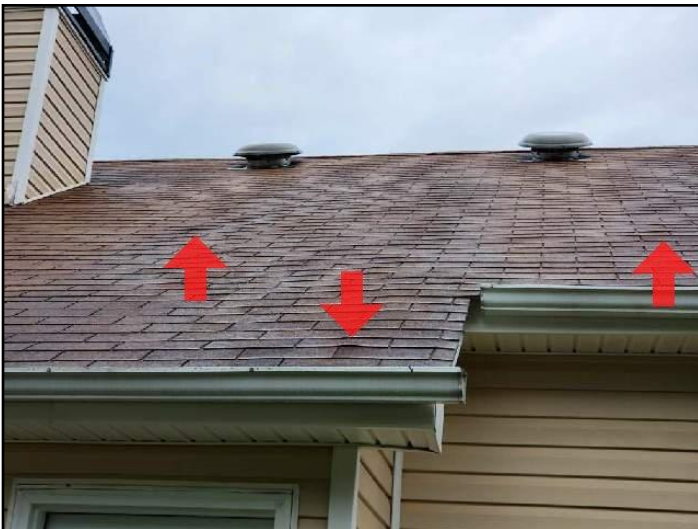
Numerous shingles cupping or curling on rear portion of roof. Recommend replacing damaged shingles and further evaluation by licensed roofing contractor.

Cupping, curling, clawing

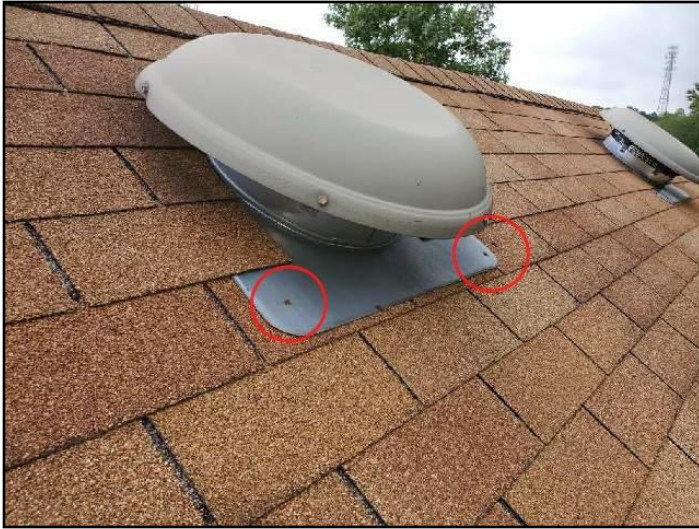
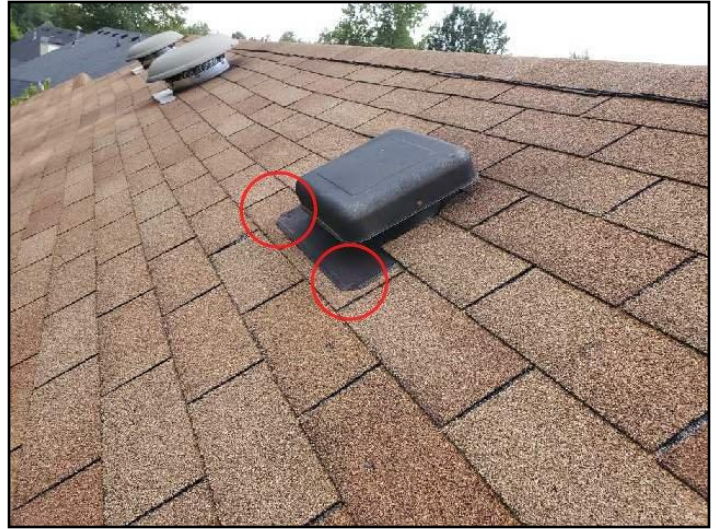
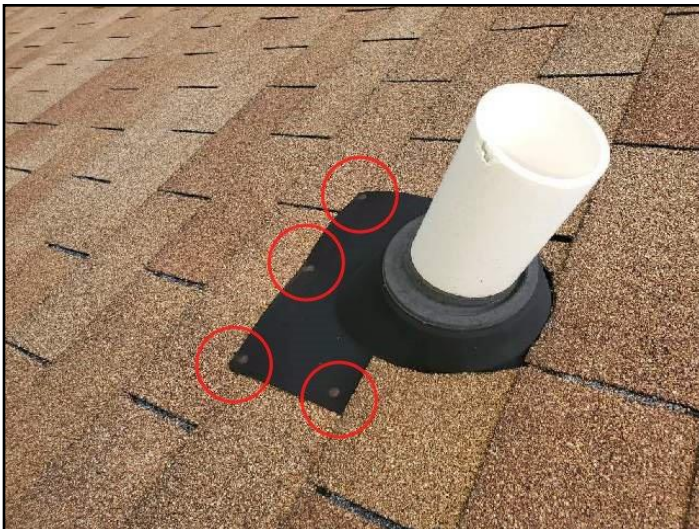
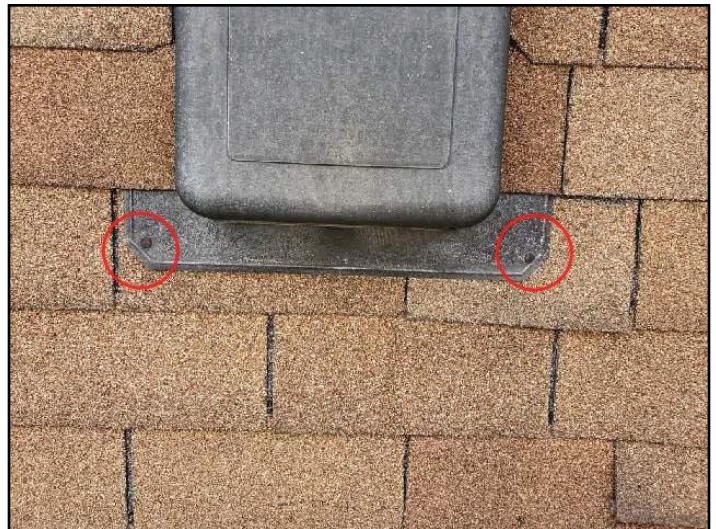
Recommend licensed roofing contractor seal all exposed fasteners on all pipe boots and roof boots to prevent water leak.

Exposed fasteners not sealed

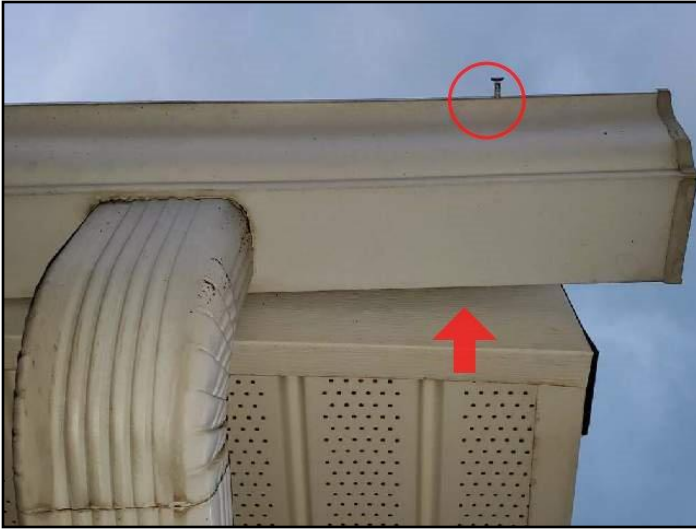
Nails backing out of gutters causing them to be loose and sag. Recommend qualified professional re-secure gutters to allow water to properly drain into gutter system. If gutters are not re-secured, there is a potential for water damage and rot to the fascia board.

Loose

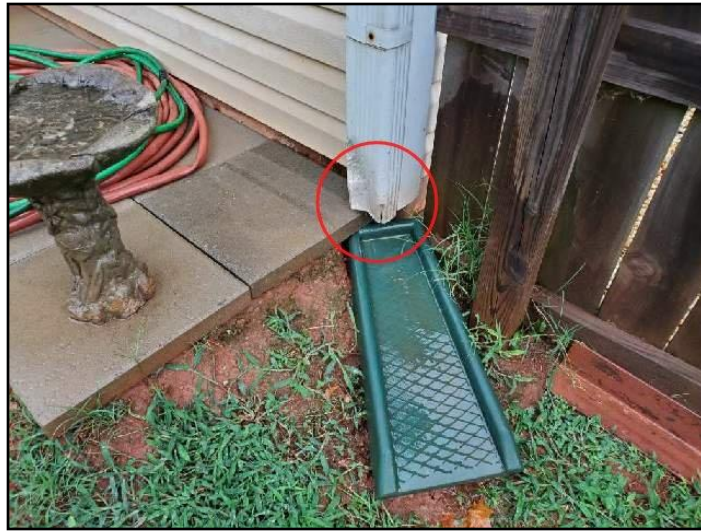
Recommend connecting down spout extender to shed water 5 to 6 feet away from foundation.

Discharge too close to building

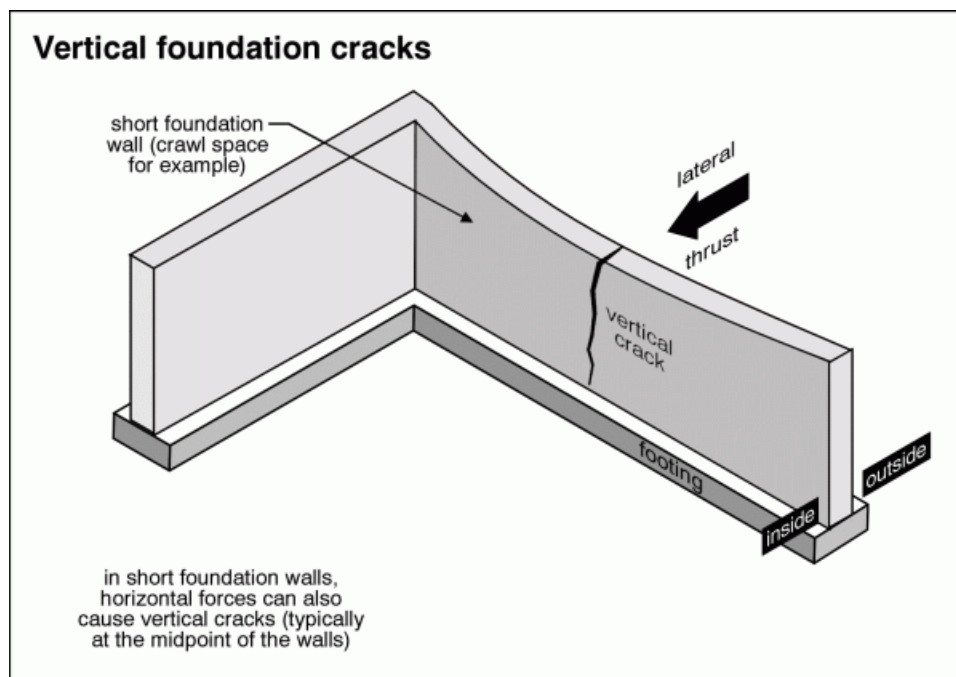
Location: Left Side

Typical vertical cracks in foundation on left side. Recommend monitoring and further evaluation if cracks get larger.

Implication(s): Chance of water damage to structure, finishes and contents | Weakened structure

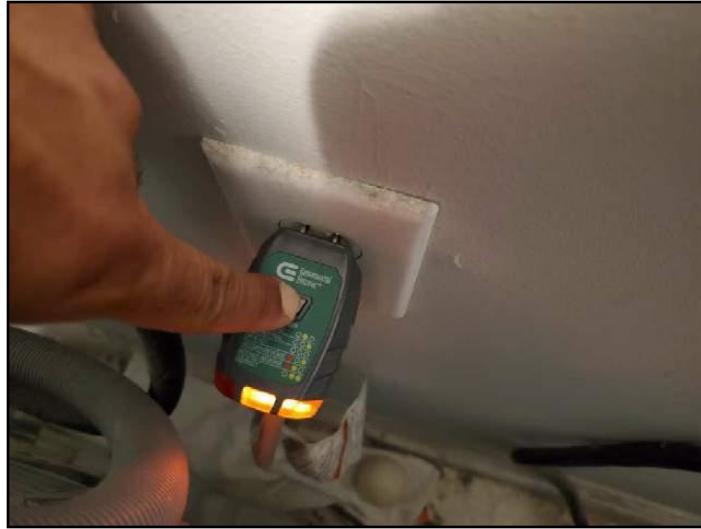
Location: Laundry Area

Implication(s): Electric shock

GFCI/GFI needed (Ground Fault Circuit...

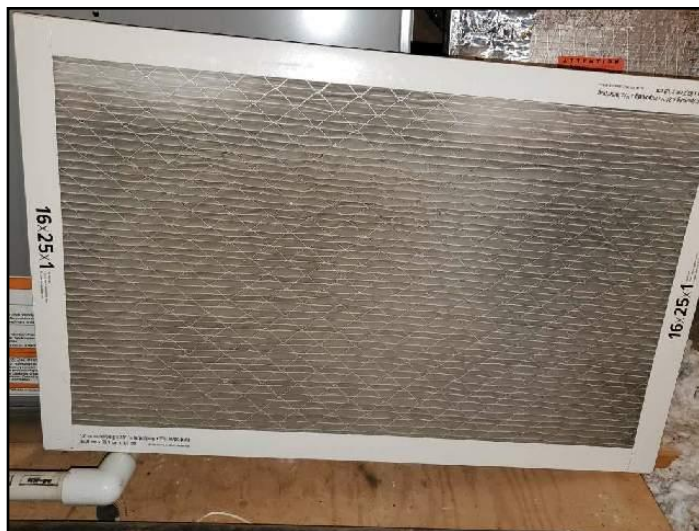
Location: Attic

Implication(s): Equipment ineffective | Increased heating costs | Reduced comfort | Increased maintenance costs

Dirty

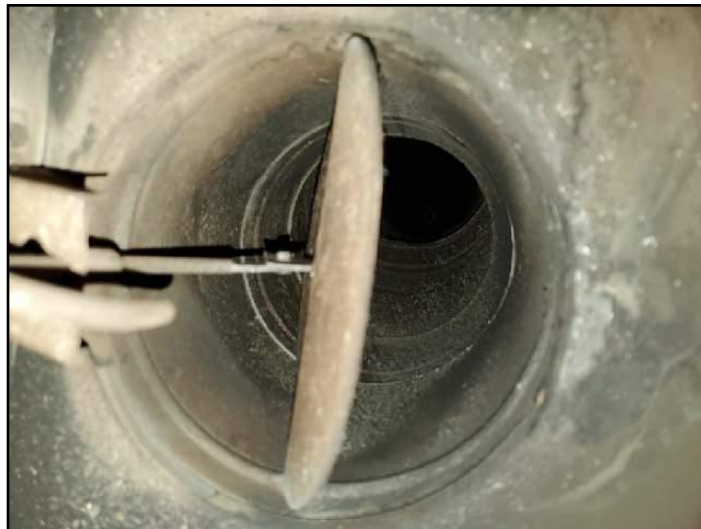
Inspect (and/sweep if needed) before using

Task: Clean

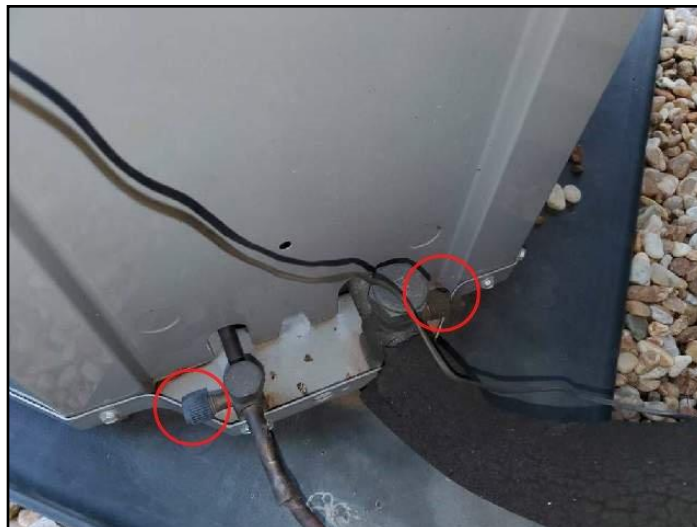
Location: Right Side

31. Condition: • Missing tamper resistant caps on freon lines. Recommend replacing current caps with tamper resistant caps to prevent theft of freon.

Missing tamper resistant caps on freon...

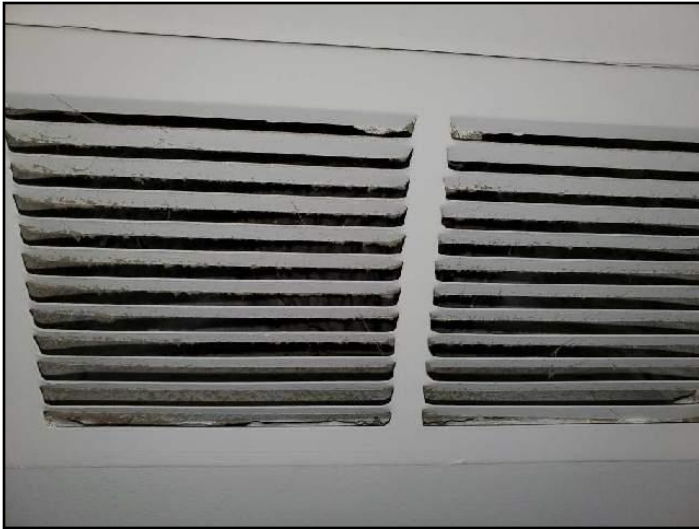
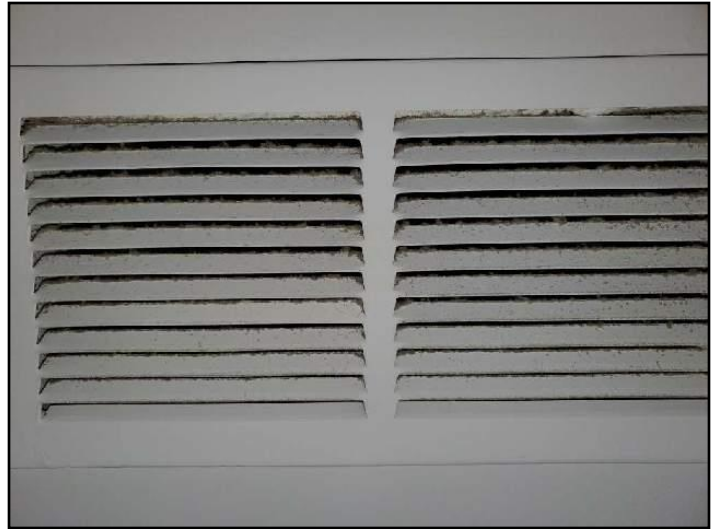
Location: Throughout

Dirty

Task: Clean

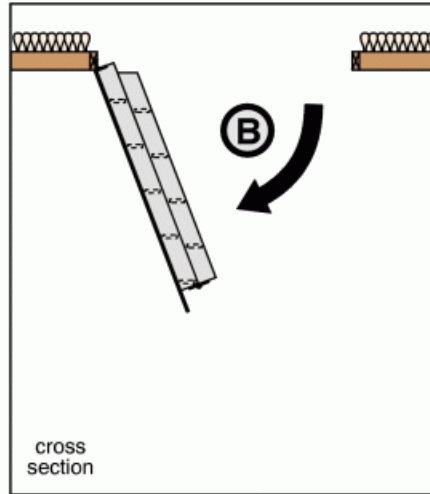
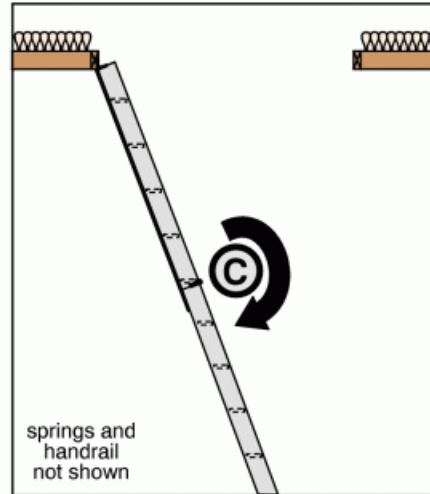
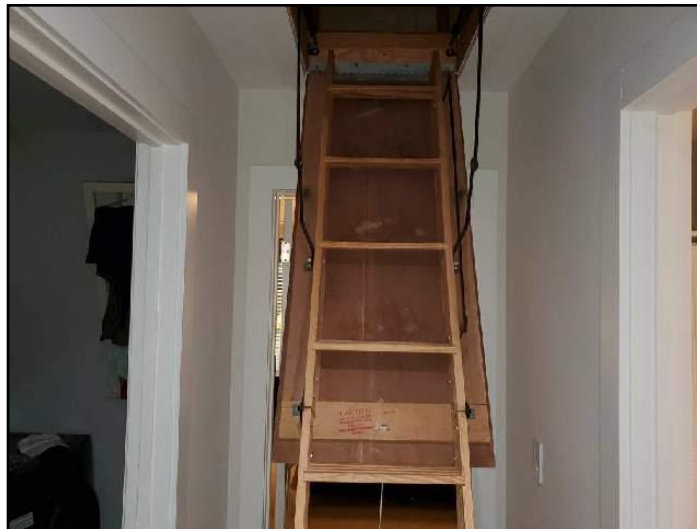
pull-down stairs can be a major source of heat loss (and air leakage) into an attic - an insulated cover should be provided

Not insulated

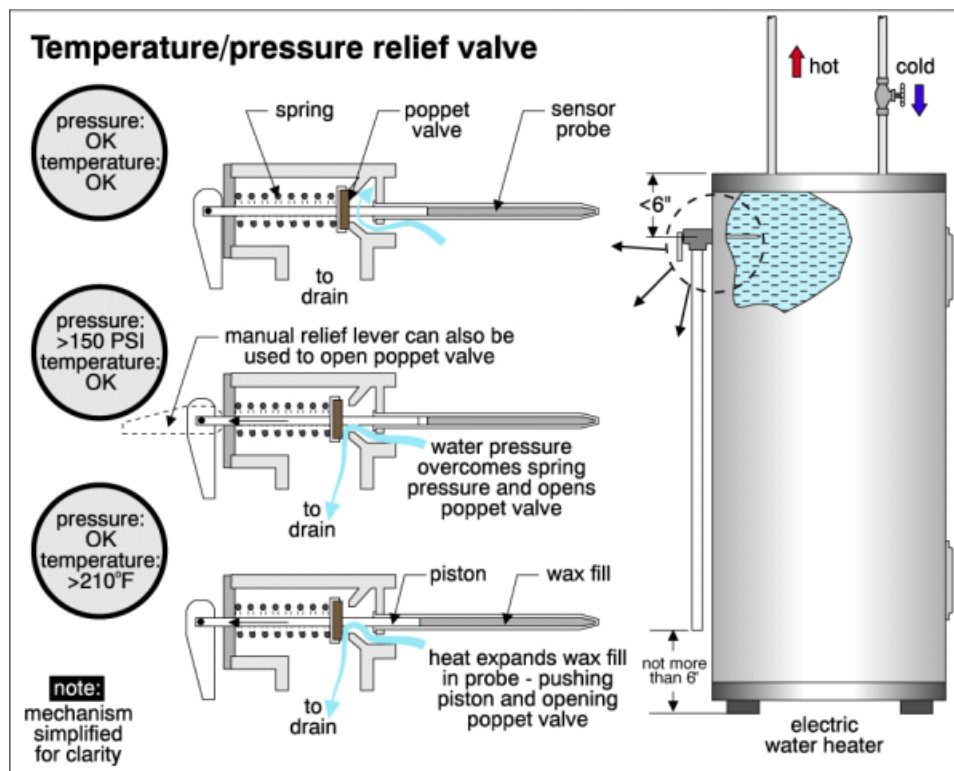
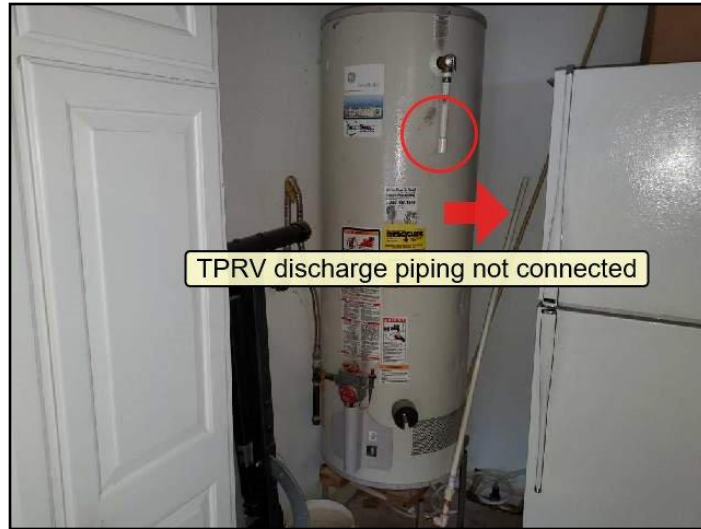
Location: Garage

34. Condition: • [Discharge tube too short](#)

Discharge pipe for the temperature pressure relief valve (TPRV) not connected. The discharge pipe shall not terminate more than 6 inches above the floor and shall not discharge in a manner that would cause personal injury. Recommend discharge pipe be reconnected to prevent injury in the event the valve opens to relieve hot water pressure.

Implication(s): Scalding

Discharge tube too short

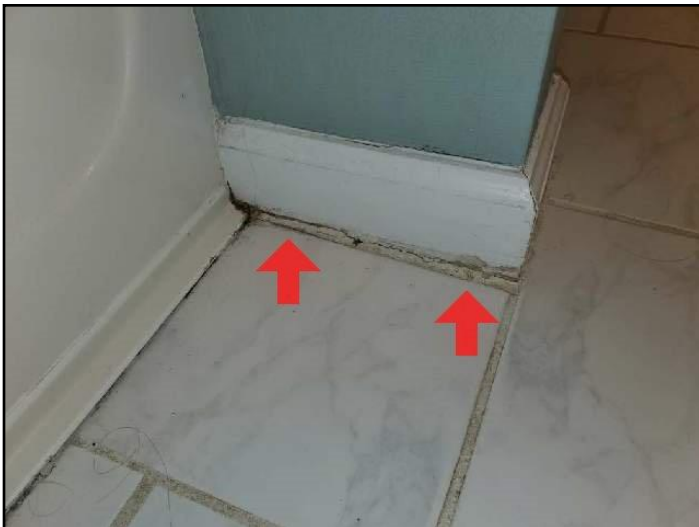
38. Condition: • [Grout missing](#)

Recommend repairing cracked/missing grout in master bathroom to prevent water damage.

Grout missing

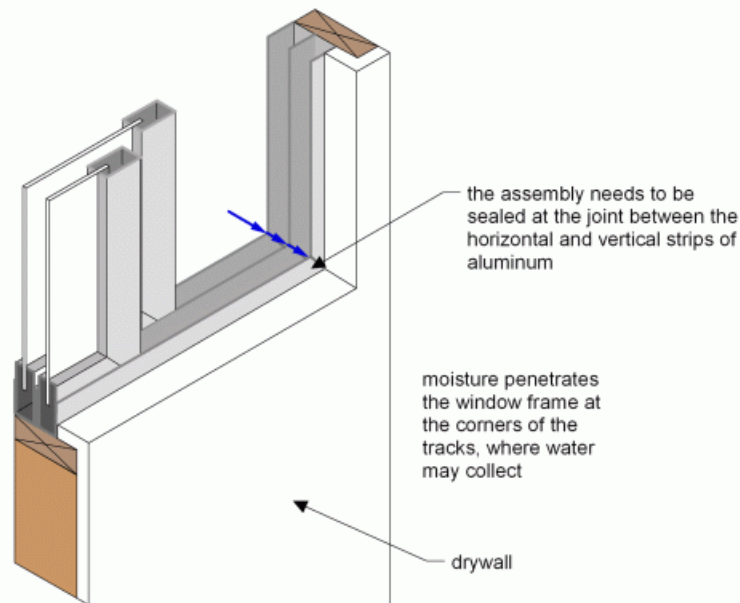
Location: Finished Room Over Garage

43. Condition: • [Water leaks](#)

Water stains observed on window sill in finished room over garage. Recommend further evaluation.

Implication(s): Chance of damage to finishes and structure | Chance of damage to structure

Water leaks

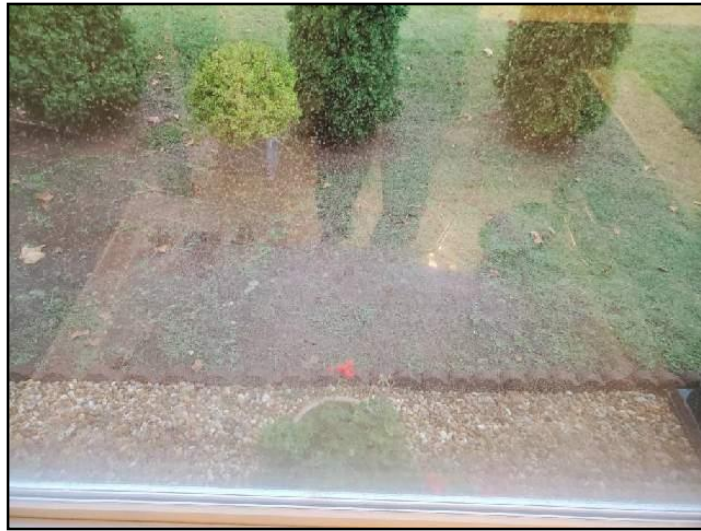
46. Condition: • [Lost seal on double or triple glazing](#)

Broken seal on master bathroom window. Recommend replacing window.

Lost seal on double or triple glazing
