# INSPECTION REPORT

For the Property at:  
**234 WAVERLEY ROAD**  
TORONTO, ON M4L 3T3

RE: Report No. 2715  
234 Waverley Road  
Toronto, ON  
M4L 3T3

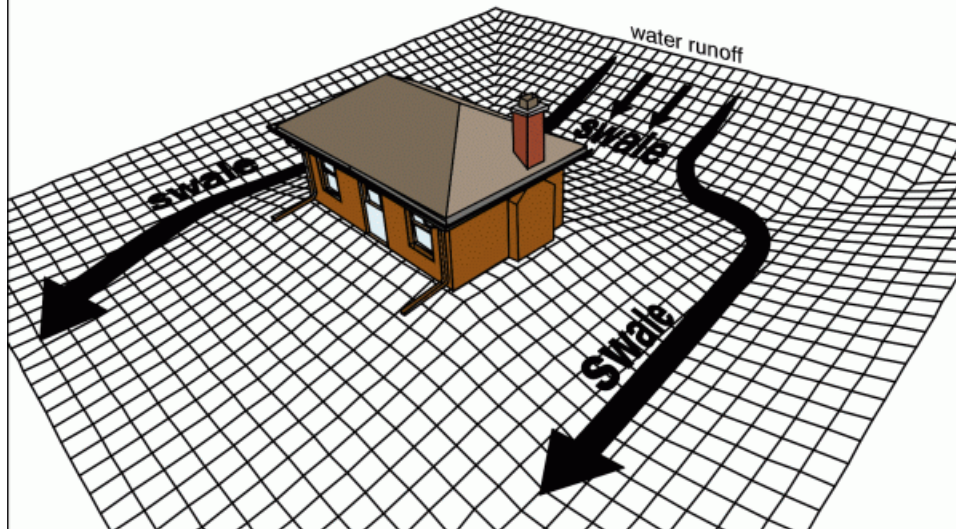
## Swales

when the overall lot drainage is toward the house, swales can be used to direct surface water away from the foundation

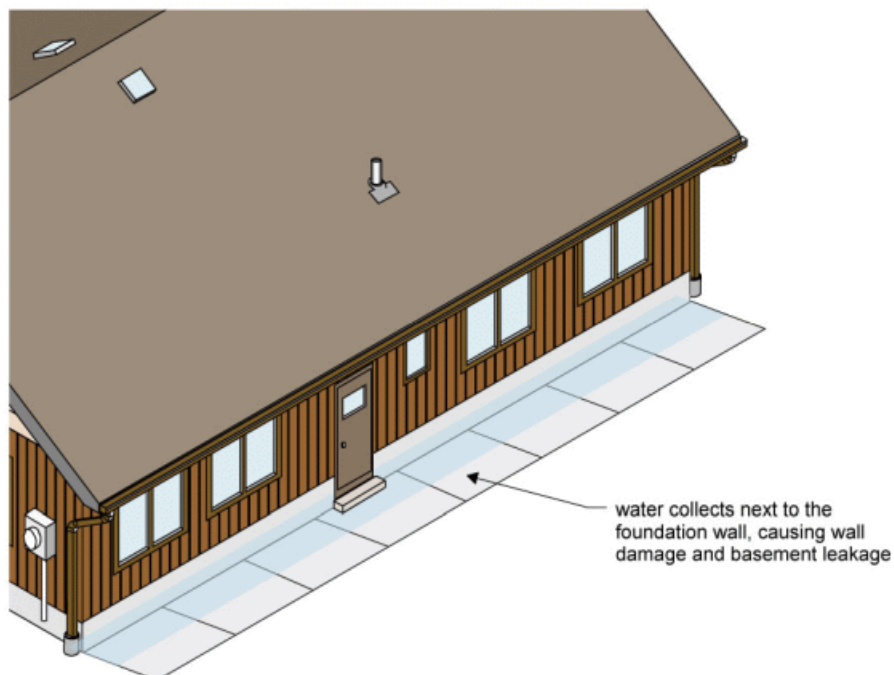
## Walk/patio sloping towards house

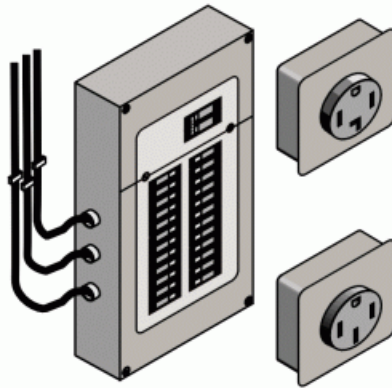
##### CUAL designation

#### 6. Condition: • [Connectors not compatible with aluminum](#)

CUAL is an appropriate designation for service equipment, panels, circuit breakers, dryer and stove receptacles, etc.
