INSPECTION REPORT

For the Property at:
211 MILL POND RD
ROSWELL, GA 30076

Prepared for: SAMPLE CONDO
Inspection Date: Monday, November 26, 2018
Prepared by: John Watson

Report No. 1011, v.2

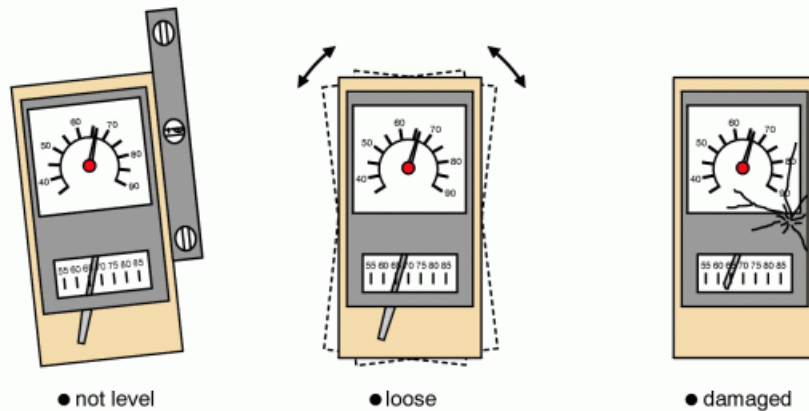
Thermostat conditions to watch for

- not level
- loose
- damaged
- poor location
- dirty
- poor adjustment/calibration
- anticipator problems

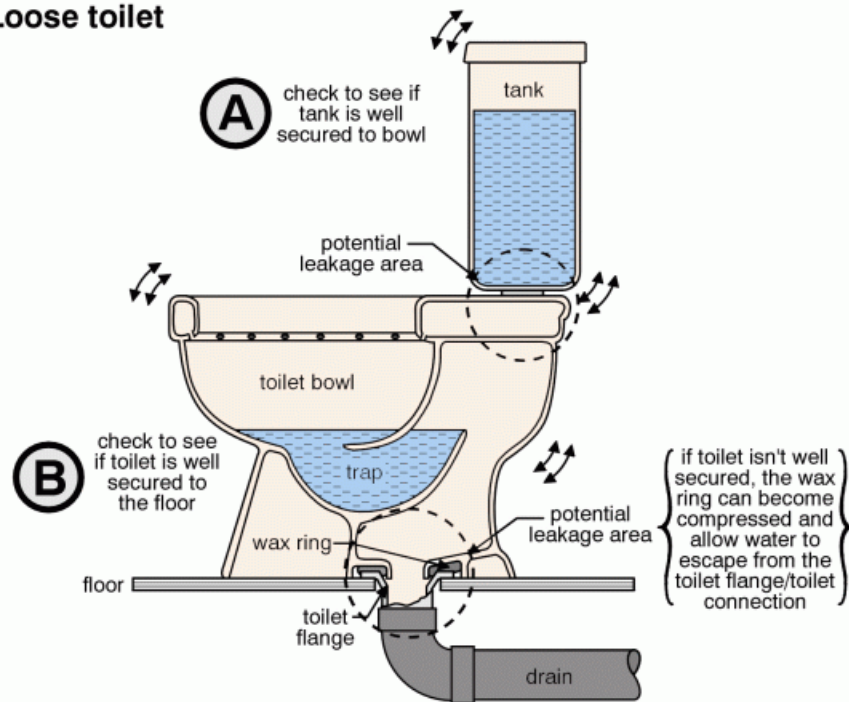
Loose toilet

Loose
