INSPECTION REPORT

SAMPLE REPORT

ANY PLACE, NY 11545

Prepared for: CLIENT HOME
Inspection Date: Tuesday, February 25, 2025
Prepared by: Rob Byrne

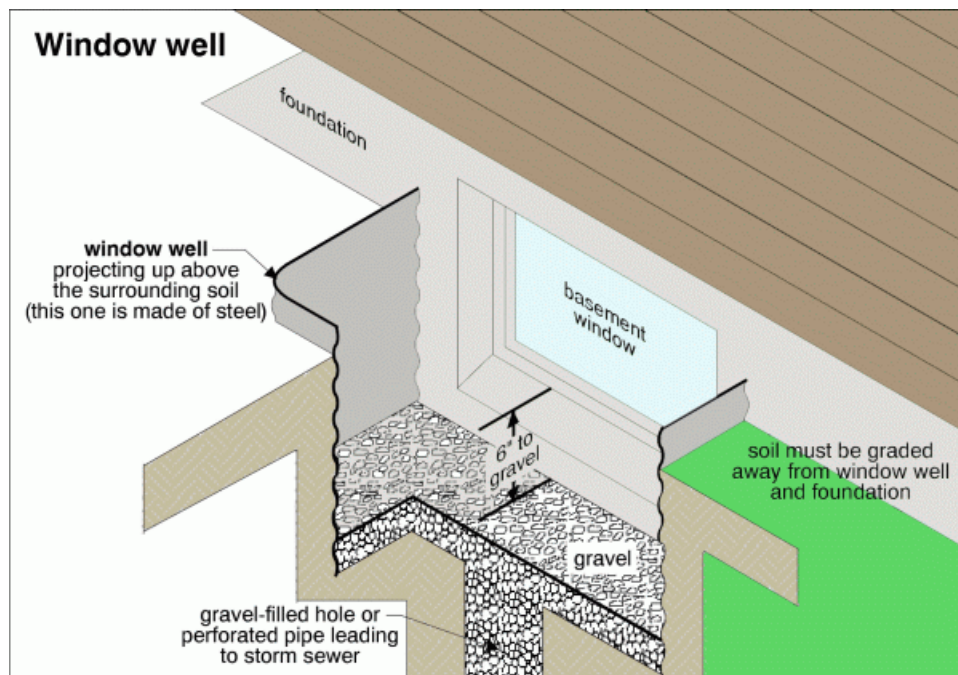
8. Condition: • [Missing](#)

Implication(s): Chance of water damage to structure, finishes and contents | Material deterioration

Location: Rear

Missing

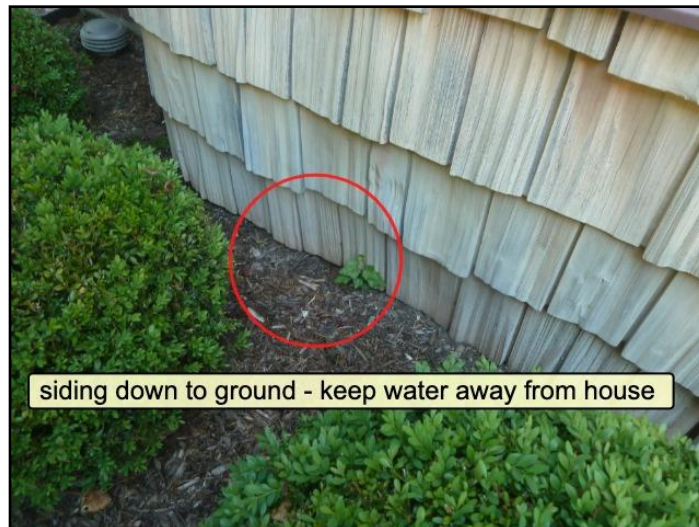
Siding close to ground is conducive to hidden moisture damage. Keep water away from foundation.

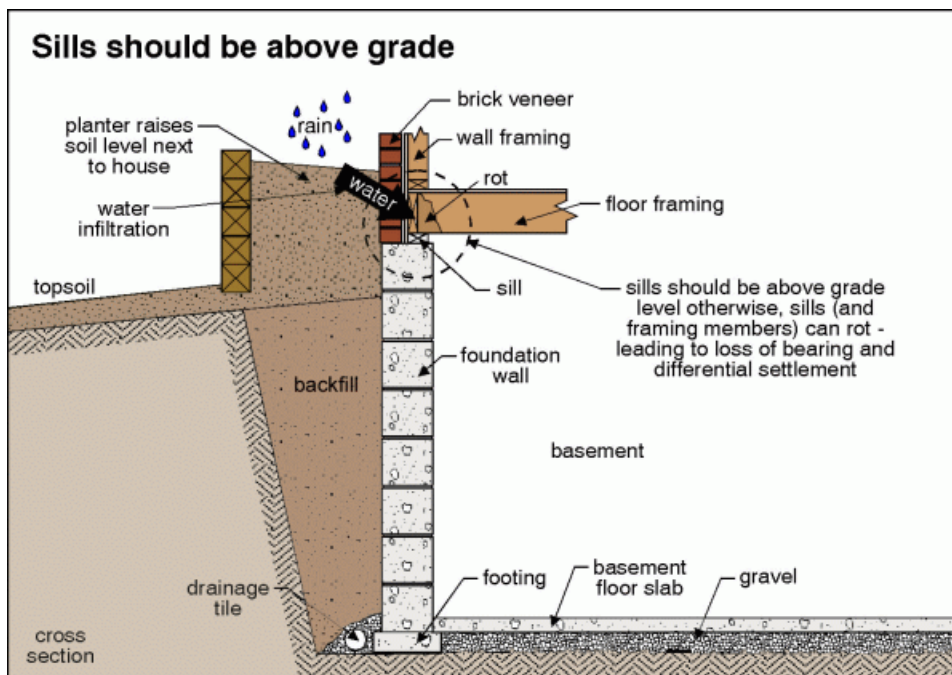
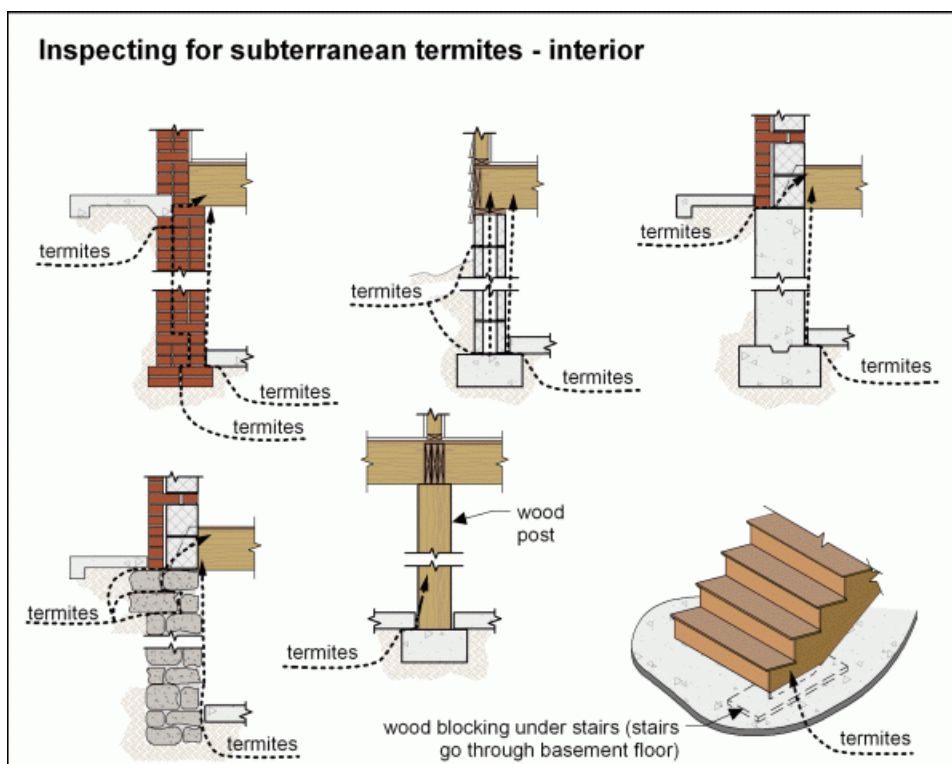
18. Condition: • Termite damage

damaged sill plate under basement stairs

Termite damage

Replace damaged wood when renovating.

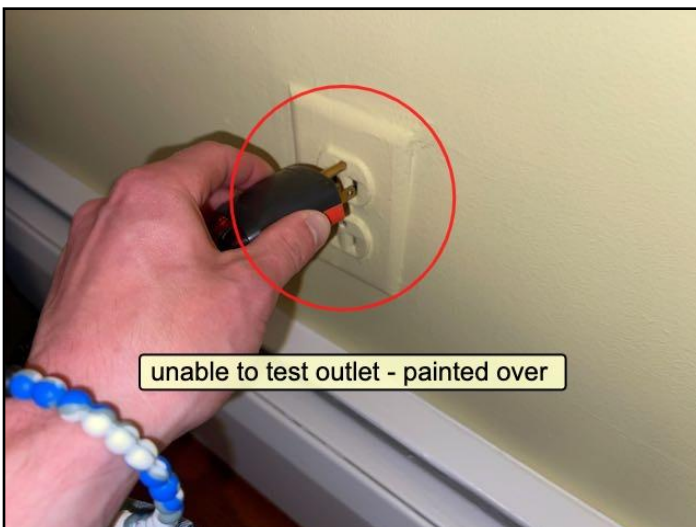
20. Condition: • [Ungrounded](#)

Implication(s): Electric shock

Location: Second Floor Bedroom

Ungrounded

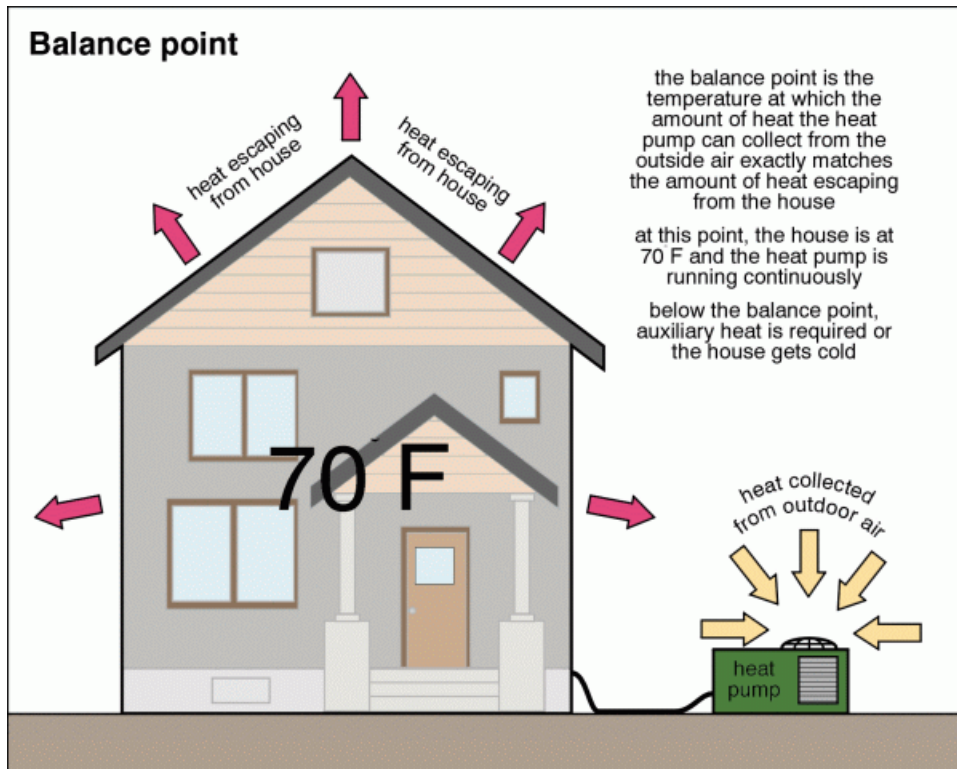
25. Condition: • [Inadequate cooling](#)

Implication(s): Increased cooling costs | Reduced comfort

Inadequate cooling

Condition: • [Inadequate cooling](#)
Air conditioner not working at time of inspection recommend further evaluation.
Implication(s): Increased cooling costs | Reduced comfort

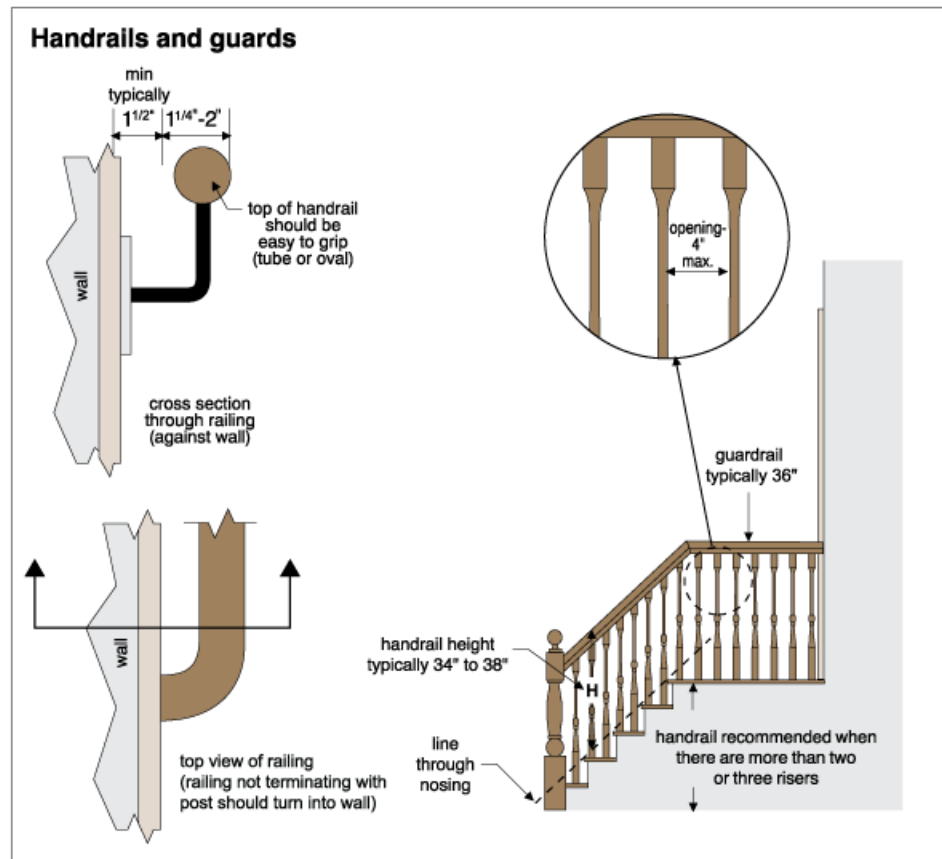
Implication(s): Fall hazard

Location: First Floor

Missing
